HOT DIP GALVANIZED STEELWORK USED TO WIDEN THE STORMS RIVER BRIDGE IN DECEMBER 1986

Our findings

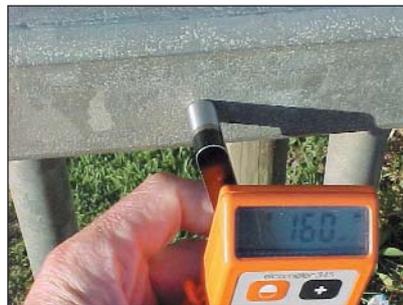
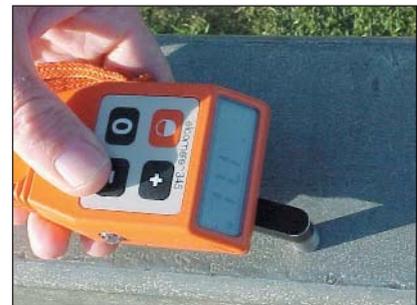
Photos 1 and 2 – Coating thickness readings on the side (160µm) and top of the handrailings (171µm).

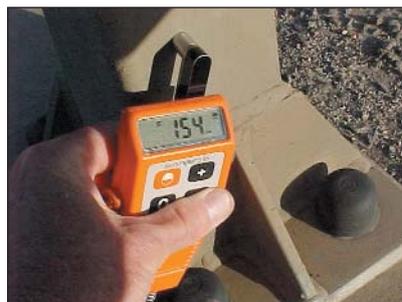
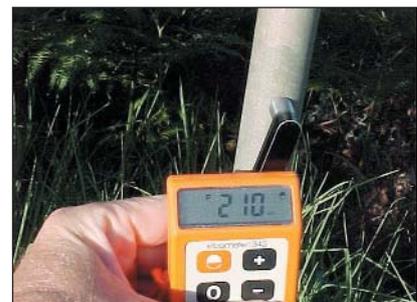
Photos 3 and 4 – Coating thickness readings on guard rail support (154µm) and balustrade transome (210µm) respectively.

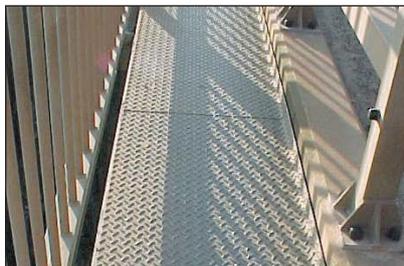
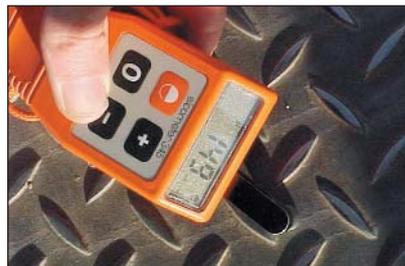
Photo 5 shows the general view of the "Vastrap Plate" walkway and photo 6 shows the general coating thickness, measured adjacent to the anti-skid ridges ($149\mu\text{m}$).

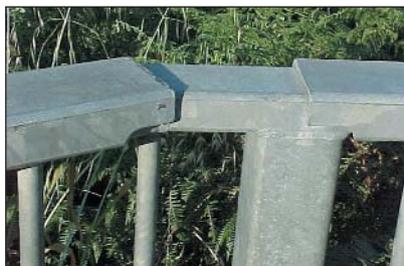
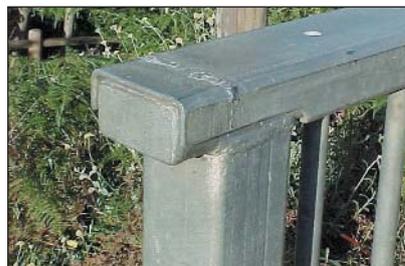
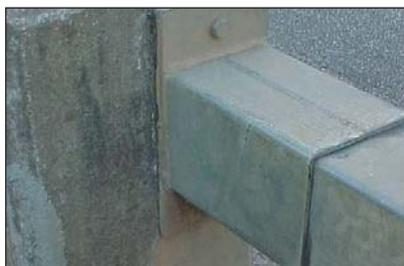
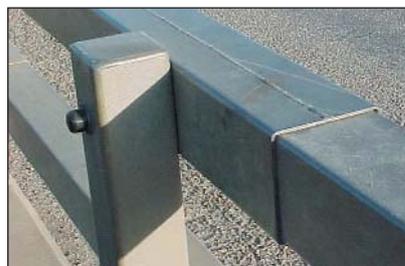
Photos 10 to 13, indicate how slip joint designs can eliminate the requirement for unnecessary site alterations and consequent coating repair.

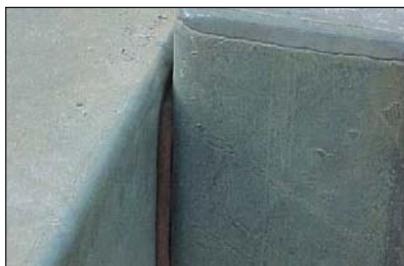
Photo 14. In order to avoid the possibility of crevice corrosion at construction joints, organic washers have been introduced.

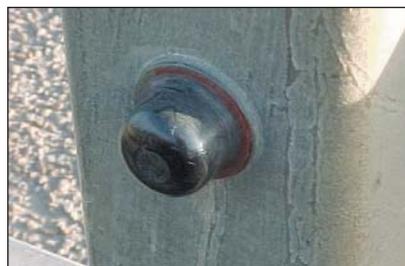
Photo 15. In order to increase the maintenance free life of the main fasteners, plastic covers were introduced, filled with a silicon sealant and then pressed home. Note the insufficiently coated washer (possibly electro-plated), which is now showing signs of corrosion.

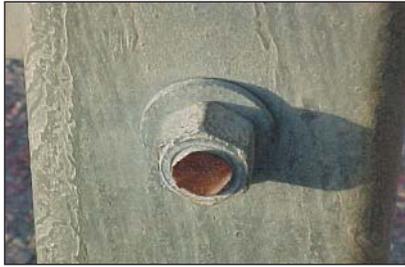
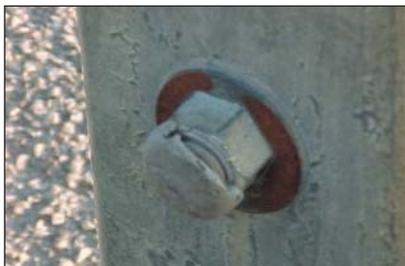
Photo 16 indicates a fastener that has lost its cover and 17 a damaged plastic cover and rusting washer.

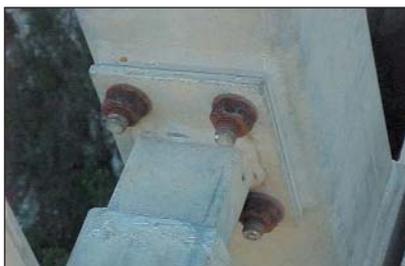
After approximately 18 years of service, the hot dip galvanized coating is providing the maintenance free life, originally specified by the client. Some fasteners, which were originally inadequately protected require coating repair. See photo 18. Should an adequate repair to these minor areas be done, the bridge will continue to provide effective corrosion protection for many, many years to come.

Photo 18. Some fasteners, which were originally inadequately protected require coating repair.
