# Evaluation of the hot dip galvanized coating on the access walkway for bungi jumping on the Bloukrantz Bridge along the N2, Eastern Cape

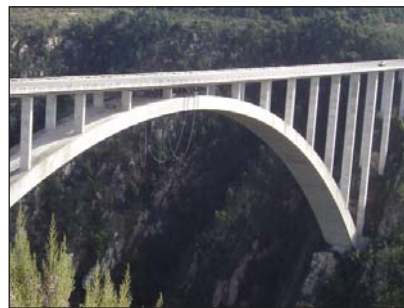
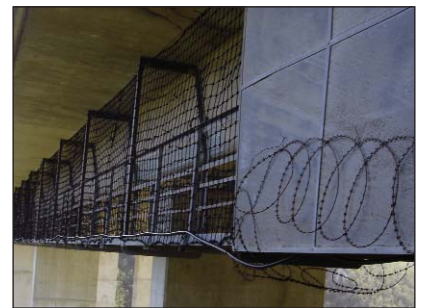
Left – A general view of the bridge from the landward side (the bungi jumping ropes can be seen in the centre of the bridge) and right - a view of the access walkway looking from the east end, fixed to the underside the bridge on the seaward side.

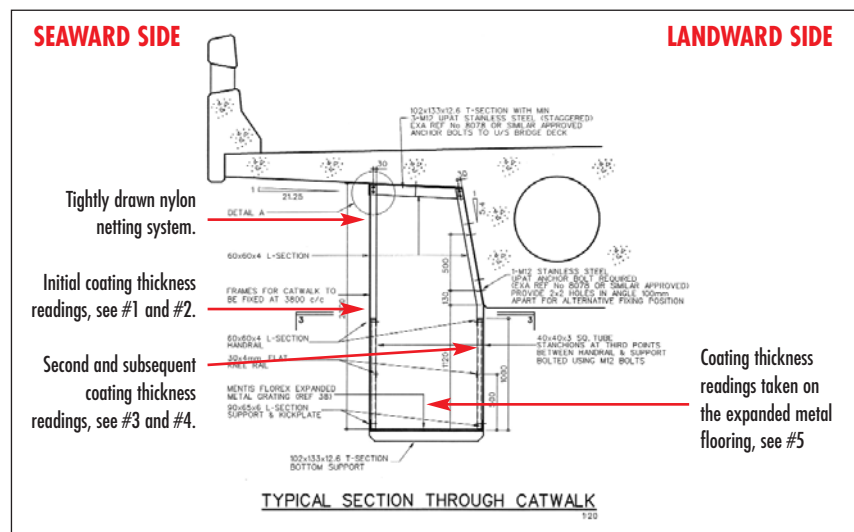
Cross sectional sketch of the walkway indicating where coating thickness readings were taken.

As the walkway was covered on the seaward side with a tightly drawn nylon netting system and other than one lot of readings, see #1 it was difficult to take all the coating thickness readings in this area. However, it was established that at several parts of the walkway the hot dip galvanized coating on the outside of the walkway was no worse than the areas that coating thickness readings were taken.

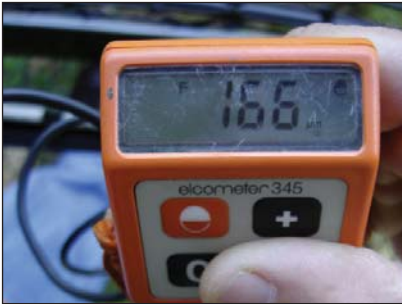
Photo 3.

Photo 3 indicates a typical coating thickness reading (166µm) taken on the east end on the seaward side of the walkway hand railing (where the nylon netting was pulled away) on an area that was scrapped clean of the zinc chloride salt layer (see further readings #1 - table 2), photo 4 - the coating thickness including the zinc chloride layer (163µm) and photo 5 where the zinc chloride layer was removed (154µm) – on the inside of the hand railing – #2 table 2.

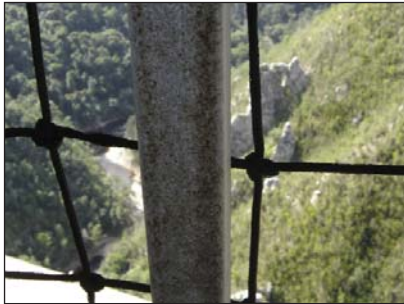
Photo 6.

Photo 6 shows the appearance of the coating on the first 40 x 40 x 3mm thick tubular stanchion (east end), photo 7 – the coating thickness

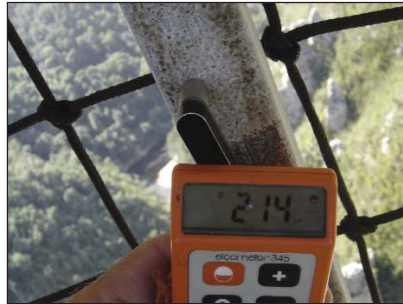
Photo 7.

including the zinc chloride layer (214µm) #3 table 3 and *photo 8* – the coating thickness reading where the coating was cleaned (92µm) #3 table 3.

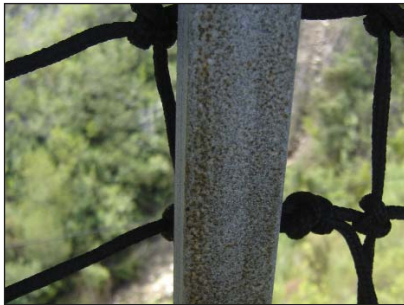
Photo 9.

*Photo 9* shows the appearance of the coating on the stanchion on the west end, *photo 10* – the coating thickness including the zinc chloride layer (291µm) #4 table 3 and *photo 11* – the coating thickness reading where the coating was cleaned (77µm) #4 table 3.

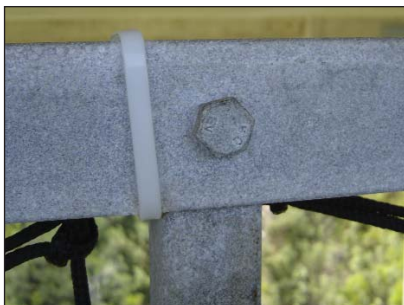
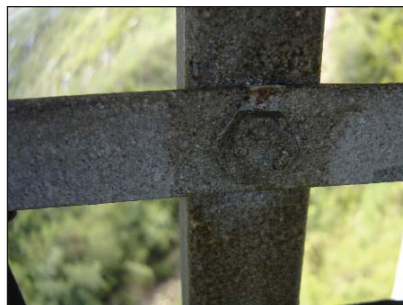
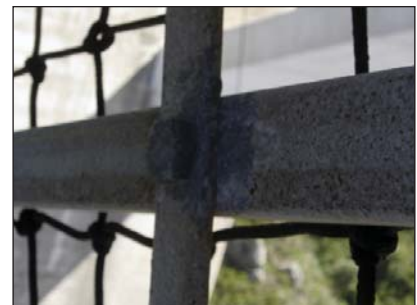
Pictorial view of the hot dip galvanized bolts on the inside of the walkway, the two on the left are facing the seaward side, with the one on the right having been over coated with paint.

- ◆ Areas that require coating repair using an approved coating repair material in accordance with the attached procedure are: All fasteners; all areas that were previously damaged and originally repaired by means of a zinc rich paint and all local areas that have subsequently been damaged and are showing discoloration or rust.
- ◆ The expanded metal flooring can also be repaired but due to the constant abrasion provided by the feet of passing traffic, may be better off being replaced using newly hot dip galvanized panel/s.
- ◆ All subsequent welding of the newly hot dip galvanized expanded metal flooring must be repaired in accordance with the Association

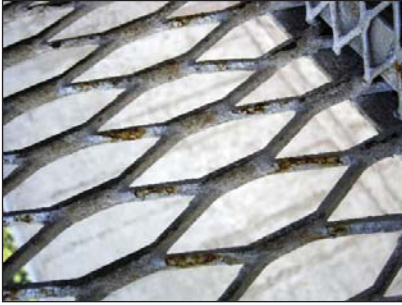
Photo 15.

*Photo 15* shows the expanded metal flooring where due to discoloration of the hot dip galvanized coating, the expanded metal was painted. The photo shows the delaminating of the paint coating. *Photos 16* and *17* show the

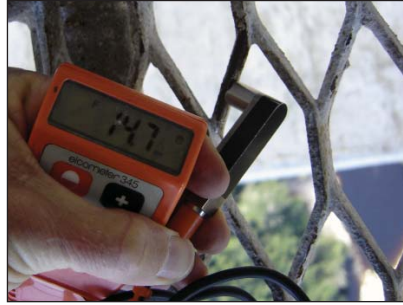
Photo 16.

residual hot dip galvanized coating thickness (14.7 and 16.3µm respectively). See #5 table 3.

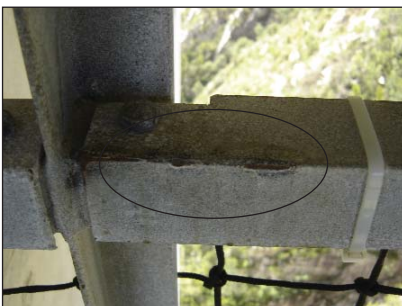
Photo 18.

*Photos 18 - 23* show where the coating was originally over cleaned and not repaired or damaged and repaired inappropriately, which has subsequently failed. *Photo 19* shows a damaged area with the zinc rich paint repair coating that has now failed and *photo 20* shows the residual coating thickness (15.6µm) at the damaged area. In *photo 22* the adjacent coating alongside the damaged area was measured to be 162µm thick and in *photo 23* residual coating thickness was

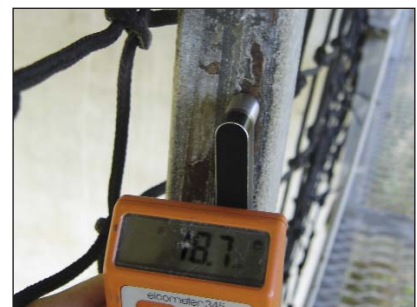
Photo 23.

measured at the damaged area (18.7µm).

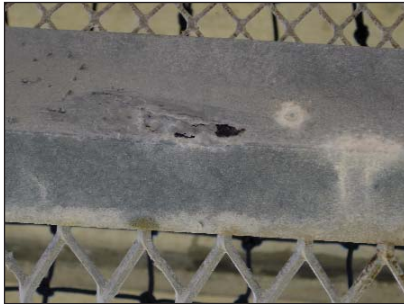
Photo 24.

*Photo 24* shows under creep film and a zinc rich paint coating failure. The zinc rich paint was most probably originally applied over a damaged hot dip galvanized coating. Unfortunately, the position of this damaged and repaired coating was out of reach so that the paint coating could not be scraped off and the surrounding hot dip galvanizing, assessed. It is felt, however, that when the paint is removed an uncoated area will be revealed surrounded by a metallic zinc coating and this should be repaired in accordance with the coating repair procedure. Corrosion at this point will be localised and concentrated at the

area of damage. Corrosion creep with hot dip galvanized coatings is impossible.

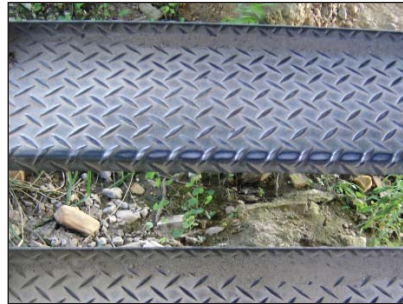
Photo 25.

The vastrap stair treads have been in place for 10 years and first impressions indicated that the coating had been worn off at the edge of the stair tread. Taking coating thickness readings proved to the contrary that a residual coating existed (see photos 25 and 26 (49µm)). Walking on the vastrap plate stair treads, the hot dip galvanized coating on the edges seemed to have been worn off by the passing traffic. A residual coating thickness, however, in excess of 40µm, was found in most instances.
