An evaluation of hot dip galvanized cable ladders after being exposed for some 25 years at a Cape Town Petro-Chemical Plant

Case History No. 18/2009

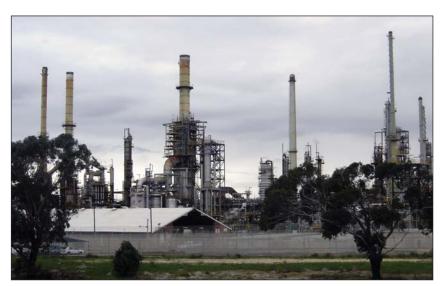
The general view on the petro chemical plant in Milnerton.

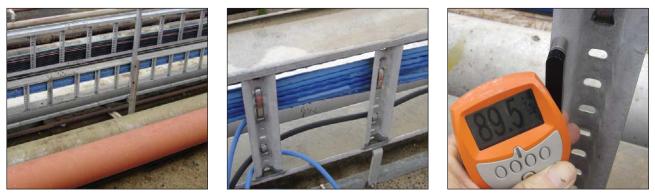
Photo left shows the A&S Cable ladder in the foreground and a more modern edge mounted cable ladder in the background. Centre shows a close up of the A&S Cable ladder and right, residual coating thickness on the cross rung (89.5 µm).

thickness greater than and equal to 1.5mm and less than 3mm the local coating thickness be 45µm and the mean be 55µm. The coating thickness readings taken on both the side rail and cross rung of the cable ladder in question, still generously exceed this initial requirement.

In requesting Association assistance in the evaluation of known aged hot dip galvanized components before over specifying the corrosion protection required by cable ladders for this plant, the electrical engineer, Ian McArthur has been rewarded with the knowledge that hot dip galvanizing on its own in most areas of the plant is the correct choice of corrosion protection.

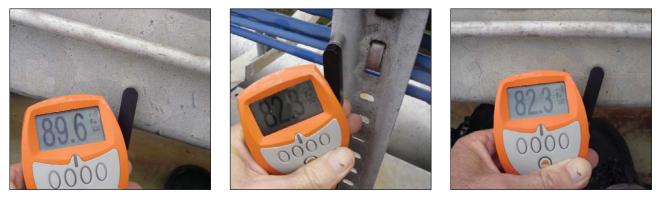
Photos above show coating thickness on the side rails (89.6 and 82.3µm) and again on the cross rung (82.3µm). Coating thicknesses are still well above that required by the standard.
