# Douglas Colliery

## Coating evaluation of overland conveyors V3, V4 and V5

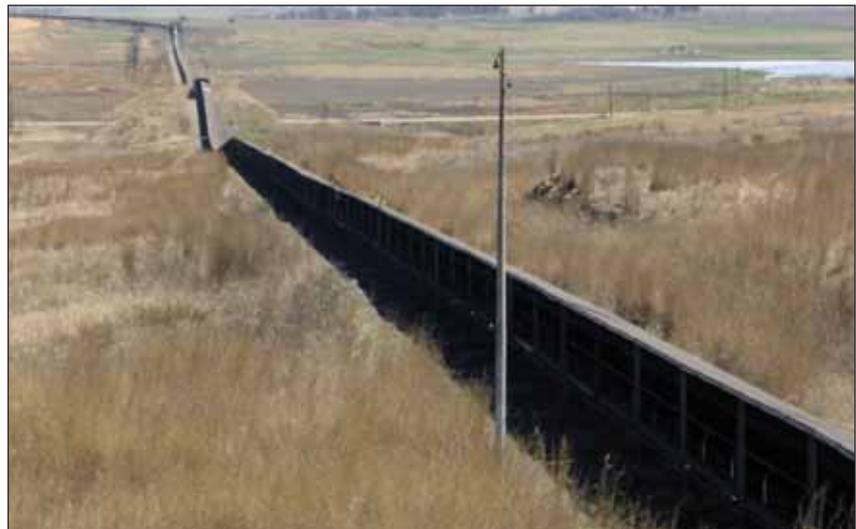
The V3 overland conveyor has been exposed to the elements for in excess of 20 years.

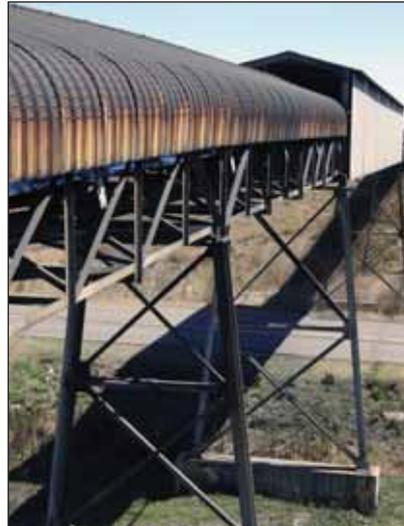
The hot dip galvanized structural steelwork supporting the overland conveyor at an access road, is still performing exceptionally well after 20 years of service.

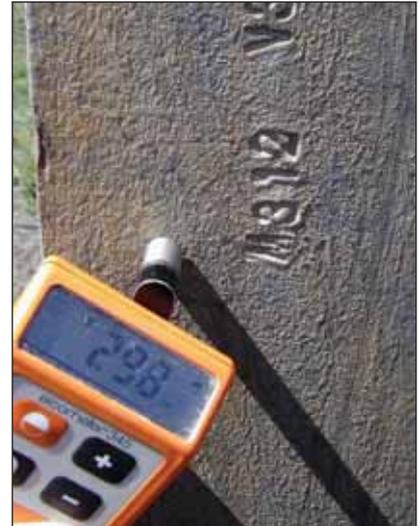
Coating thickness readings taken on the supporting structural steelwork at the access road were still in excess of that required by the specification.

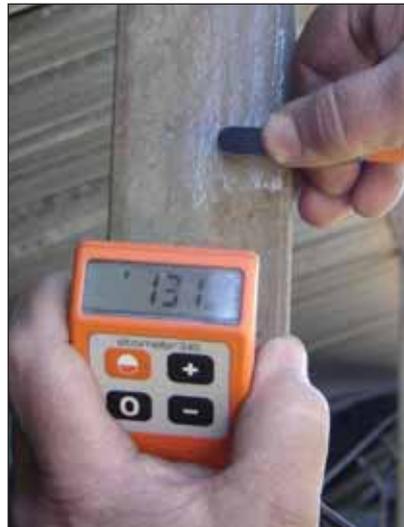
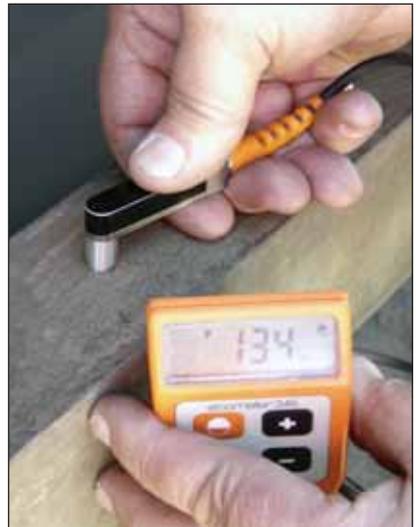
condition, with coating thickness readings varying between 117 to 279 $\mu\text{m}$  with a mean coating thickness of 140 $\mu\text{m}$ . The coating thickness readings are still well in excess of that required by the specification SANS 121, for this thickness of steel. All together 108 coating thickness readings were taken on both the horizontal and vertical angle support steelwork.

Coating thickness readings taken on all the horizontal and vertical overland conveyor steelwork were still in excess of that required by the specification.
