Evaluation of the hot dip galvanized coating at Pentrich Sub-Station, Mkondeni, Pietermaritzburg

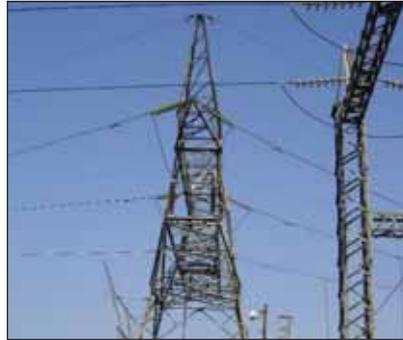
The 132/88kV terminal tower on the Georgedale / Pentrich line.

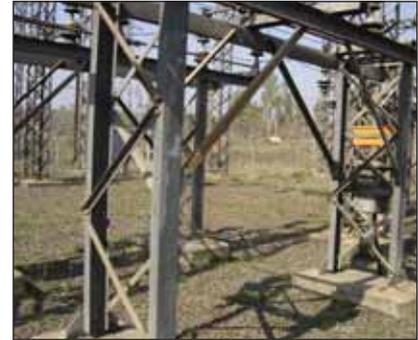
A typical 132/88kV isolator support.

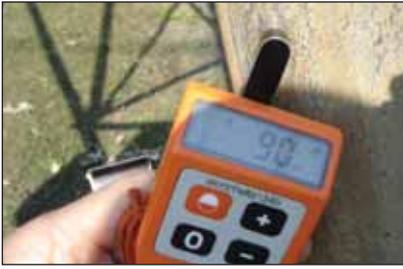
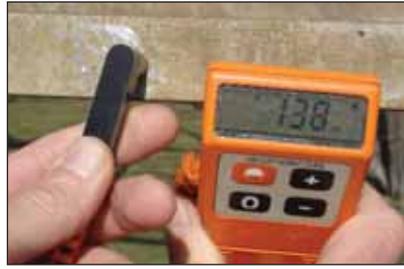
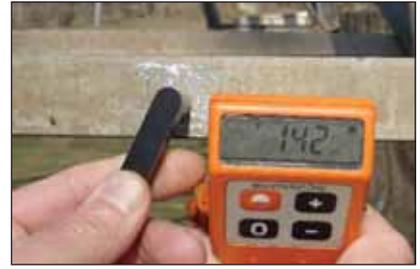
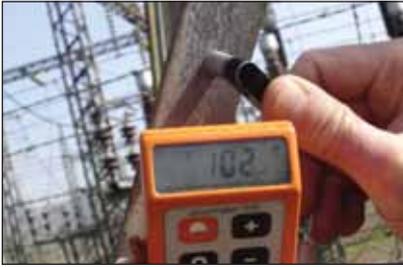
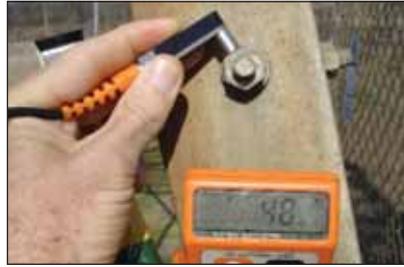
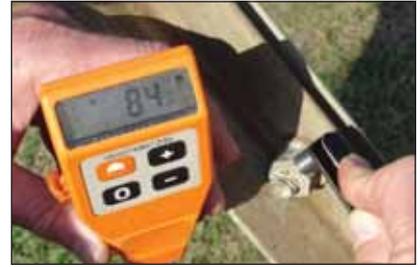
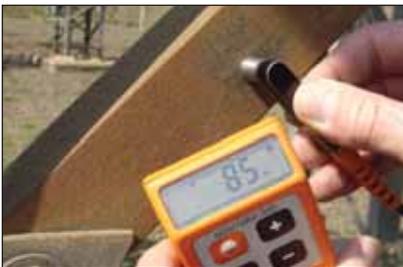
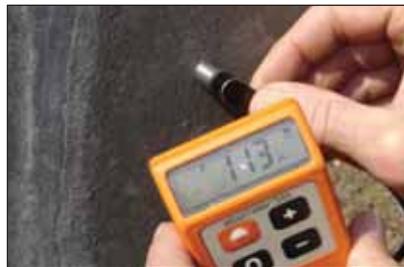
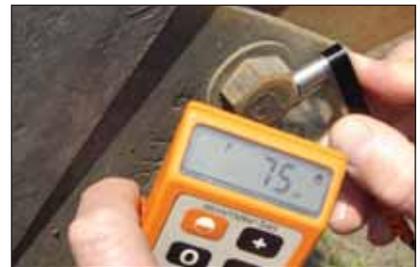
Photos above starting top left in each row show residual coating thickness readings of 90; 138; 142; 102; 48; 84; 85; 113 and 75 μ m, taken on the 132/88kV terminal tower and one of isolator supports.

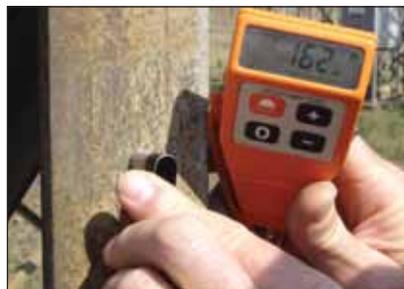
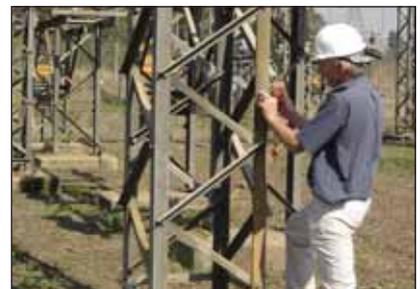
Photo right shows Mr Rob Maitland-Stuart of Eskom Distribution looking very satisfied at the thought of not having to refurbish the coating due to its substantial residual coating, see photo above left (162 μ m).

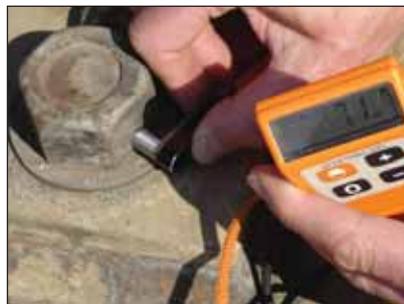
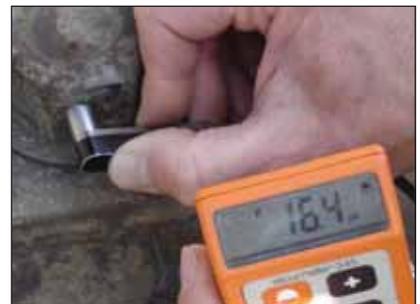
The paint support barrier over the HD nuts was easily removed and the residual zinc electroplated coating measured between 7.1 and 16.4 μ m.

The holding down nuts and bolts of all the structures from the coating thickness readings taken, seemed to have been originally zinc electroplated and are breaking down. The holding down bolts have subsequently been over coated using some zinc rich paint, which was scrapped off to measure the residual metallic zinc coating thickness. Although because of their size and the local atmospheric corrosion conditions, corrosion of these bolts in the medium term would never really compromise the life of the structure, they however should be repaired using an appropriate zinc rich epoxy.

“Zincfix” due to its convenient size, easy achievement of the required coating thickness in a single application and durable performance, is recommended as the preferred coating repair material. See the Association’s Coating Repair Procedure.

The uncoated holding down bolts and zinc electroplated nuts, should be suitably cleaned and comprehensively over coated with an approved paint
