# Goedehoop Colliery

## The application

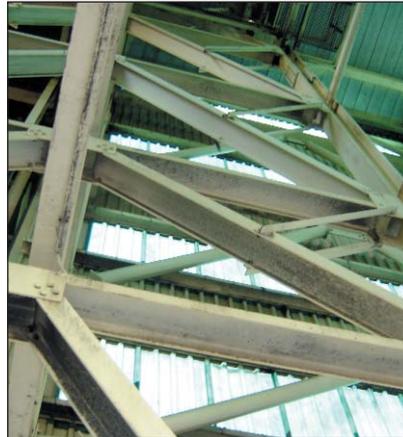
General photo of the structure.

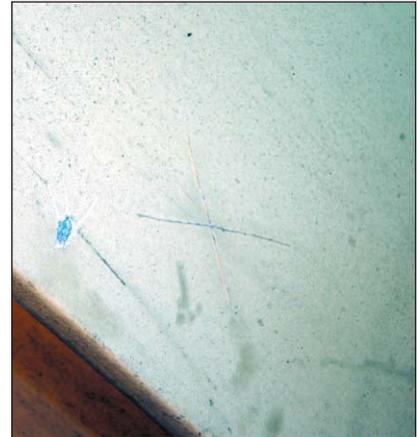
Cross cutting proved that adhesion of the coating was sound.

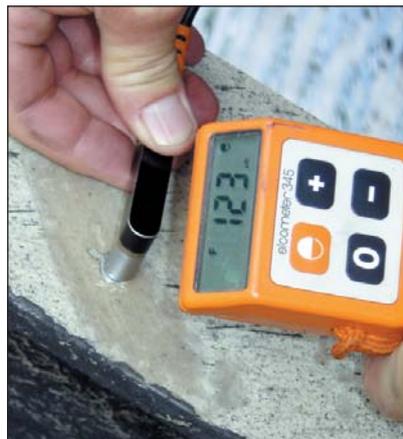
Hot dip galvanized coating thickness (paint removed).

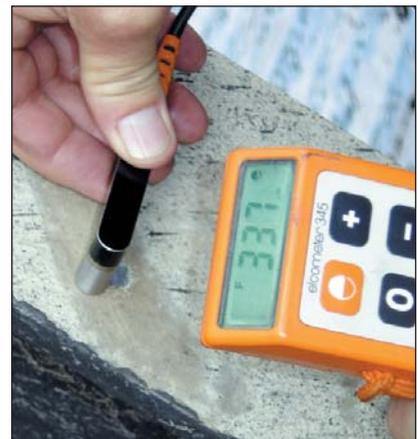
Total duplex coating thickness.

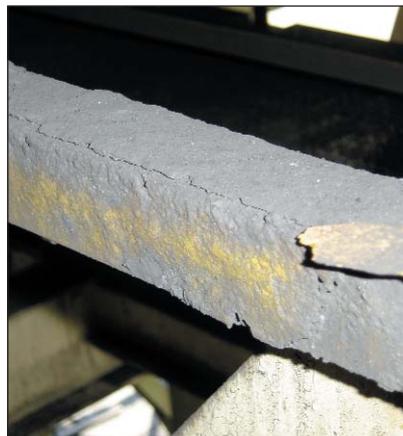
In comparison the paint coating on the carbon steel hand rails of the coal washout facility had failed.

In comparison the paint coating on the carbon steel handrails has failed.

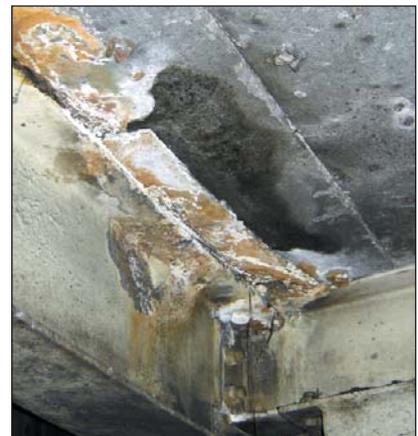
Although in existence for a number of years the old wash out plant was found to have several coating failures. Coatings in these conditions are extremely difficult to maintain unless the entire operation is shut down.

General corrosion conditions of the coal washout facility.
