Eskom coastal sub-stations

Accompanied by Jannie du Toit of Eskom Brakenfell, Cape Town, Duine, Paardekloof and Rietvlei sub-stations were visited at the tail end of February 2014 and the hot dip galvanizing inspected and evaluated. *(Due to a space constraint only Duine Sub-Station is reported in this case history. The other two will follow in subsequent editions).*

Duine Sub-Station

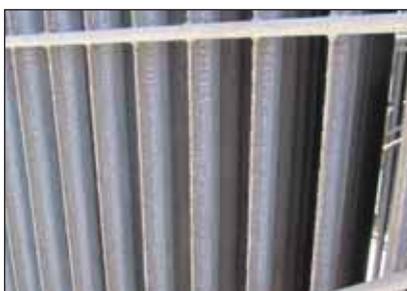
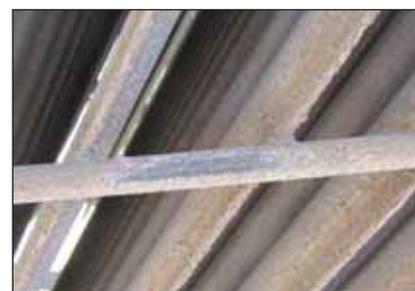
Edge of the radiator (above left) and close up of the edge of the radiator showing visible marine chloride salts and an area cleaned for taking coating thickness readings (above right).

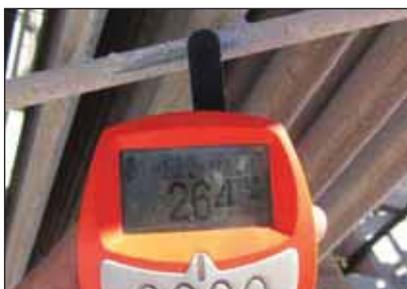
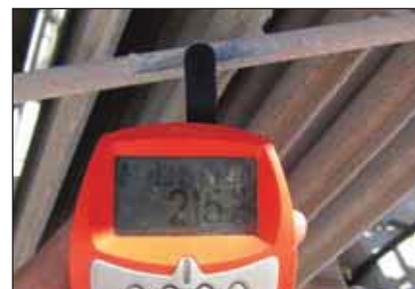
Above left and right: Residual coating thickness readings of 264 & 215µm respectively on the bracing struts.

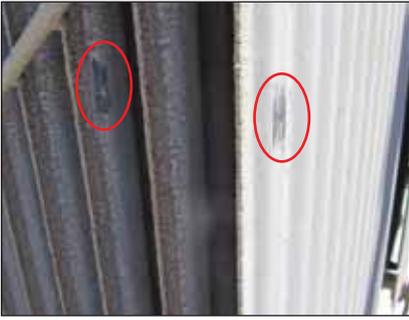
Edge of the radiator showing the two cleaned areas where residual coating thicknesses were taken.

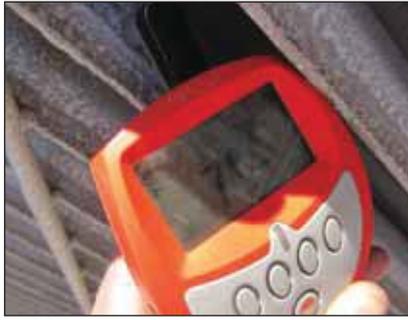
Above left and right: Residual coating thicknesses of 71.4 and 69.0µm respectively.

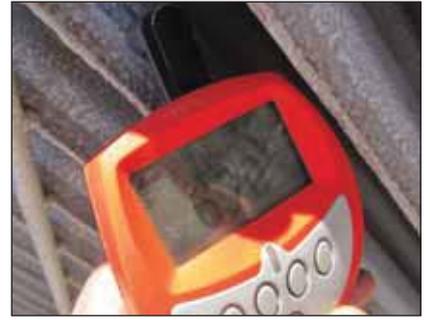
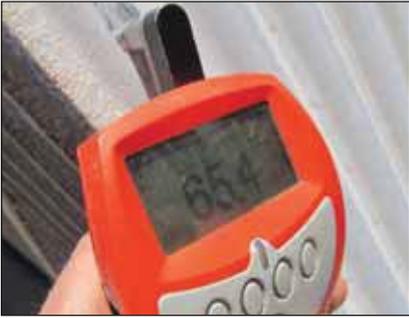
Above left and right: Residual coating thicknesses of 65.4 & 75.2µm respectively.

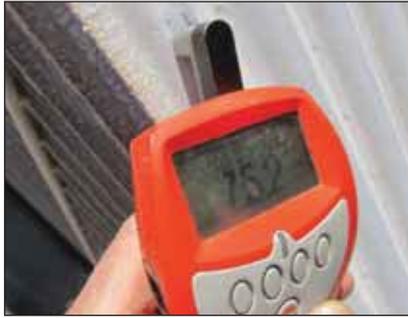
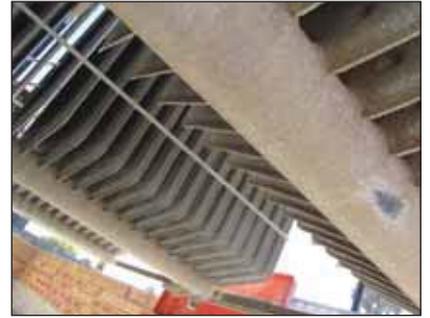
Chloride salts cleaned off the underside of the radiator.

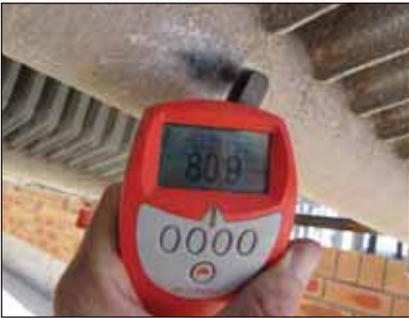
Above left and right: Residual coating thicknesses of 80.9 and 98.8µm respectively taken on the underside of the radiator.

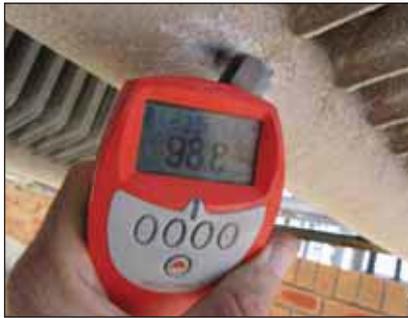
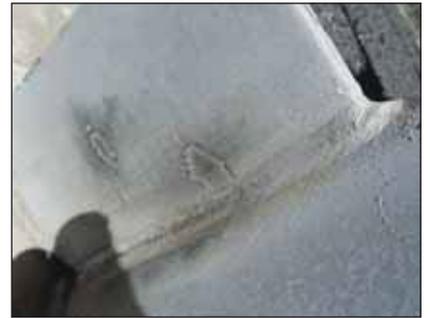
Areas of coating damage (no corrosion creep).

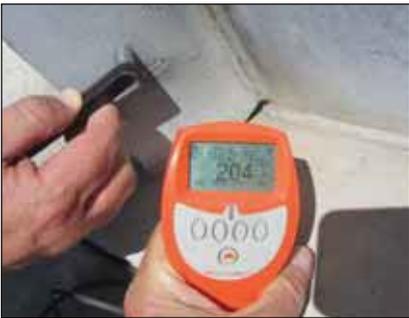
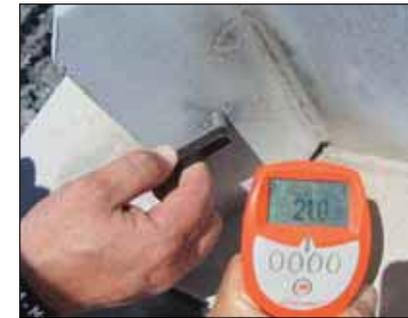
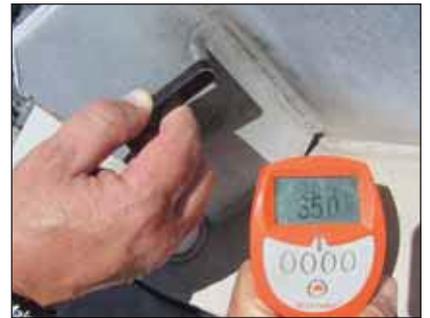
Above left, centre and right: Residual coating thicknesses adjacent to mechanical damage of 204µm, residual iron zinc alloy coating thickness at damage of 21.0 and 35.0µm respectively.

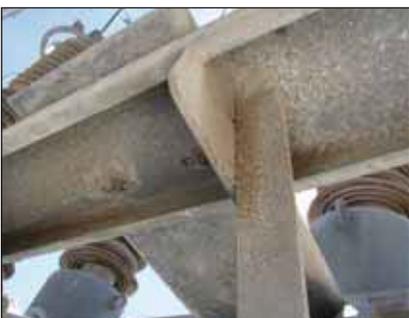
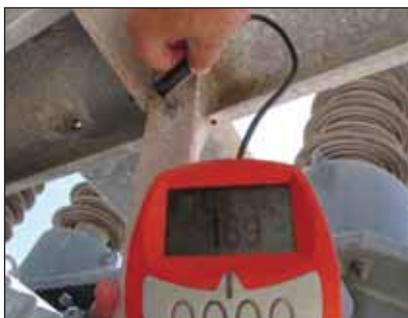
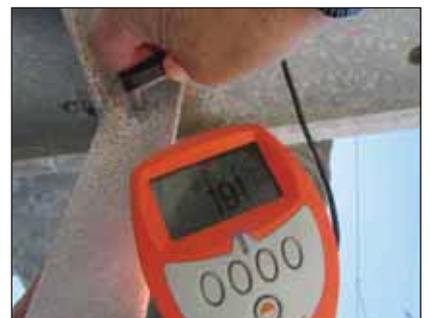
Above left, centre and right: Appearance of the coating on support angle, with residual coating thickness taken at a cleaned area of 169 and 191µm respectively.

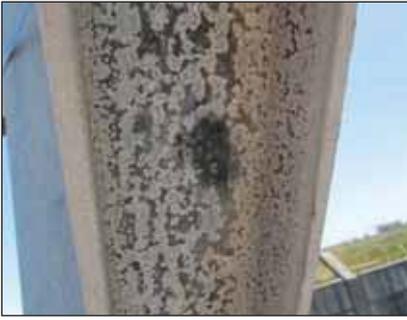
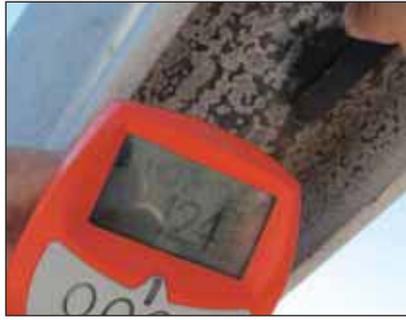
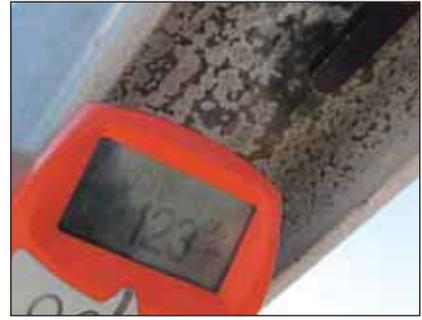
Above left, centre and right: Another component showing visible chloride salts, removed and residual coating thickness readings of 124 and 123 μ m respectively.

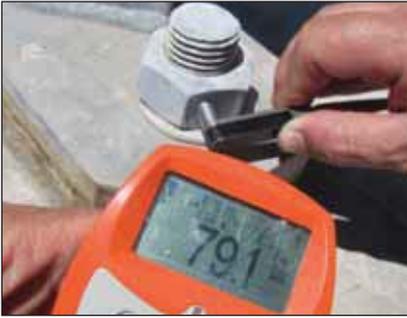
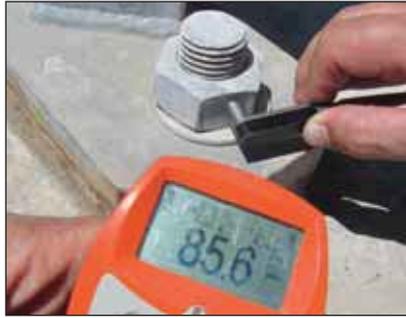
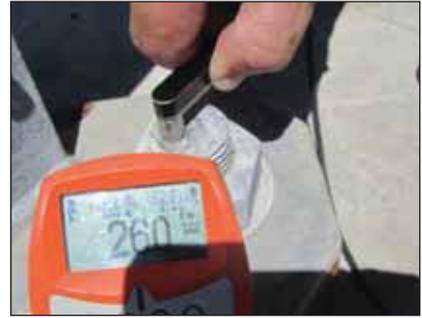
Above left, centre and right: Residual coating thickness readings on cleaned holding down nuts and bolts of 79.1, 85.6 and 260 μ m respectively.

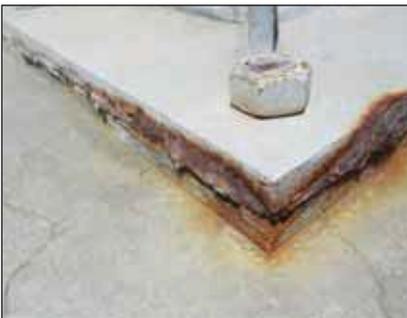
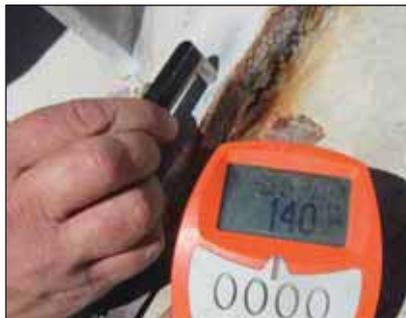
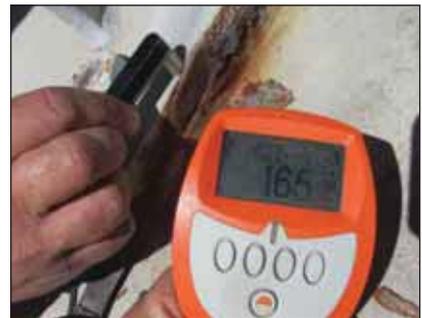
One single base plate showed corrosion on the edge. Residual coating thickness readings of 140 and 165 μ m were taken adjacent to the corroded area. A possible cause is an original over cleaned edge or use of an acidic grout.

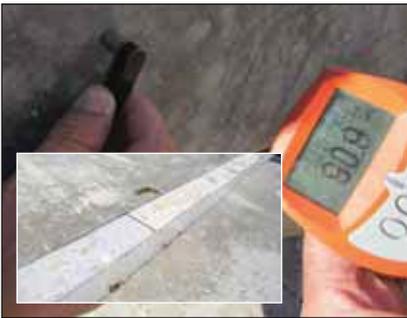
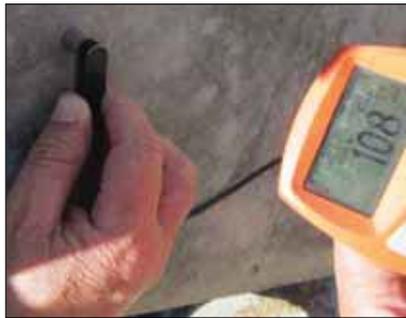
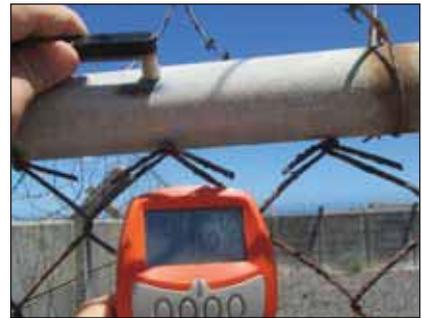
Insert showing galvanized steel duct cover plates. Above left and right: Coating thickness readings of 90.9 and 108 μ m respectively on the underside of the duct cover plates.

Coating thickness reading of 112 μ m on the steel entrance gate.

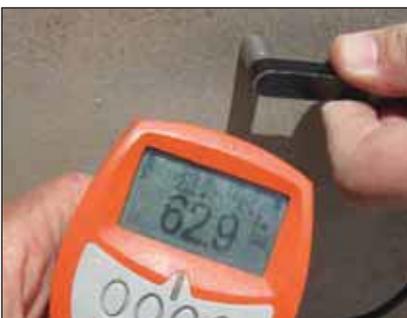
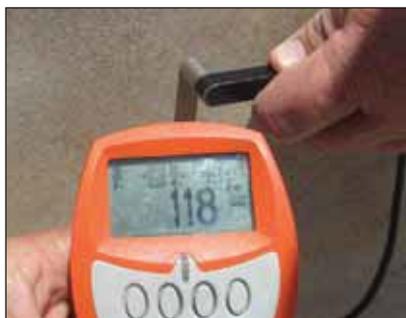
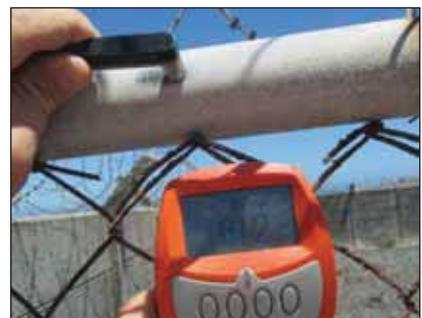
Above left and right: Coating thickness readings of 62.9 and 118 μ m respectively on the topside of the duct cover plates.

Coating thickness reading of 61.2 μ m on the steel entrance gate.
