# The performance of Pandrol rail fasteners in a marine environment on the Natal South Coast

Two sites were selected on the Natal South Coast for this study, viz, Park Rynie some 65kms south of Durban and Port Shepstone, 115kms south of Durban. Both areas were selected on the basis of their proximity to the sea being within 100 to 200 metres of the high water tide level. Surrounding corrosive conditions were observed by the review of other steel components in the area.

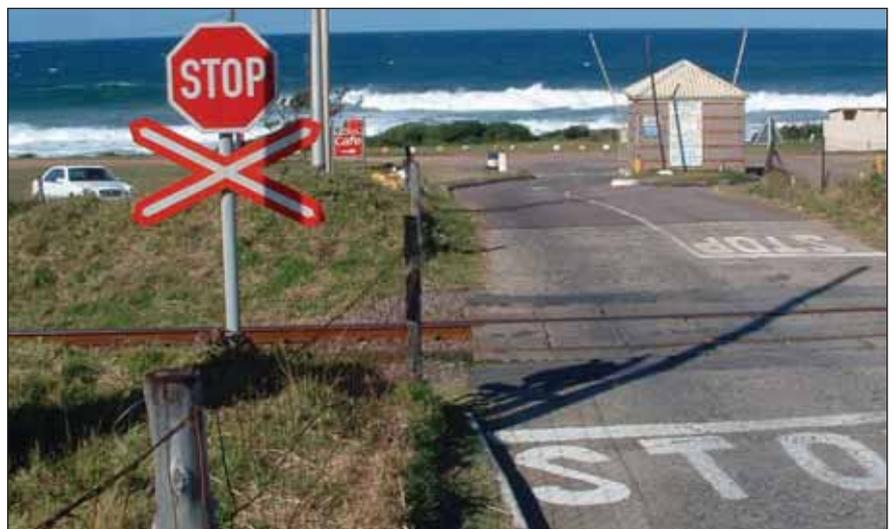
Figure 1.

- The Park Rynie site (*figure 1*), visited on 19 May 2004, is located approximately 65kms south of Durban. Zinc coating thicknesses measured as follows: minimum 83 $\mu$ m, mean 121 $\mu$ m and maximum 150 $\mu$ m.
- Coating thickness measurements were taken on a Pandrol rail fastener and cast iron shoulder, both components having been hot dip galvanized. The hot dip galvanized coating on the Pandrol rail fastener measures 143 $\mu$ m (*figure 2*).
- Coating thickness of the hot dip galvanized cast-iron shoulder measured 134 $\mu$ m (*figure 3*). It is estimated that these components have been in service for between 18 to 20 years. By

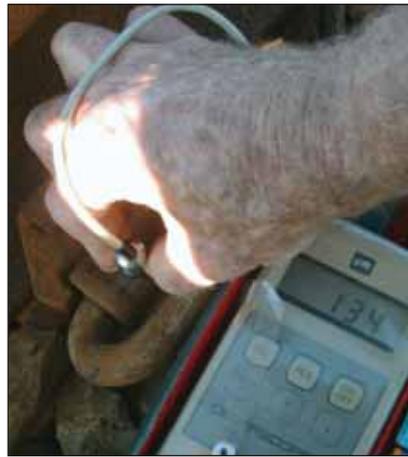
Figure 3.

providing the same degree of corrosion protection to the shoulder clip assembly, a balanced design is achieved without the potential for a galvanic couple.

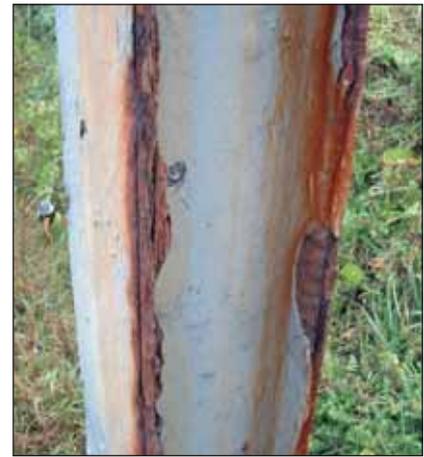
Figure 4.

- A painted steel mast at the Park Rynie rail crossing illustrates the severity of the corrosive environment experienced at this particular site (*figure 4*). It is believed, subject to confirmation, that this mast was coated with an epoxy tar.

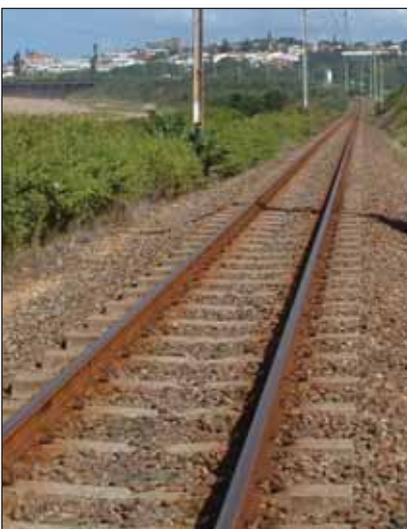
Figure 5.

- The sea is approximately 200 metres to the left of the Port Shepstone site and the town some 6kms further south (*figure 5*). Zinc coating thicknesses measured as follows: 136 $\mu$ m minimum, 154 $\mu$ m mean and 197 $\mu$ m maximum.
- The seaside (using an ungalvanized cast iron) shoulder had corroded away exposing the hot dip galvanized Pandrol (*figure 6*). The holding capacity of this particular fastener has become totally ineffective. Note the condition of the "land (lee) side" of the rail, where the system is intact and operative.
- *Figure 7* shows an example of a missing fastener, where the "ungalvanized" cast-iron shoulder is presumed to have

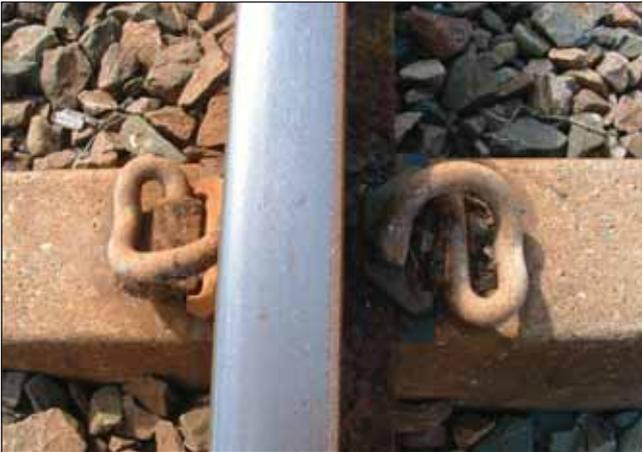
Figure 6.

corroded away, allowing release and removal of the hot dip galvanized Pandrol fastener. No trace of the Pandrol rail fastener was found.

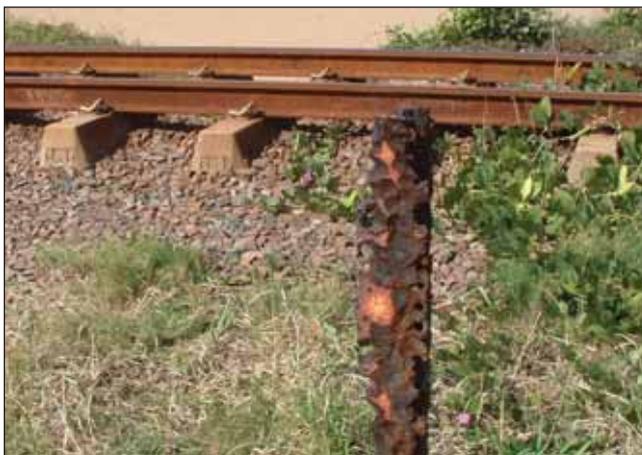
Figure 8:

- Figure 8 is a general view across the rail track illustrating the location of the site relative to the sea and the resultant marine environment. Note the severe corrosion of the steel fence post in the foreground.
- Figure 9 indicates the condition of an un-galvanized rail fastener, which is obviously a replacement as it has been installed in the reverse direction to all the other hot dip galvanized fasteners. Note the severe corrosion of the un-galvanized cast-in shoulder and the "pitting type" corrosion that has developed on the un-galvanized Pandrol rail fastener.

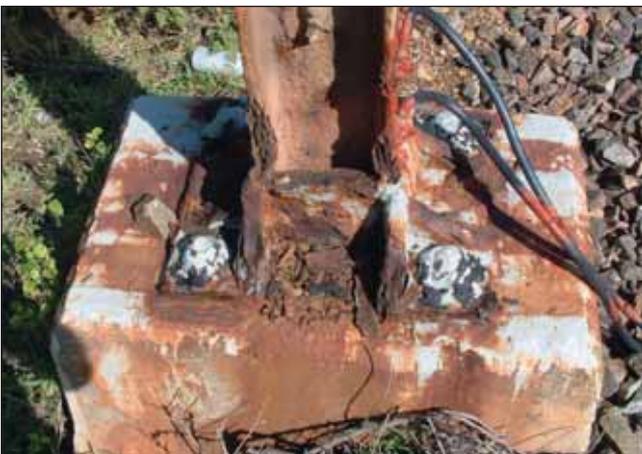
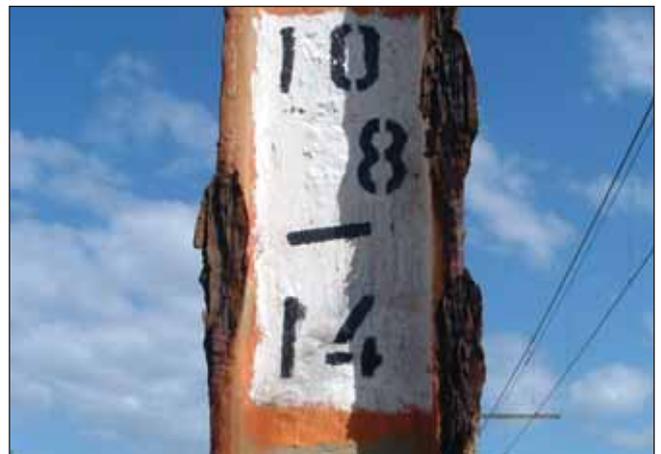
Figures 10 and 11 are an indication of the corrosive conditions that can be determined from the state of mast 108/14 together with its base. These "ungalvanized" components would appear to have been coated with an epoxy tar or a bitumastic compound. Where the protective coating had been penetrated, corrosion of the steel is at an advanced state. ➡➡
