Electrical transmission towers

The application

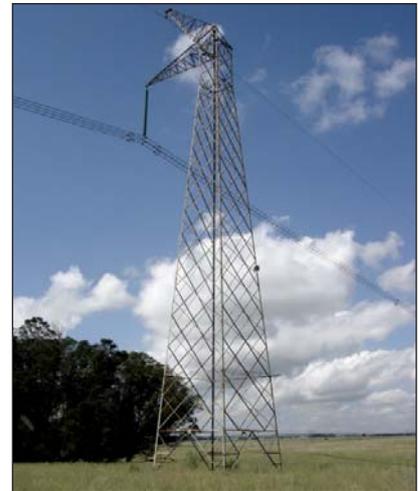
Relatively benign conditions.

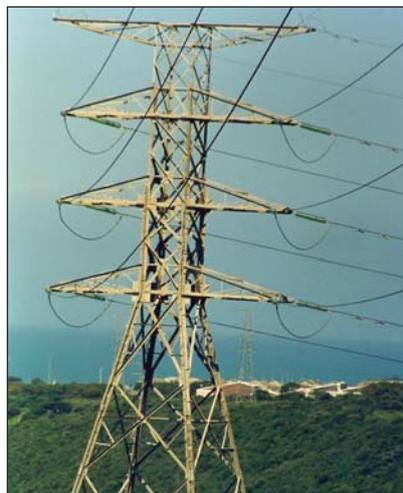
Severe marine coastal conditions. Buffalo-Port Rex Transmission line situated in East London. At the time of the coating inspection, the towers had been in service for about 25 years.

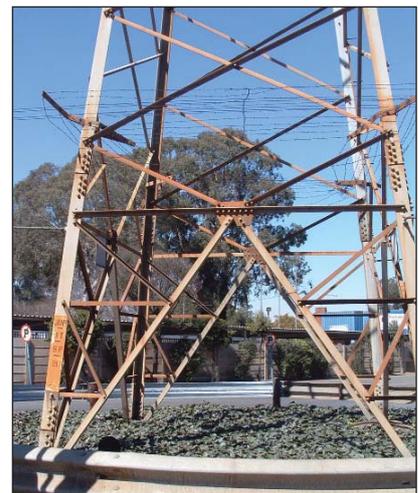
Inland industrial site selected for its relatively severe corrosive conditions. This site is located within Germiston Industrial area. The specific tower is believed to have been in service for the past 50 years.

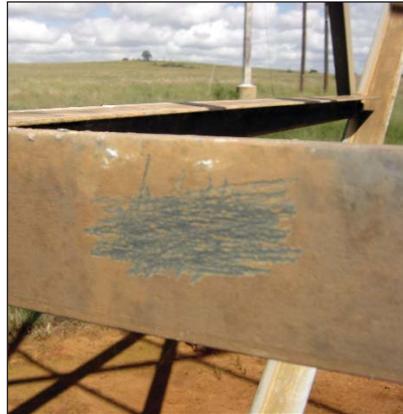
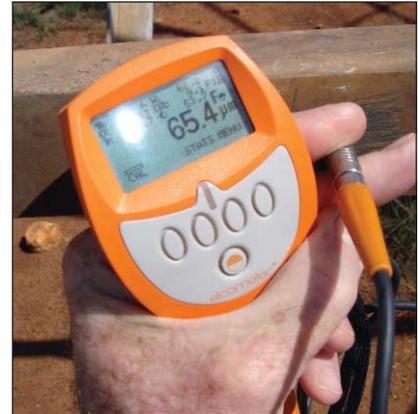
After removing the "apparent" rust discolouration, the underlying zinc hot dip galvanized coating measured

65.4mm. Accuracy of the instrument is approximately 5%.

Site No 1. – After removing the “apparent” rust discoloration, the underlying hot dip galvanized coating measured 65,4µm. Accuracy of the instrument is approximately 5%.

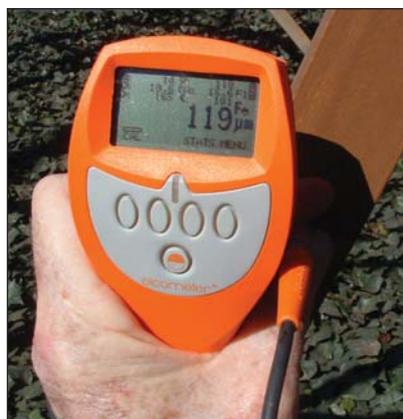
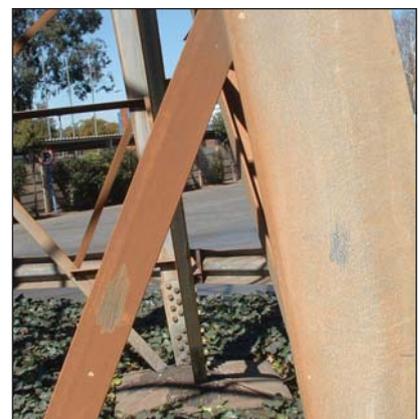
After the removal of the discolouration, i.e. corrosion products, a measurement of the remaining hot dip galvanized coating revealed 119mm.

Site No 2. After the removal of the discoloration, i.e. corrosion products, the hot dip galvanized coating thickness measured to be 119µm.

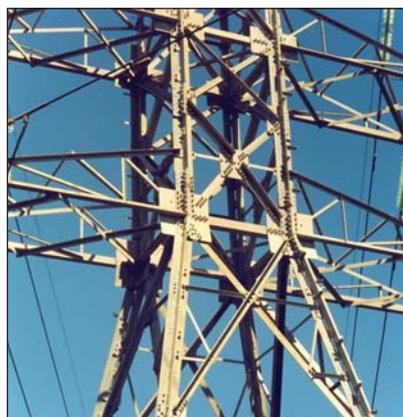
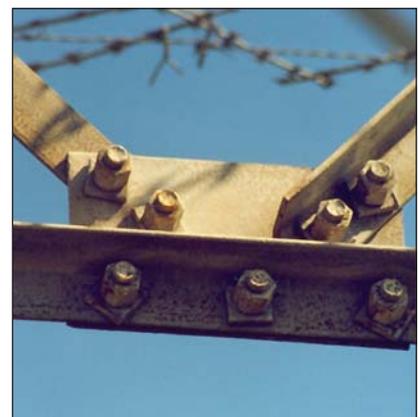
General condition of the tower after 25 years of service, was found to be such that an over coating of a paint system was recommended in order to extend the service life of the structure.

The tower that was inspected is situated approximately 3km from the ocean next to the Buffalo River salt-water estuary, as well as alongside a city dump. At the time of the inspection the tower had been in service for 25 years. The initial corrosion protection comprised hot dip galvanizing and had never been over coated with an organic coating system. Severe corrosion with subsequent metal loss was observed on some of the structural members. In one isolated instance the degree of metal loss was so severe that it had resulted in the perforation of the member. The nuts and bolts of these corroded members were also severely rusted. The most severe corrosion was mainly located on the inner surfaces of the members. The members that showed severe signs of corrosion were either perforated or the degree of metal loss was in the 1 to 2mm range. The outer surfaces of these members were only superficially corroded and the hot dip galvanized thickness readings ranged from 87 and 104µm.

Site No 3. General condition of the tower after 25 years of service. A subsequent paint coating (providing a duplex coating system), has been recommended in order to extend the life of the structure.
