PGM Concentrator

The application

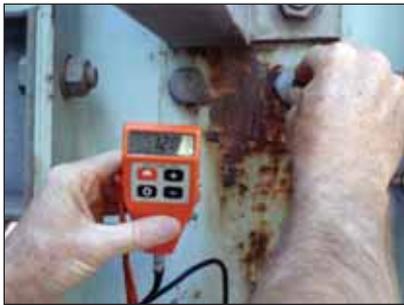
Photo 1: Comparison between hot dip galvanizing and paint in the reagent area.

Photo 1 shows that in comparison to the coating on the hot dip galvanized bolt (128 μ m), the performance of the paint system has been marginal. Although the use of hot dip galvanizing in this area was excluded, some installed components and structures were hot dip galvanized and have performed extremely well. The performance of the coating in this area suggests that hot dip galvanized steel would have been the better option than the paint system originally selected.

Due to the fact that reagents may be altered over the life of the plant and that other concentrators may use a different suite of reagents, it may be more prudent in other cases to consider a duplex coating system.

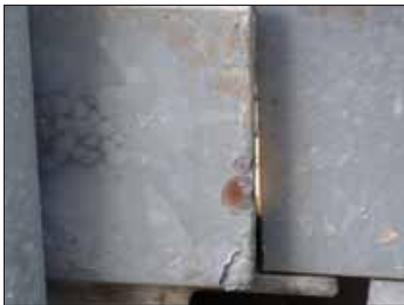
Damaged coating in reagent loading area.

Having walked throughout the plant, apart from a bit of discoloration at a welded and non-repaired area on a bracket and a damaged coating in the Reagent Loading area, both of which should ideally be repaired, the coating in general is performing extremely well. Coating thickness readings ranged from 59 μ m # on water piping to 267 μ m on structural steelwork. The specification requires that for structural steel the local coating thickness should be 70 μ m and the mean 85 μ m.

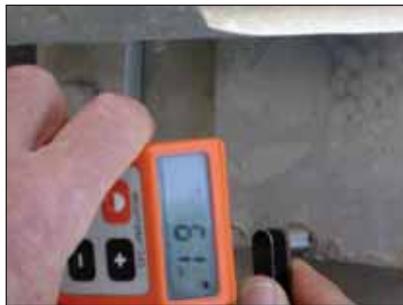
Coating thickness at damaged area in reagent loading area (#1).

#1: In most instances where hot dip galvanizing gets damaged at edges due to excessive coating thickness, a residual iron/zinc alloy layer remains which generally measures between 25 and 60 μ m.

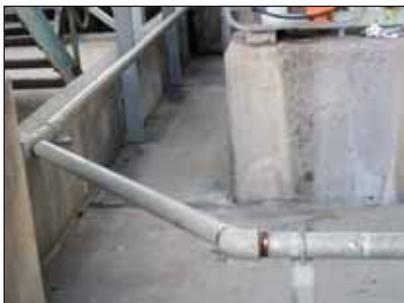
Hot dip galvanized water pipe in the reagent area.

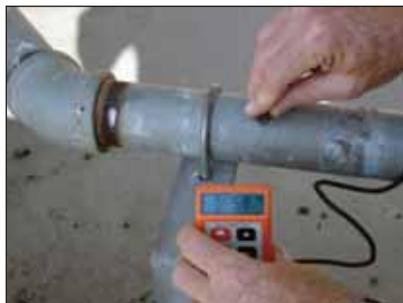
Coating thickness of a hot dip galvanized water pipe in the reagent area.

– Hot dip galvanizing of plain ended tube is done in accordance with SANS 32 (EN 10240) which requires a minimum coating thickness of 55 μ m for A1 & A2 coating qualities for the conveyance of gas and water.

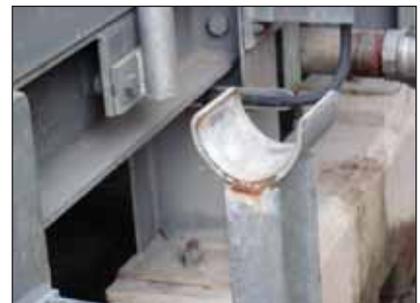
Coating damage and inadequate repair in the reagent loading area.

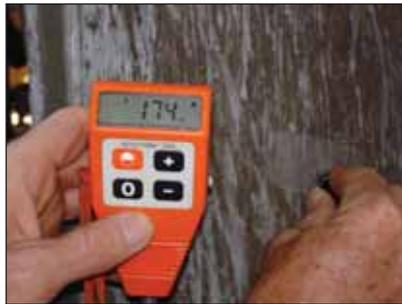
Coating thickness on structural steel adjacent to the reagent area.

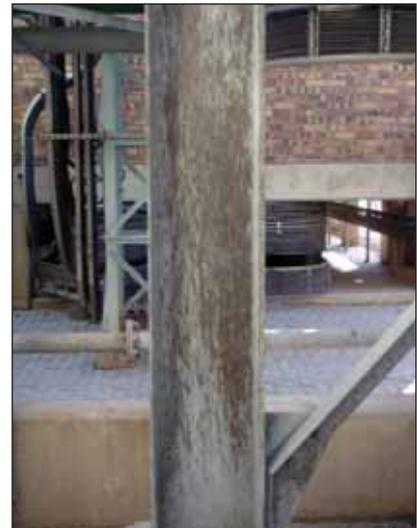
Hot dip galvanized structural steel adjacent to the reagent area.
