## **Hot Dip Galvanized Case Study No. 1 Blouwater substation**

#### **Eskom's Saldana Blouwater sub-station**

**Blouwater Substation** lattice steel structures were examined in order to establish the condition of the hot dip galvanized coating after 34 years in service.

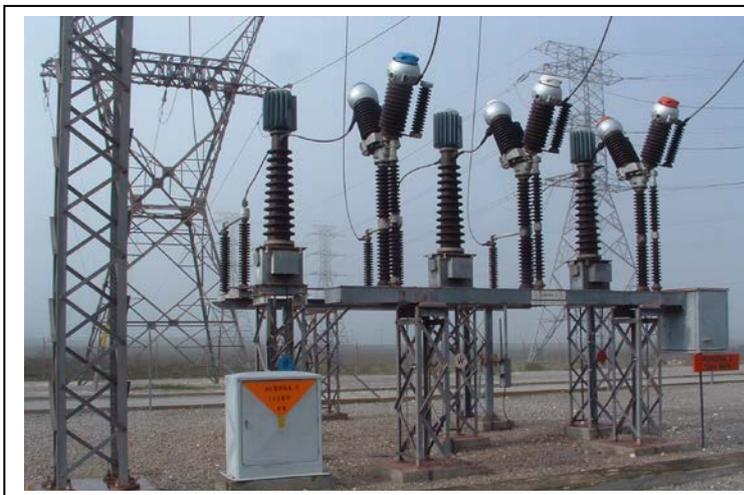
**General view of a section of  
the Blouwater Substation  
that was inspected on  
22 July 2004**

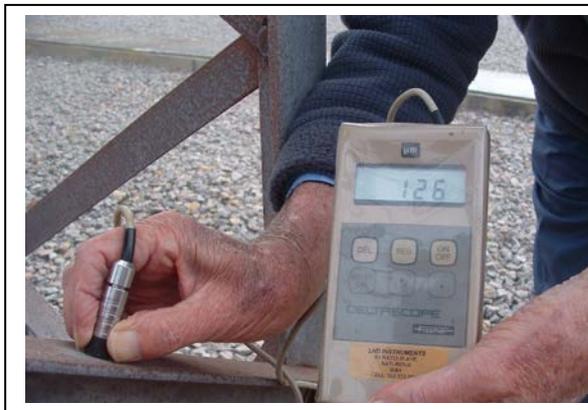
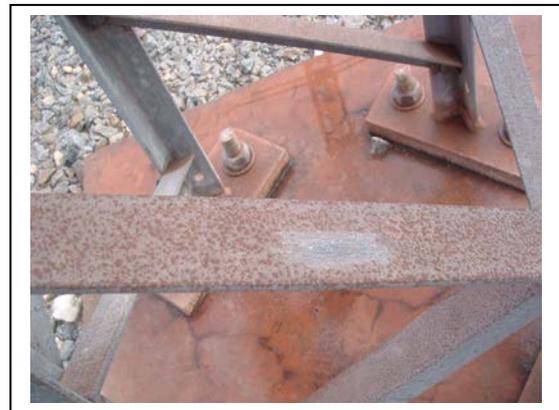
**Despite the apparent “rust” contamination of the galvanized surface, once removed the galvanized coating measured  $126\mu\text{m}$ .**

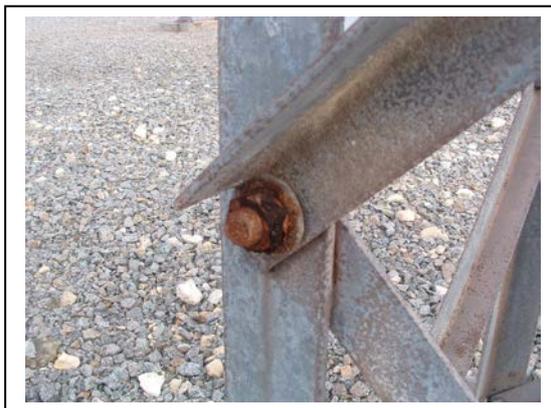
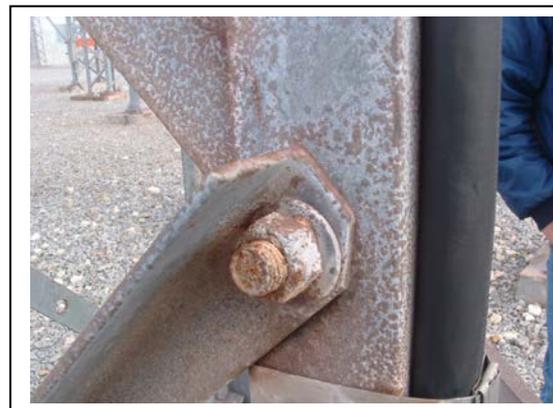
In general, the coating is in remarkably good condition despite misleading surface contamination. Interestingly, some of the bolts and nuts showed signs of distress. This appeared to be limited to fastener assemblies underneath the lower end of the inverted diagonal angle bracings. The reason for this is due to an extended period of accumulated wetness and being shielded from the sunlight. The use of zinc-electroplated fasteners (electro-galvanizing) is unacceptable due to the extremely thin zinc coating obtained (normally  $< 10\mu\text{M}$ , compared to  $55\mu\text{M}$  of hot dip galvanized fasteners). The following photographic analysis of the survey illustrates our findings.

**Condition of the “upper” and “lower” fastener assembly illustrating the differential rate of corrosion due to the “Time of Wetness”**
