## **Hot Dip Galvanized Case Study No. 8 Power Transmission Lines**

**Hot Dip Galvanized Case Study No. 8  
Power Transmission Lines**

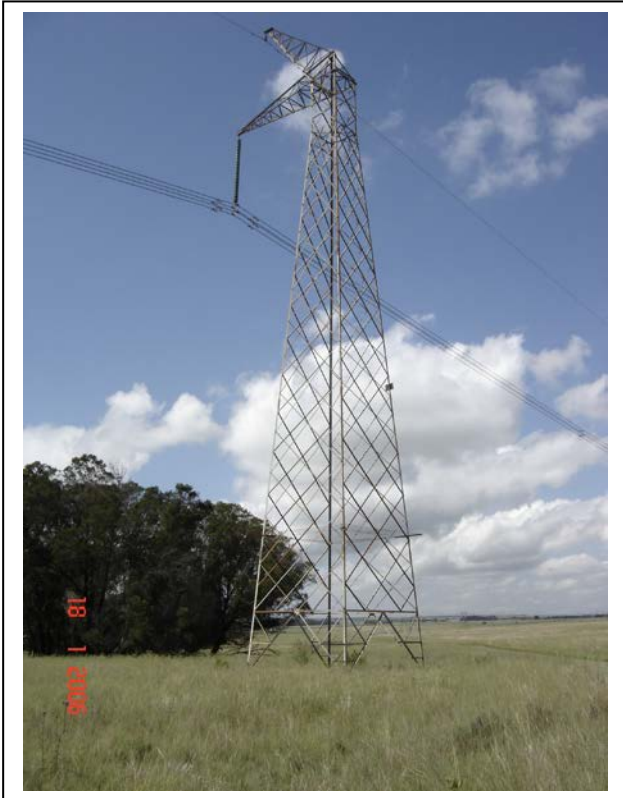
**Site No. 1**

**Relatively Benign Conditions  
ISO C2 or C3**

**53kV DC line from Cabora Basa to  
Eskom's Apollo Sub-Station South  
of Pretoria installed 1973**

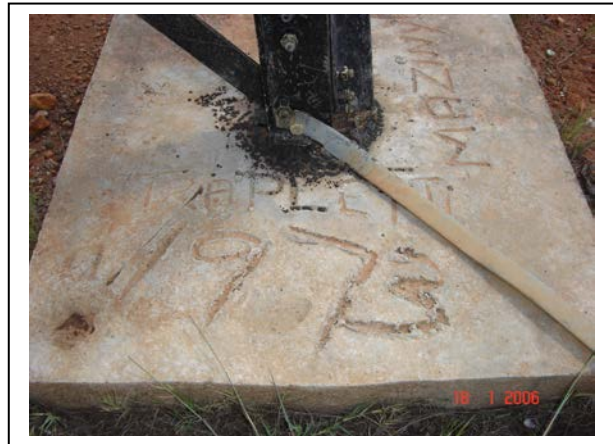
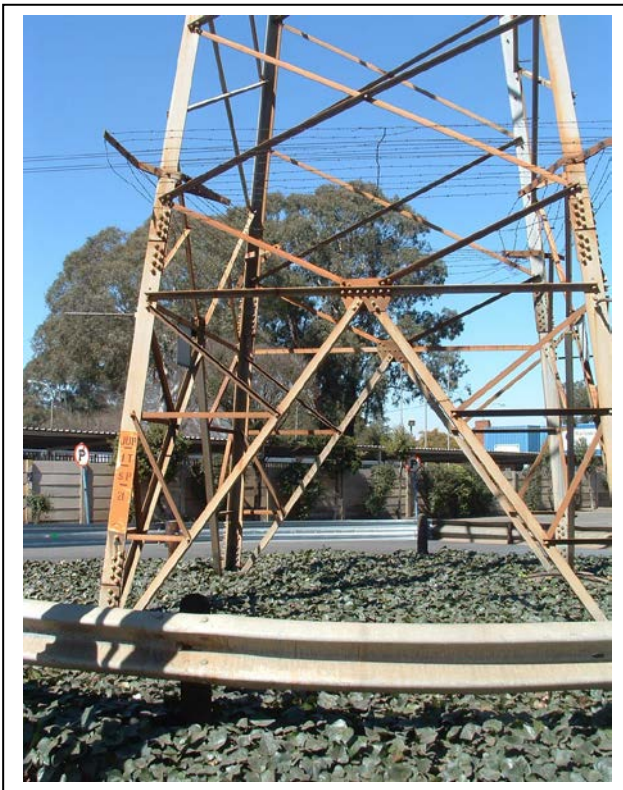
**Site No. 2**

**Inland Industrial site selected for its  
relatively severe corrosive conditions**

**This site is located within Germiston  
Industrial area and the tower is believed  
to have been in service for the past 40  
plus years**

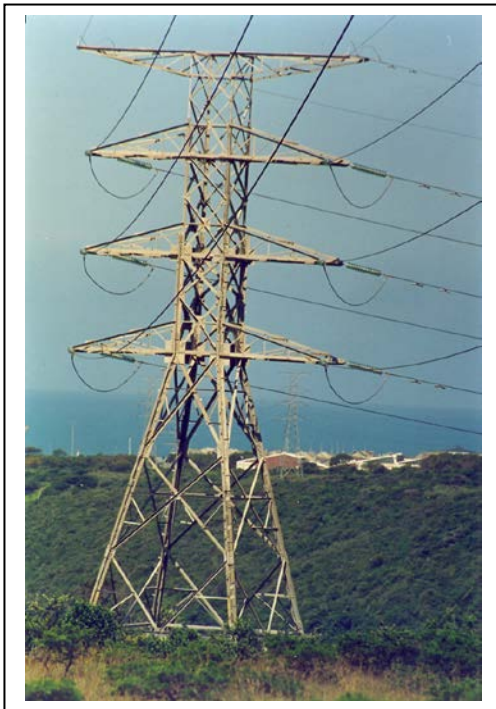
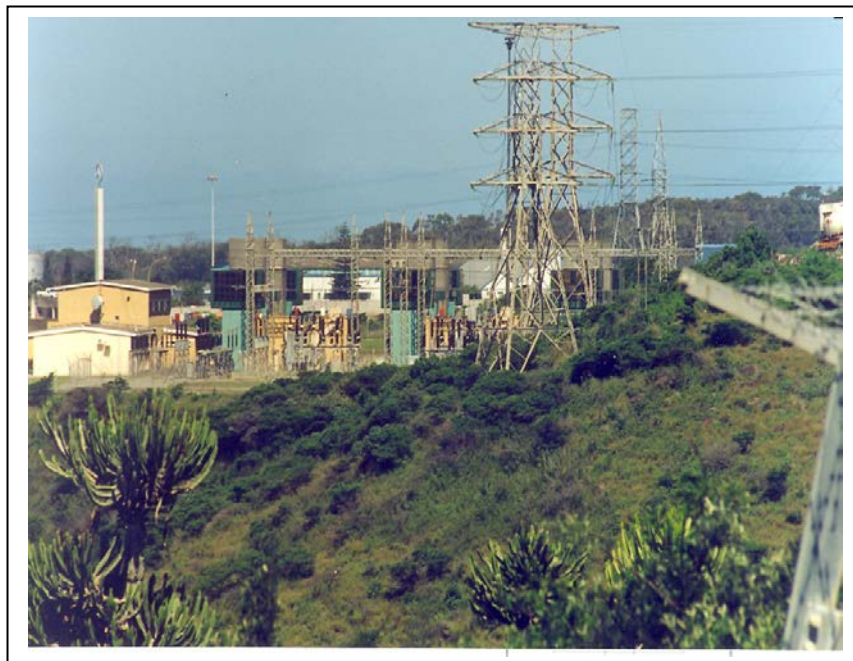
### Site No. 3

#### Severe Marine Coastal Conditions

**Buffalo-Port Rex Transmission Line  
situated outside of East London high up  
and exposed to winds from off the  
Indian Ocean**

**At the time of the inspection, the towers  
had been in service for 25 years.**

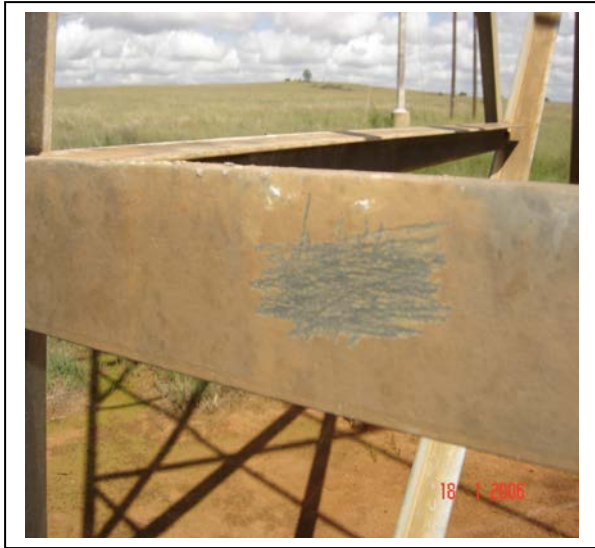
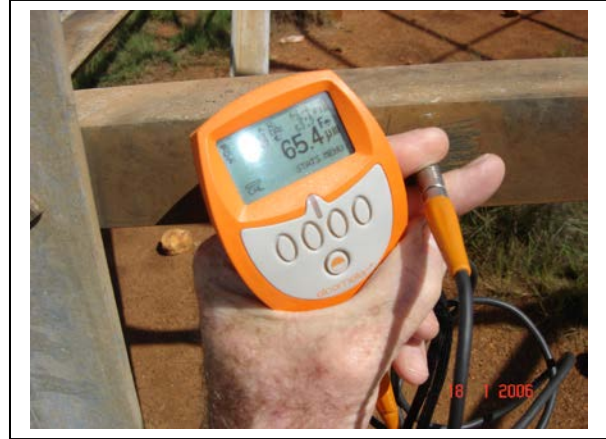
#### Site No. 1

After removing the “apparent” rust discolouration, the underlying zinc hot dip galvanized coating measured 65µm. Accuracy of the instrument is approximately 5%.

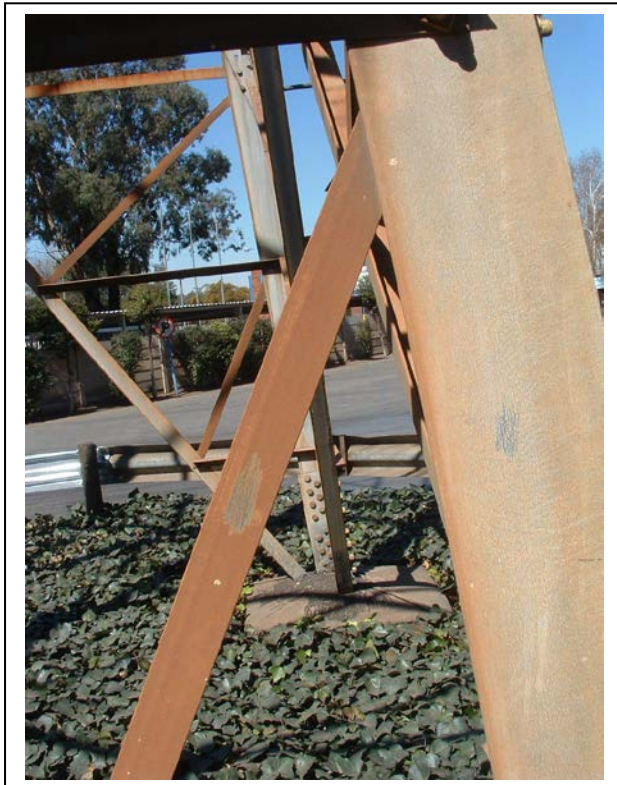
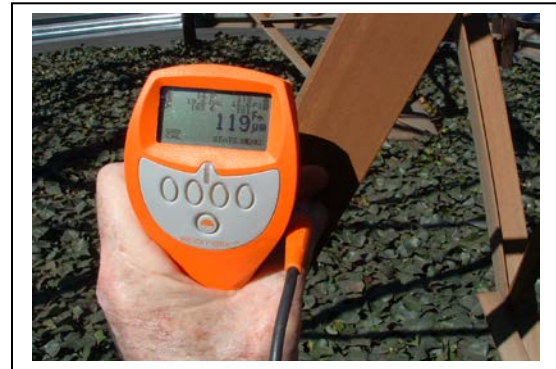
#### Site No.2

After the removal of the discolouration, i.e. corrosion products, a measurement of the remaining hot dip galvanized coating revealed 119µm.

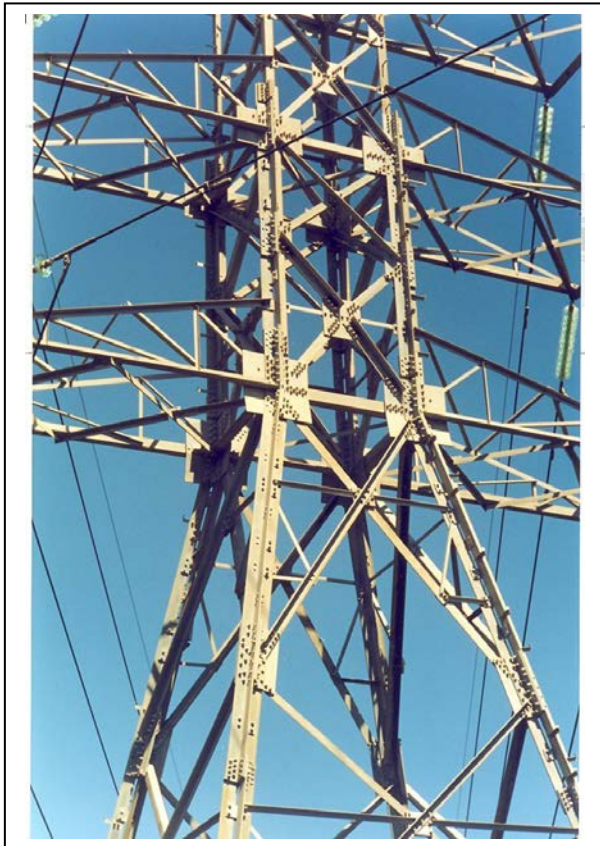
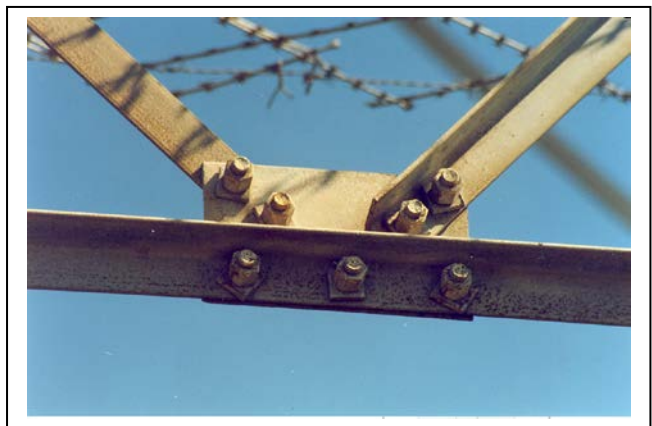
### Site No.3

**General condition of the tower after 25 years of service, was found to be such that an over coating of a paint system was recommended in order to extend the service life of the structure.**

The tower that was inspected is situated approximately 3 kilometres from the ocean next to the Buffalo River salt-water estuary, as well as alongside a city dump.

At the time of the inspection the tower had been in service for 25 years. The initial corrosion control comprised hot dip galvanizing and had never been over coated with an organic coating system.

Severe corrosion with subsequent metal loss was observed on some of the structural members. In one isolated instance the degree of metal loss was so severe that it had resulted in the perforation of the member.

The nuts and bolts associated with these sections were also severely rusted. The most severe corrosion was mainly located on the inner surfaces of the members. The members that showed severe signs of corrosion were either perforated or the degree of metal loss was in the 1 to 2 mm range. The outer surfaces of these members were only superficially corroded and the hot dip galvanized thickness readings ranged from 87 and 104  $\mu\text{m}$ .
