## **Hot Dip Galvanized Case Study No. 11 Platinum Group Metals Concentrator**

## Hot Dip Galvanized Case Study No. 11 PMG Concentrator

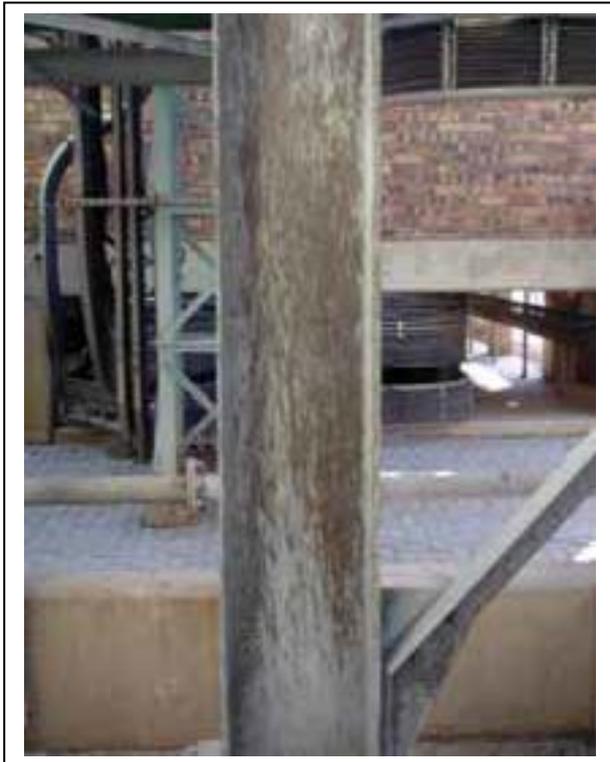
**Hot dip galvanized structural steel adjacent to the reagent area where zinc coating thicknesses were measured in excess of 150µm**

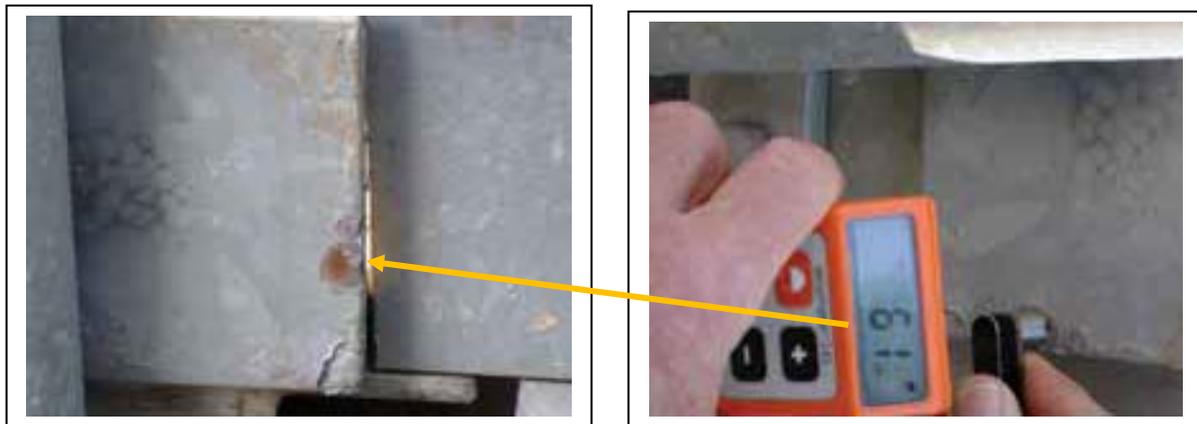
**In areas where hot dip galvanizing is damaged, usually due handling damage and/or excessively thick coatings (>200 $\mu$ m), a residual iron/zinc alloy layer remains that generally measures between 25 and 60 $\mu$ m**

In such damaged areas, rust staining can develop indicating that the zinc/iron alloy layer is providing corrosion control. More importantly with a hot dip galvanized system, no under corrosion creep is possible, due to the metallurgical bond as well as zinc being electro-negative to carbon steel.

Having walked throughout the plant, apart from a bit of discoloration at a welded and non-repaired area on a bracket and a damaged coating in the Reagent Loading area, both of which should ideally be repaired, the coating in general is performing extremely well.
