## **Hot Dip Galvanized Case Study No. 15 Pentrich Sub-station, Mkondeni, Pietermaritzburg**

**Pentrich Substation** lattice steel structures were examined in order to establish the condition of the hot dip galvanized coating after 40 years of service life.

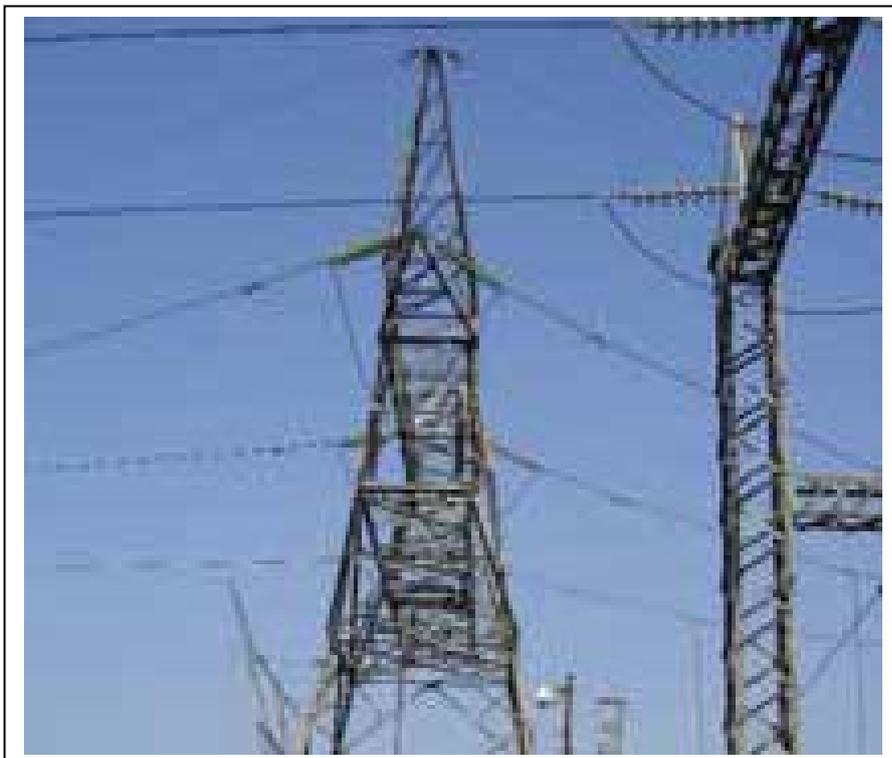
**A 132/88kV  
termination pylon  
at the Pentrich  
sub-station of the  
Georgedale to  
Pentrich  
transmission line**

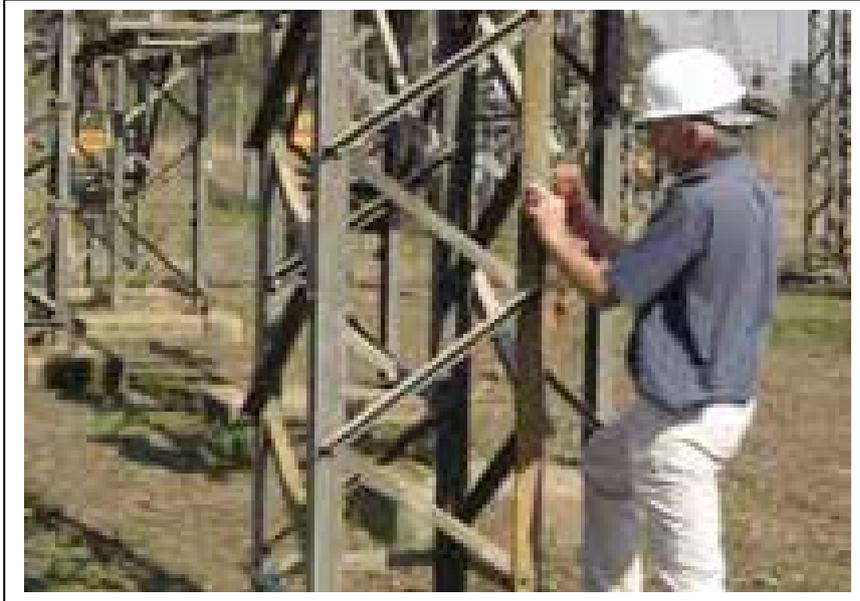
**Examination of the hot dip galvanized steel indicated that no maintenance would be required and the “rust staining” was found to be that of surface contamination**
