Hot Dip Galvanized Case Study No. 18 Cape Town Petro-chemical plant cable ladders

The original petro-chemical plant in Cape Town was established in 1966. The subject case study cable ladders were installed in about 1984 and therefore have an estimated service life of approximately 25 years.

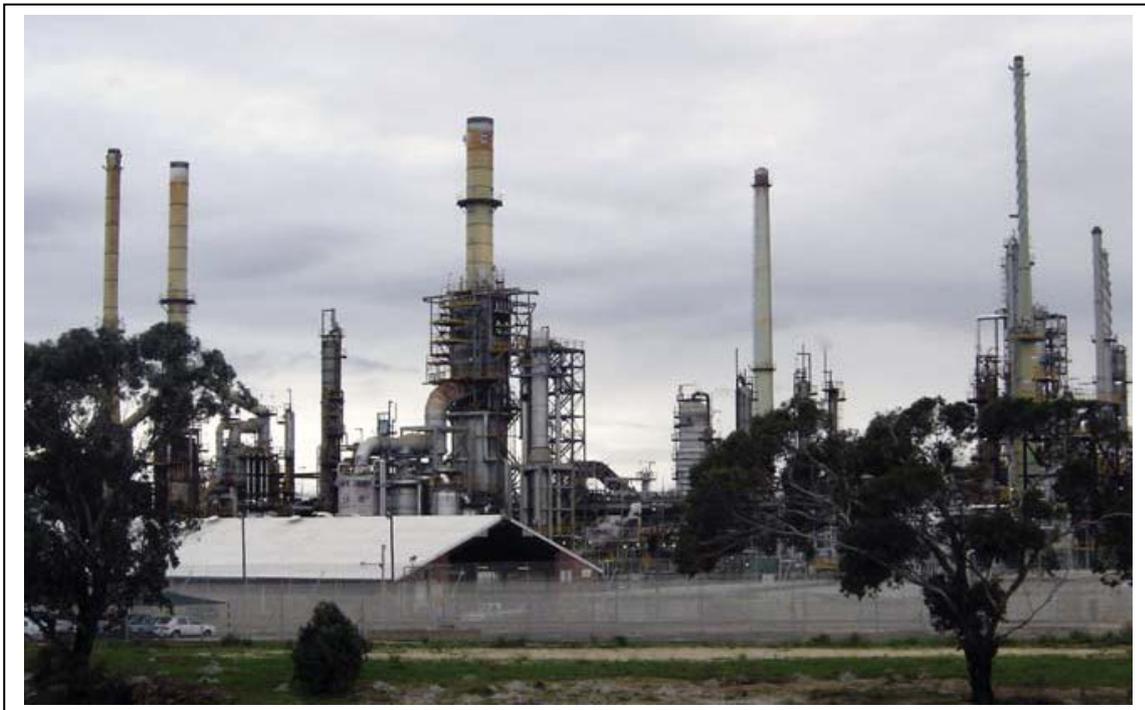
General view of the petro-chemical plant at Milnerton Cape Town

25 year old duplex coated cable ladders were used as the bases of the case study

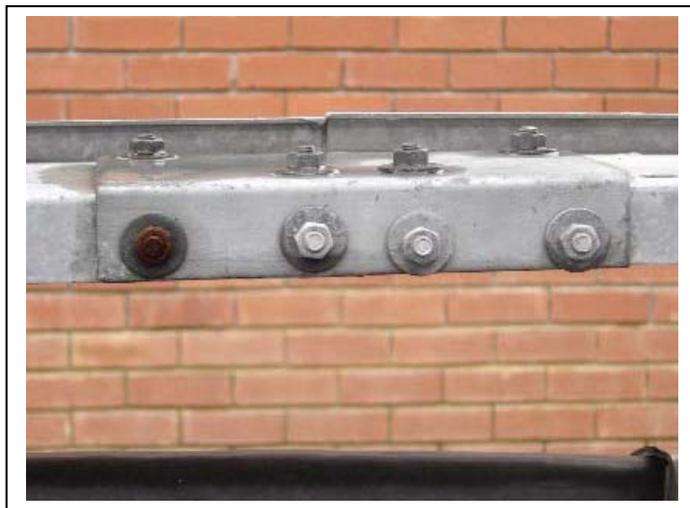
Zinc electro-plated fasteners were used for splice plates, with coating thicknesses normally less than 10µm

Many of the fasteners were found to be corroding and in need of maintenance

Unfortunately the mechanical and electro-plated fasteners were found to be corroded and require corrective action in order to extend the service life of these items.

As indicated the fasteners require maintenance and to this end it is recommended that the corroded components be replaced or thoroughly cleaned and generously over coated with an appropriate zinc rich epoxy, such as “Galvpatch” or “Zincfix”.

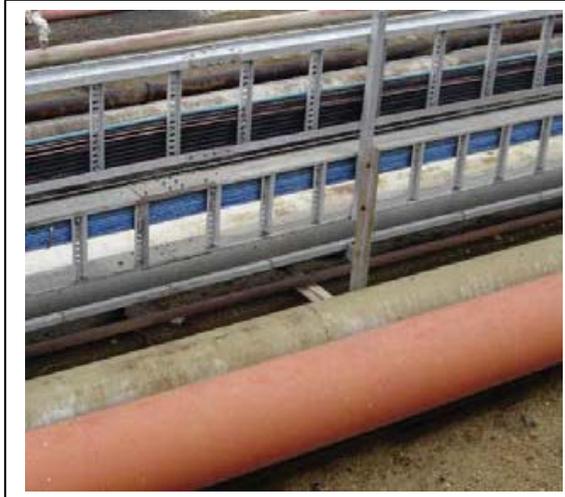
A&S Cable ladder and a more modern edge mounted cable ladder in the background

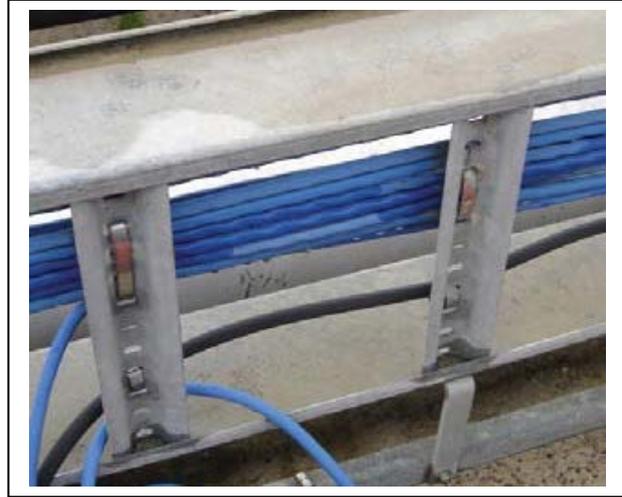
Close up view of the A&S Cable ladder

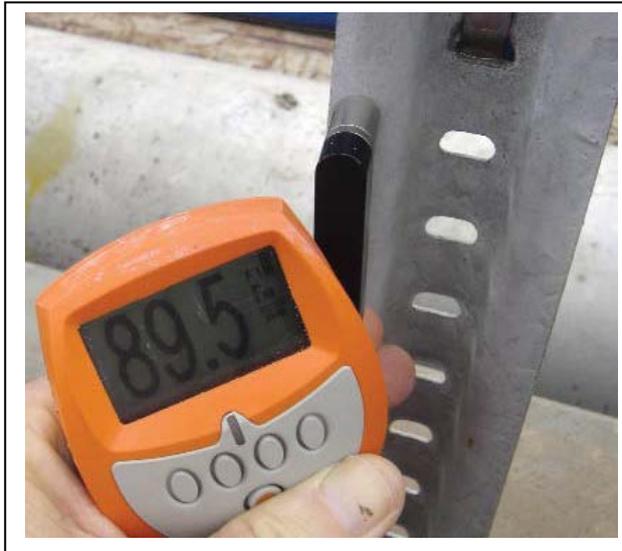
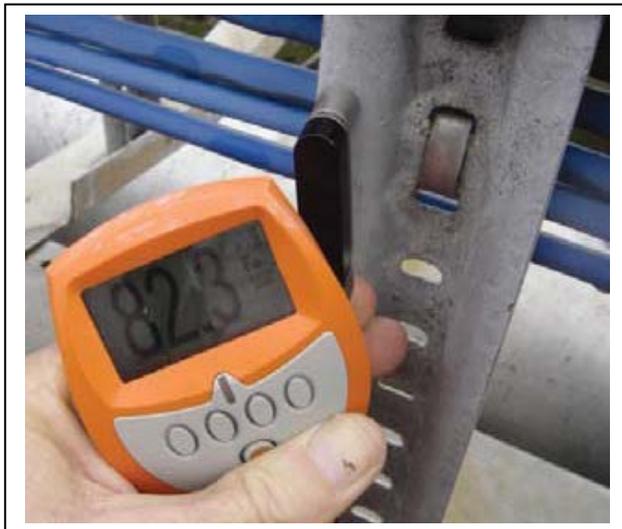
SANS 121 (ISO 1461) specification requires that for steel thicknesses equal or greater than 1.5mm, but less than 3mm, must have a minimum local coating thickness of 45µm and a mean of 55µm. The coating thickness readings taken on both the side rail and cross rung of the cable ladder in question remain well in excess of this specification. Coating thicknesses on all the cable ladders inspected and measured were found to exceed 80µm.

Examples of hot dip galvanized cable ladder being measured at 89μm and 82μm respectively
