## **Hot Dip Galvanized Case Study No. 25 Pandrol rail fasteners - Natal**

This case study has been based on an extended survey of hot dip galvanized rail fasteners within a marine environment. Two Natal South Coast sites, from the country wide survey, have been used to for this review.

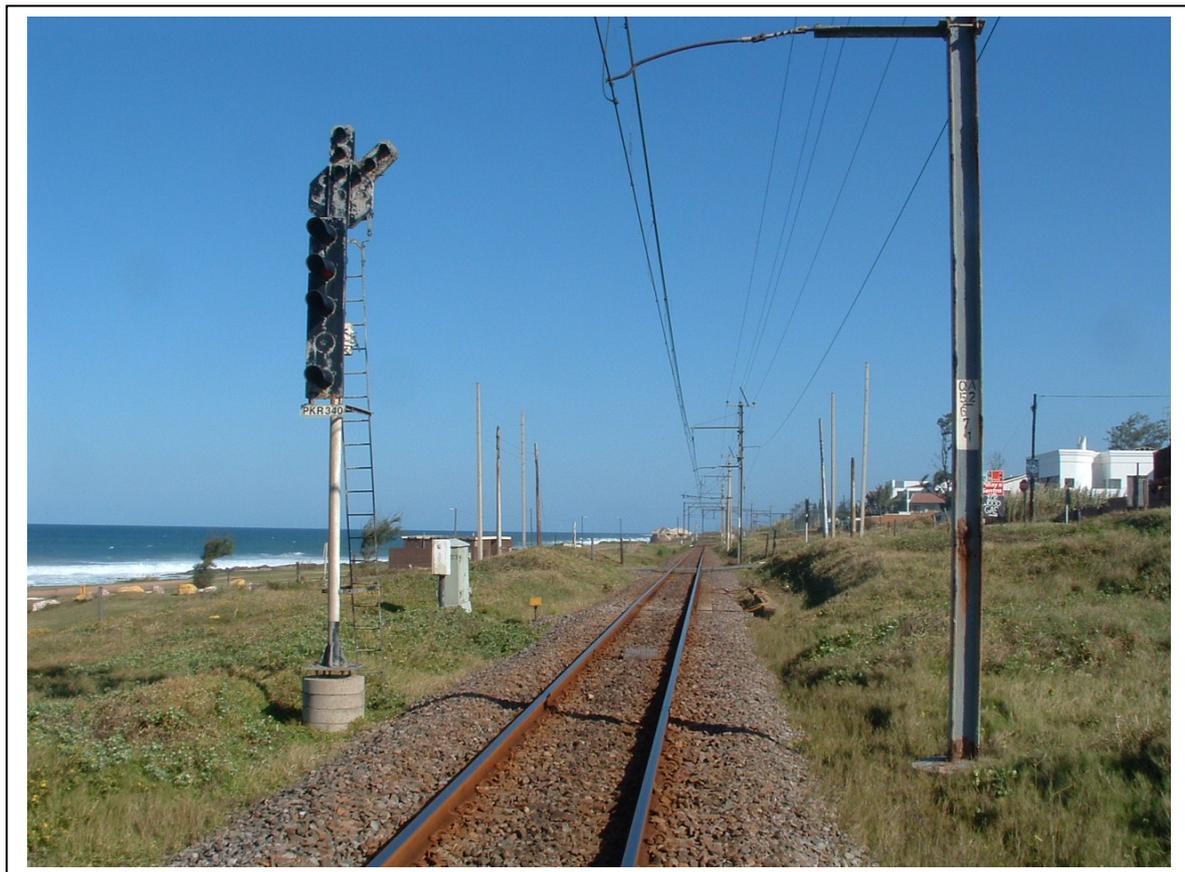
**Two different sites were chosen, both well within a marine environment  
100 to 200 metres from the ocean**

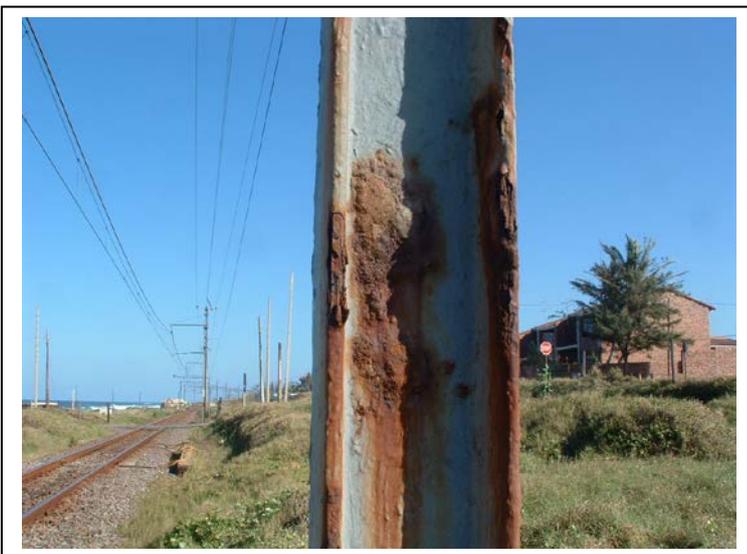
#### Park Rynie

**Aa epoxy tar painted steel mast at the Park Rynie rail crossing illustrates the severity of corrosive environment of the site**

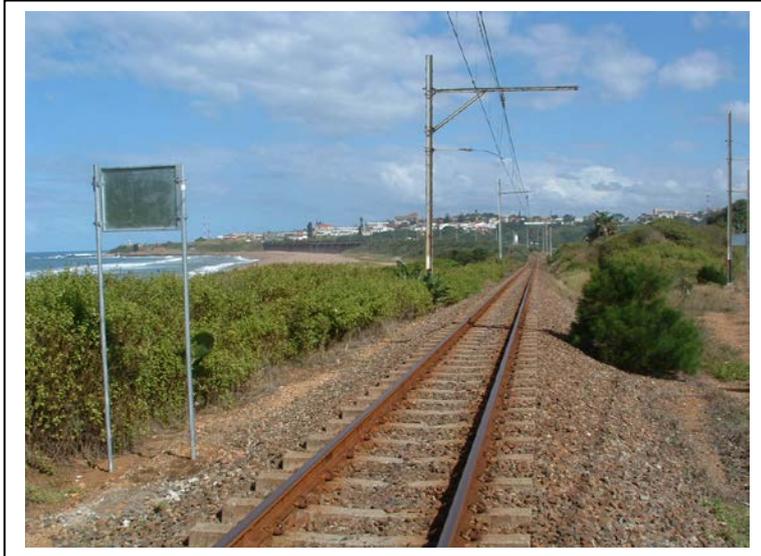
### Port Shepstone

The sea is approximately 200 metres to the left of the Port Shepstone site

The town is in the distance some 6kms further south

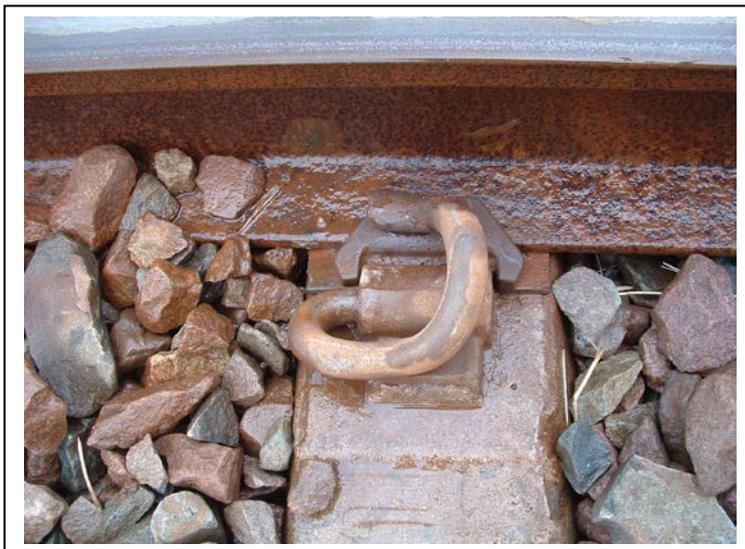
#### Park Rynie

Numerous coating thickness measurements were taken of the hot dip galvanized Pandrol rail fastener with the following zinc coatings recorded; maximum of 150 $\mu$ m, a mean of 121 $\mu$ m and a minimum 83 $\mu$ m.

The galvanized components were estimated to have been in service for the past 18 to 20 years

Note the corrosion of the uncoated rail

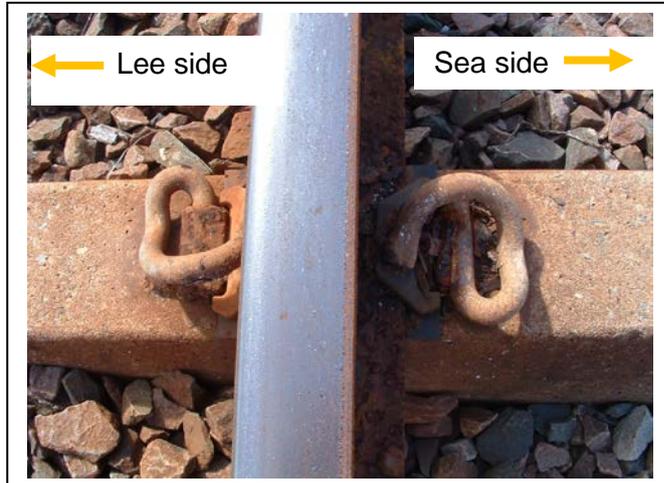
### Port Shepstone

Zinc coating thicknesses measured as follows: 136µm minimum, 154µm mean and 197µm maximum.

**Fasteners that face the sea were affected to a greater extent than those on the lee side of the track**

**The rail height provides a degree of “shielding” from the sea spray**

The sea side (using an ungalvanized cast iron) shoulder had corroded away exposing the hot dip galvanized Pandrol. Holding capacity of this assembly had been lost and is totally ineffective. Note the condition of the “land (lee) side” of the rail, where the system is intact and operative.

It was clear that the side of the rail, together with the fasteners that face the sea were affected to a greater extent than those on the lee side of the track. The rail provides a degree of “shielding” from the sea spray. This is a subjective observation as it is also clear that the severe corrosive environment is attacking both sides of the rail.

In some positions the un-galvanized cast-in shoulder had corroded away and was no longer operative. In four instances the Pandrol rail fastener together with its cast-iron (un-galvanized) shoulder had completely disappeared.
