## Simonstown utility gantry

# Case History

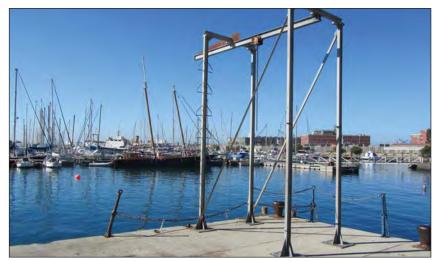
Photos above show the gantry with some uncoated carbon steel that has been added. This will in time tend to discolour the hot dip galvanizing when the former begins to rust. Photo right shows the inappropriately coated fasteners, which were most probably originally only zinc electroplated, requiring replacement or coating repair.

The only items that require maintenance on the gantry are the uncoated plate above the gantry and the zinc electroplated fasteners. Should this be carried out shortly, using a reputable repair material such as Zincfix or Galvpatch, the fasteners will not have to be replaced.

The mild steel plate should be protected against the elements and the fasteners over coated using something like Zincfix or Galvpatch which are reputable coating repair products recommended by the Association.
