Hot Dip Galvanized Case Study No. 5 Goedehoop Colliery

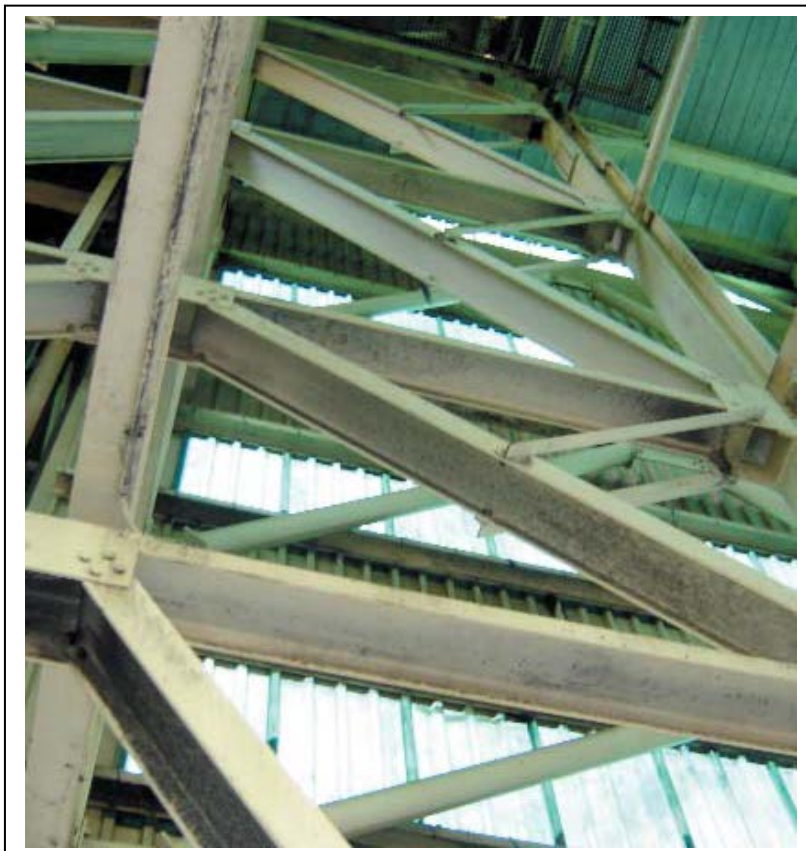
**General view of the
structure at
Goedehoop Colliery in
2005**

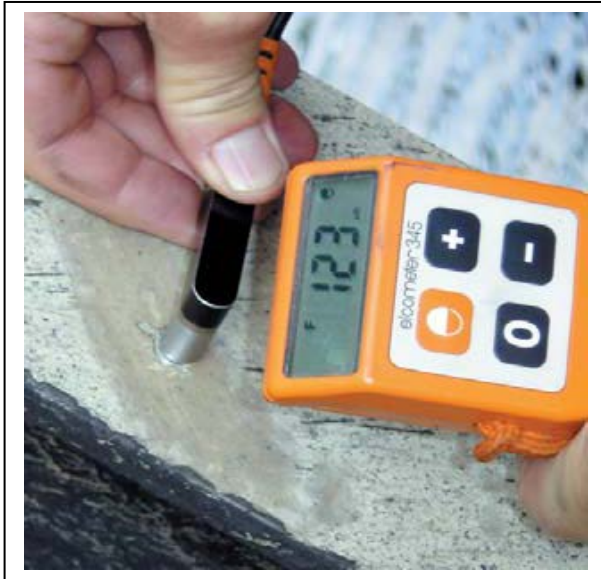
Hot dip galvanized coating being measured (123µm) after the top paint coating had been removed

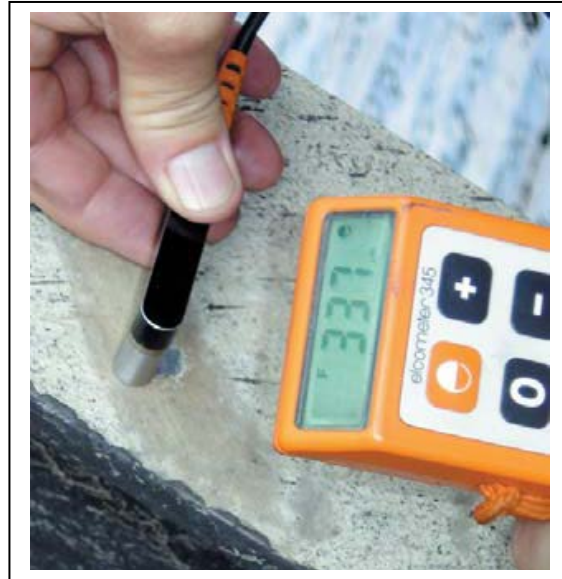
Measurement of the full duplex system (hot dip galvanized plus the top paint system being checked (337µm)
