Hot Dip Galvanized Case Study No. 21 Eskom Coastal Sub-station

In this case study the Duine sub-stations in the Western Cape was visited during February 2014 to evaluate the durability of the hot dip galvanized carbon steel structures.

The original steelwork for Duine sub-station was erected in September 1977. At the time of the site inspection the installation had been in service for the past 37 years being exposed in an aggressive marine environment adjacent to Koeberg Power Station.

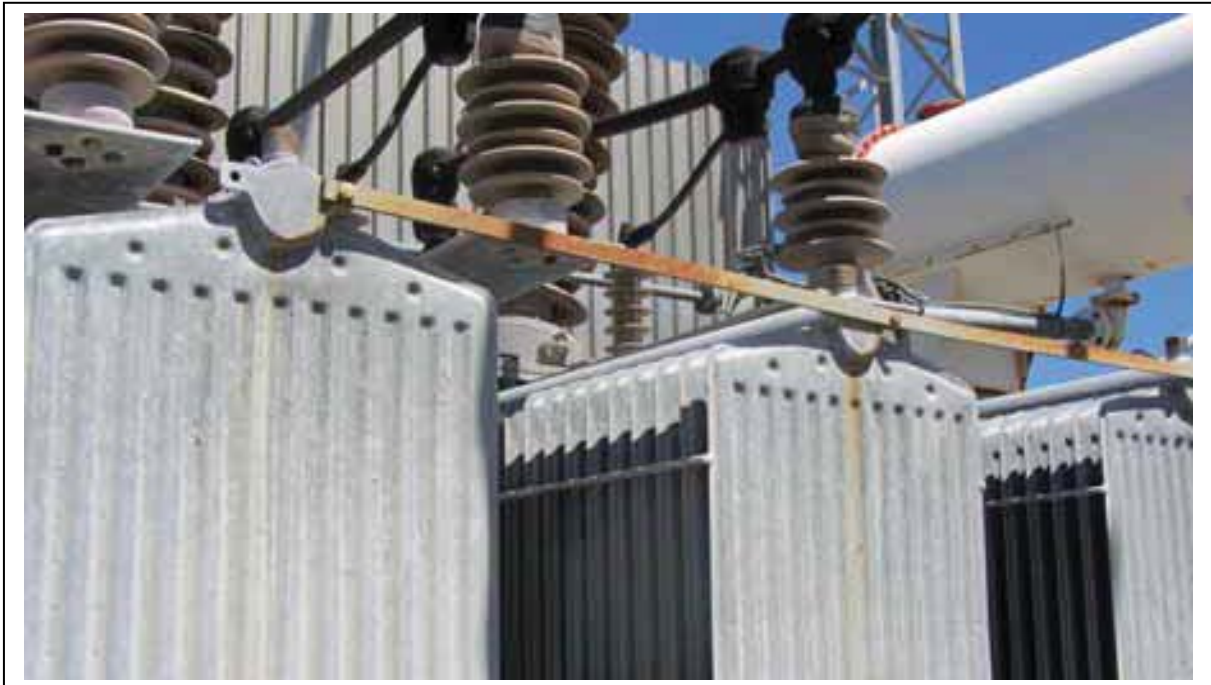
Hot dip galvanized power transformer radiators

Hot dip galvanized coating thicknesses on the transformer radiators were recorded in a range of 65 to 75 μ m.

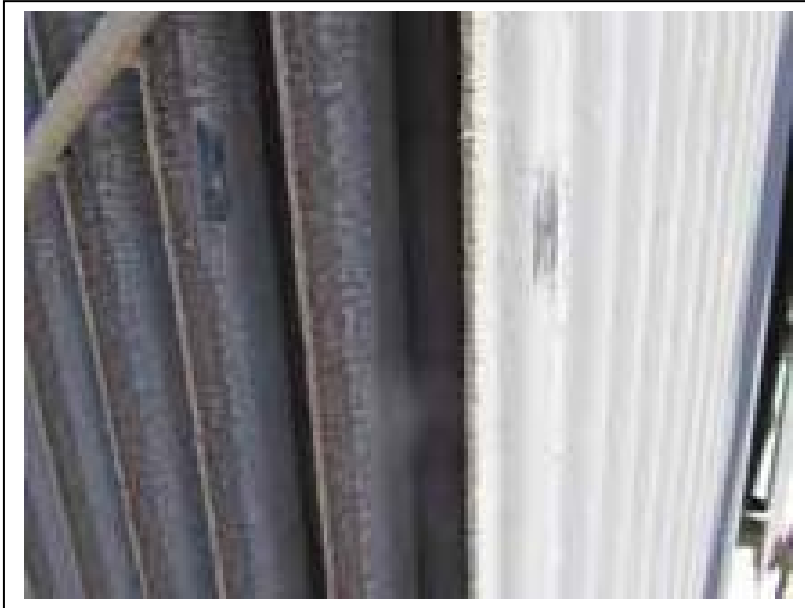
Location the two cleaned area on the transformer radiator showing where residual coating thicknesses were taken

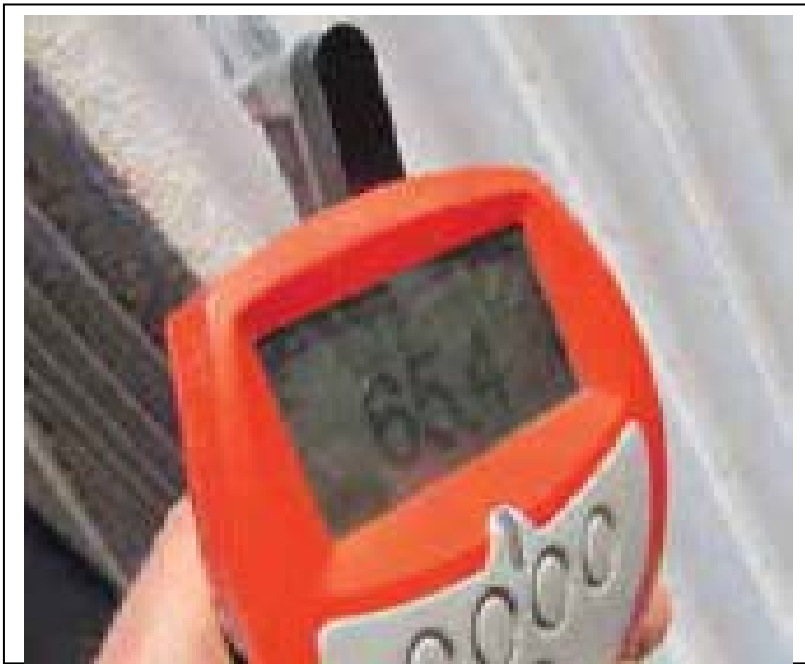
Typical coating thickness measurement being taken using an Elcometer 456 magnetic instrument

Zinc coating thickness on the Elcometer is 65 μ m

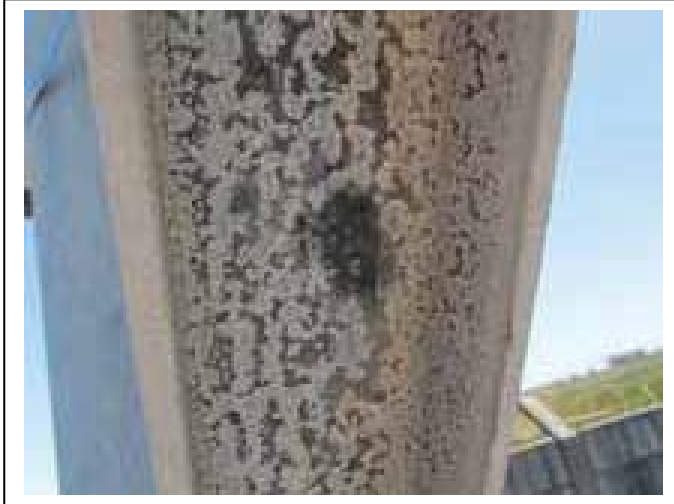
A galvanized steel component showing visible chloride salts

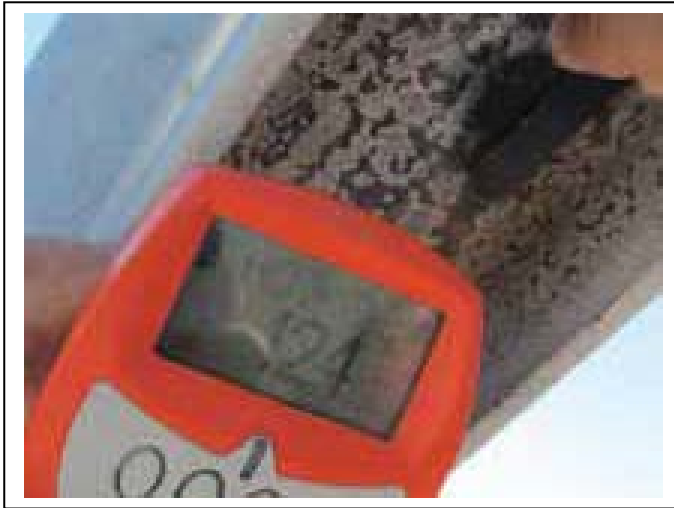
Removal of the surface contamination coating thickness readings of 124 μ m

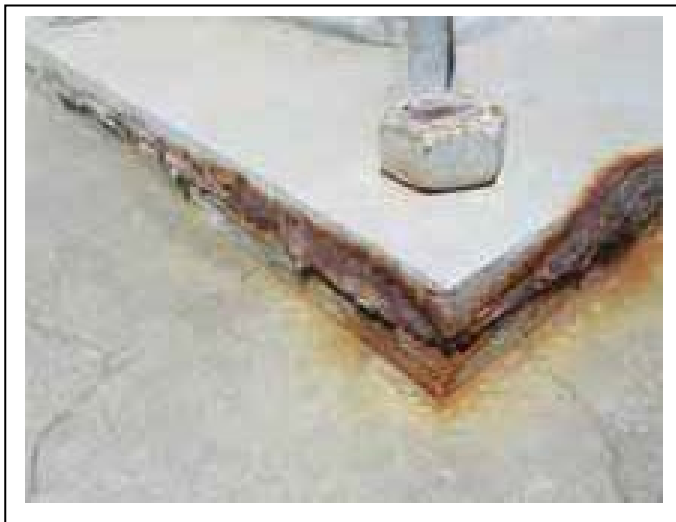
One base plate showed corrosion on the edge, indicating that crevice corrosion was active

Residual coating thickness readings of 140 and 165 μ m were taken adjacent to the corroded area

Remedial action would be to seal the crevice and prevent the ingress of moisture
