Hot Dip Galvanized Case Study No. 22 Bellville Transport Interchange Upgrade

The Application

Findings

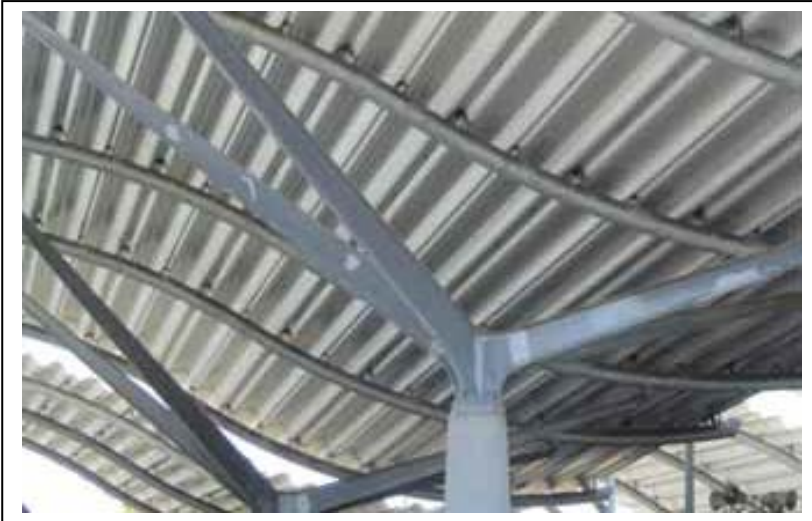
The use of a zinc rich "silver spray" paint that draws attention to the welding repairs as the hot dip galvanized surfaces form the matt grey surface protective zinc carbonate patina

The areas where the ‘upside down spiders’ were welded and originally repaired using A zinc rich epoxy should be cleaned and recoated with either Galvpatch or equivalent.

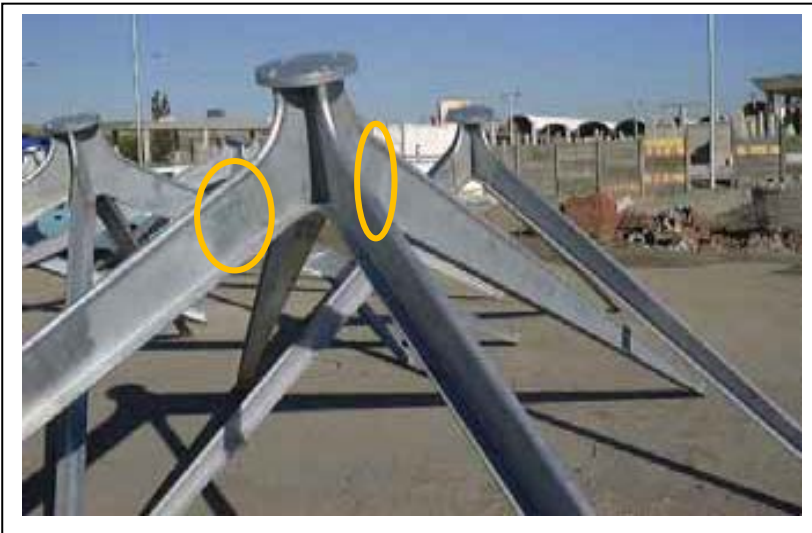
The "upside down spiders", as delivered to site, have similar similarly grey surface tones to that of the galvanized components when Galvpatch or Zincfix are used for repairs

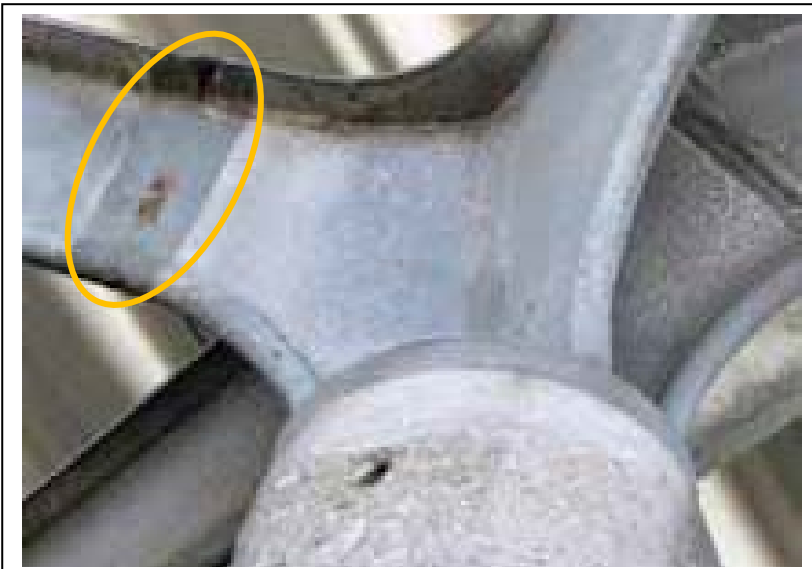
Where the zinc rich epoxy has been incorrectly applied (too thin and less than 100µm) premature corrosion is evident

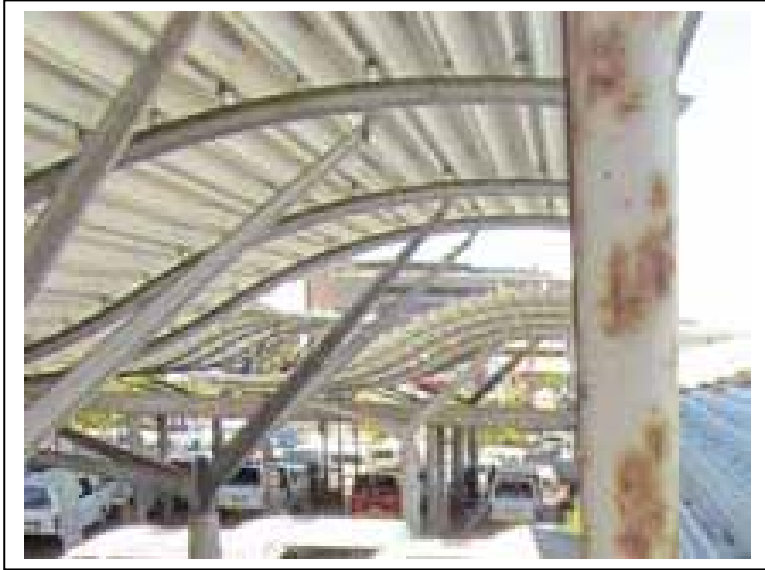
A row of pipe bracings which were originally only painted were showing signs of some corrosion and will also require future maintenance or replacement.

A row of pipe bracings were originally painted and showing signs of corrosion

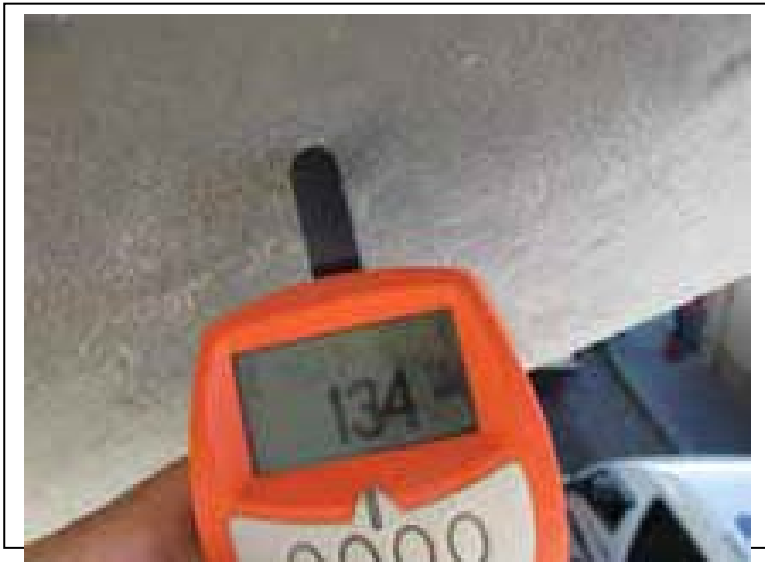
Zinc coating thicknesses taken on the hot dip galvanized tubular purlins were found to be in excellent condition with more than 130 μ m of residual zinc remaining

From the recorded residual hot dip galvanized coating thicknesses that range from approximately 130 to over 200µm and a zinc corrosion rate of say 2µm per year, it can be calculated that a further 60 plus years of service life is anticipated.

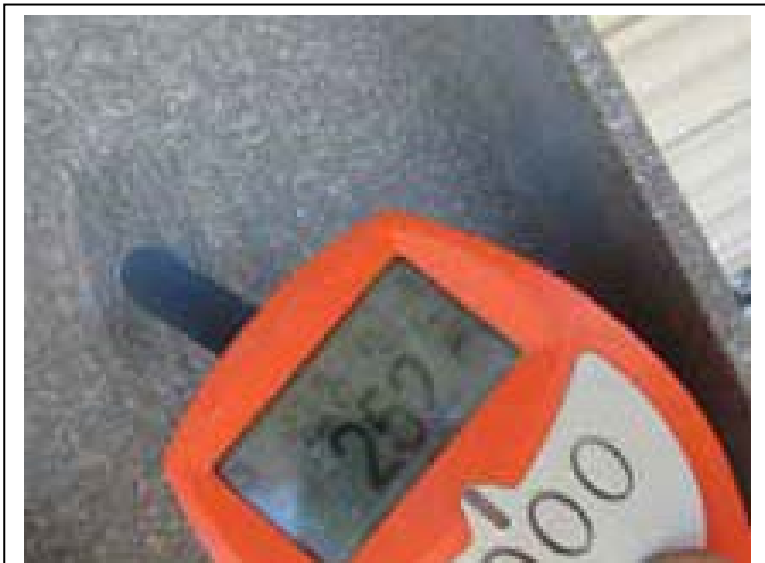
Hot dip galvanized I-Beam tubular purlin support, showing a residual coating thickness of 252 μ m
