METALLURGICAL INVESTIGATION INTO THE ORIGIN OF CRACKS AT WELDED CONNECTIONS ON A HOT DIP GALVANISED FABRICATED STRUCTURAL STEEL PERIMETER WALKWAY PLATFORM FOR THE NEW KUSILE POWER STATION IN SOUTH AFRICA

Report no. 220512

22 May 2012

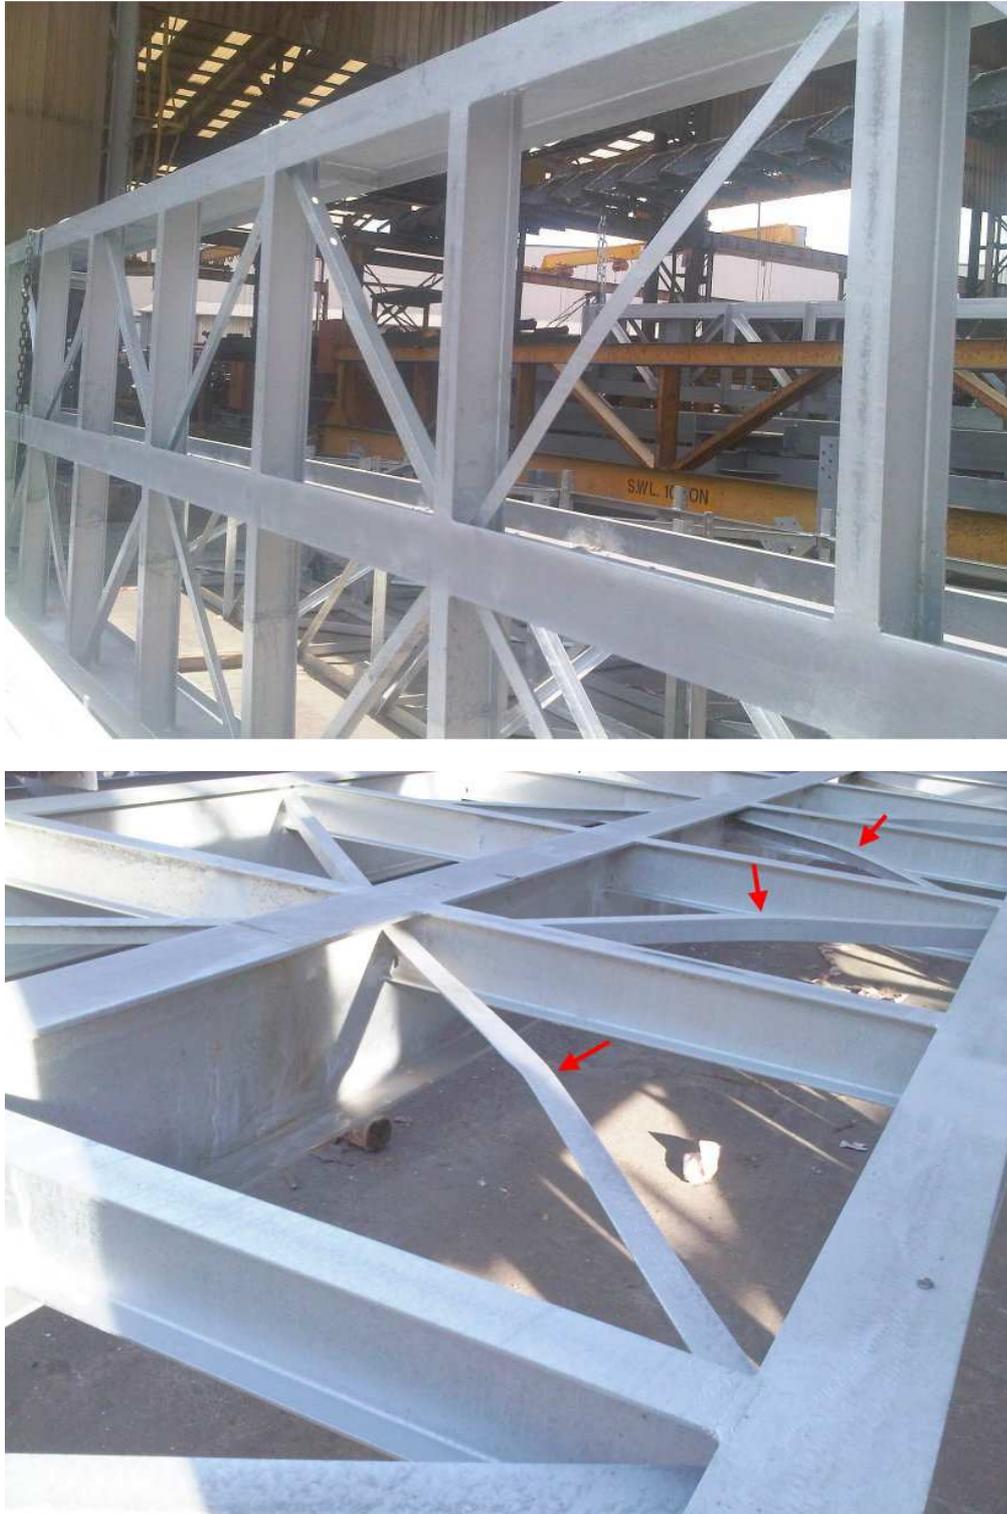
- 1.1.5 Cracks had also developed from the relatively sharp 90° corners at T-joints between the flanges of I-beams (cf. Figure 1d).
 - 1.1.6 Many of the angle section chords had distorted/buckled severely during hot dip galvanising (cf. Figure 1a).

Figure 1a: Hot dip galvanised walkway platform with severely distorted 50 x 50 x 4 mm angle section chords. Cracks were discovered after hot dip galvanising at a number of the welded connections at the ends of the angle section chords. The angle sections had been welded to the 90° corner between the I-beam chords as shown in the top image in Figure 1b. (Images provided by Mr Riaan Louw and annotated by Grobler.)

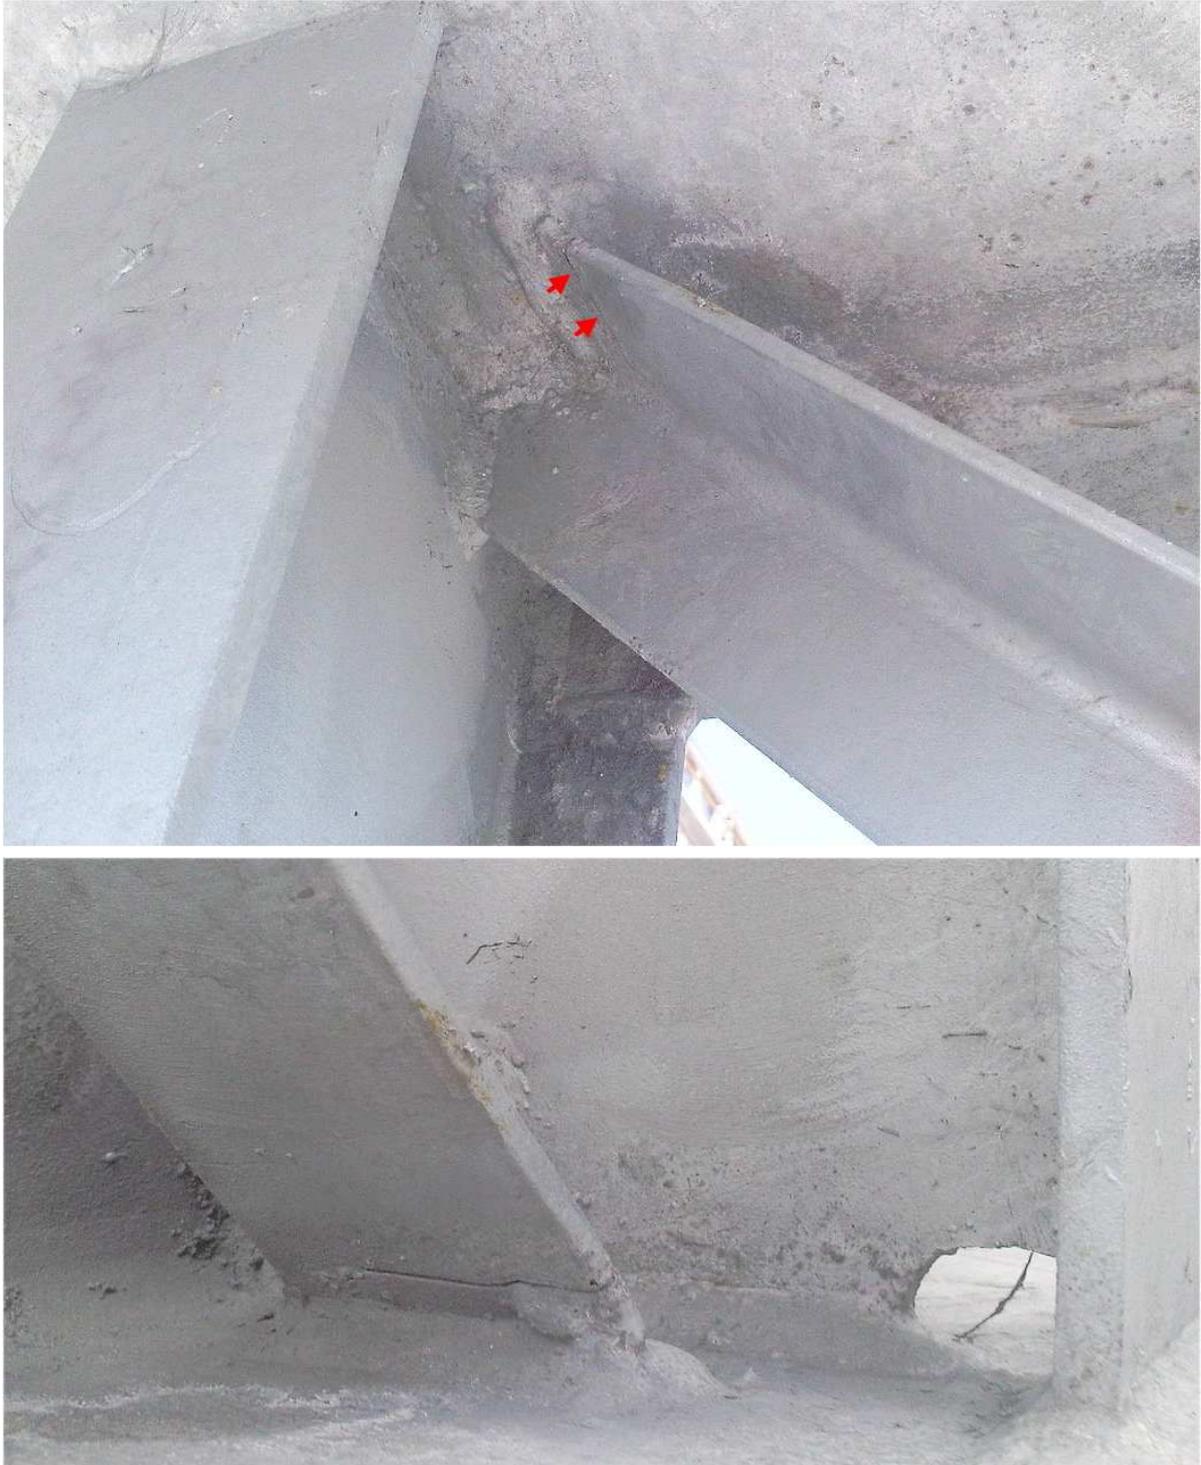
- 1.1.1 Most of the cracks were at connections between 50 x 50 x 4 mm diagonal structural steel angle section chords welded to much larger section I-beams at T-joints between longitudinal and transverse chords (cf. Figure 1a to 1c).

Figure 1b: The top image shows the connection between the angle section chord and the two I-beam chords at a 90° T-joint. The arrows indicate the position of a crack in the angle section chord. The bottom image shows the same crack. The crack had developed in the unaffected base metal next to the weld heat affected zone of a fillet weld. (Images provided by Mr Riaan Louw and annotated by Grobler.)

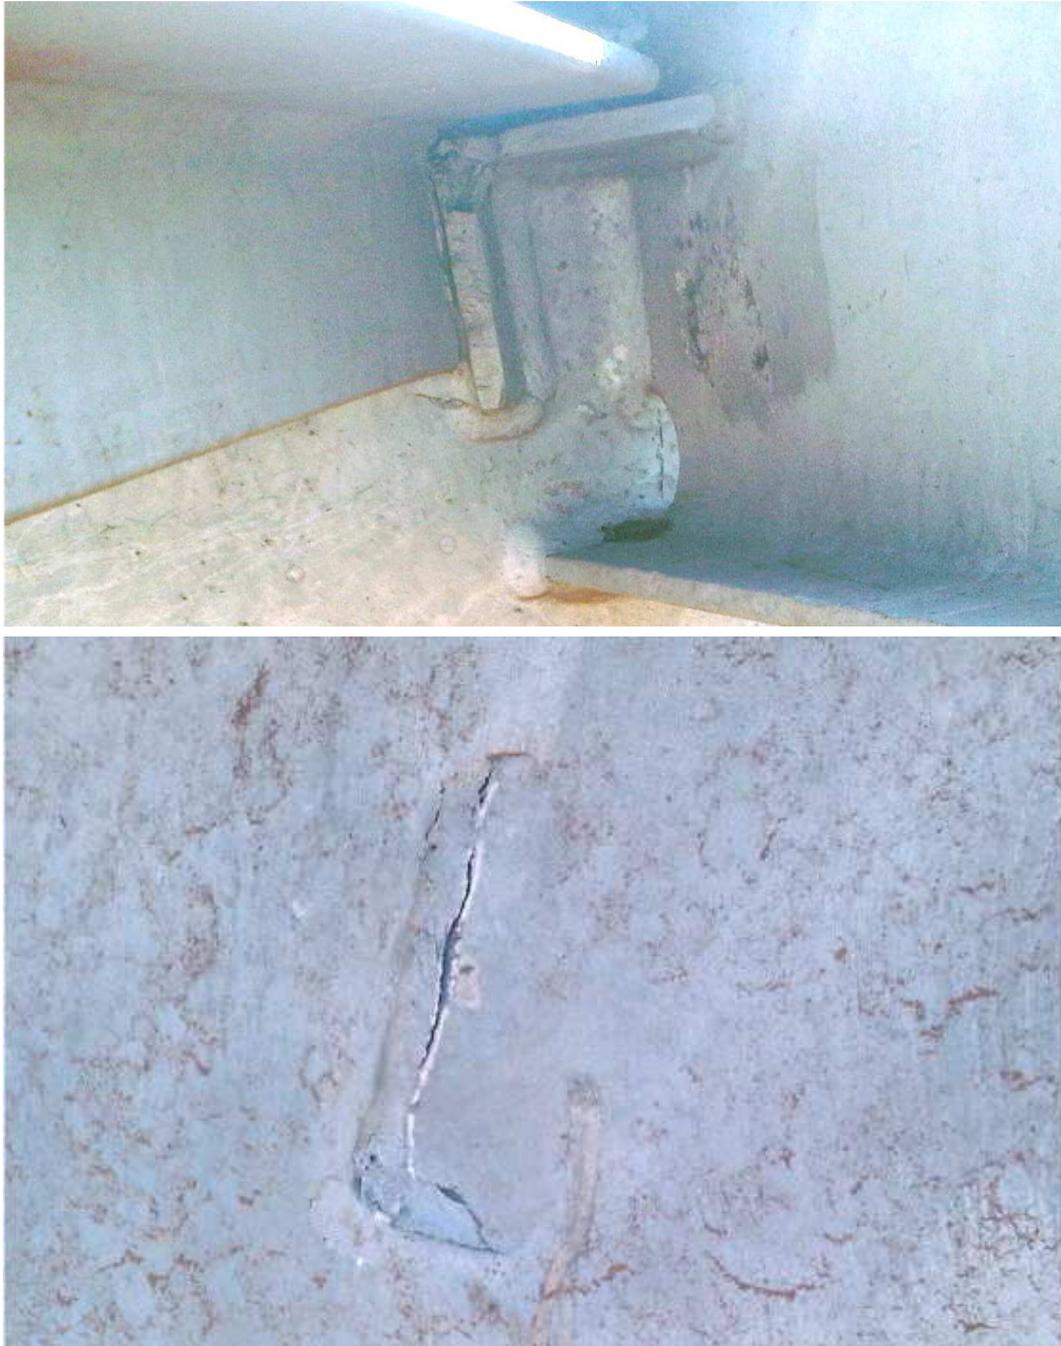
- 1.1.2 Some of the angle diagonal chords had fractured completely (cf. Figure 1c).
 - 1.1.3 Some of the fracture locations were some distance from the weld heat affected zones in the unaffected base metal (cf. Figure 1c).

- 1.1.4 Through-thickness cracks had also developed in the webs of some of the I-beams at the toes of fillet welds joining the angle section chords to the webs of the transverse chords (cf. Figure 1c).

Figure 1c: Some of the angle section chords had fractured completely in the base metal some distance from the fillet welds and weld heat affected zones. The bottom image shows cracks that had penetrated the web of an I-beam chord at the fillet welded connection between the angle section chord and web of the I-beam chord at the opposite side. (Images provided by Mr Riaan Louw and annotated by Grobler.) The failure of the angle section chord in the top image is similar to the LMAC failure of a diagonal chord on girder reported by CROSS¹ in the United Kingdom.

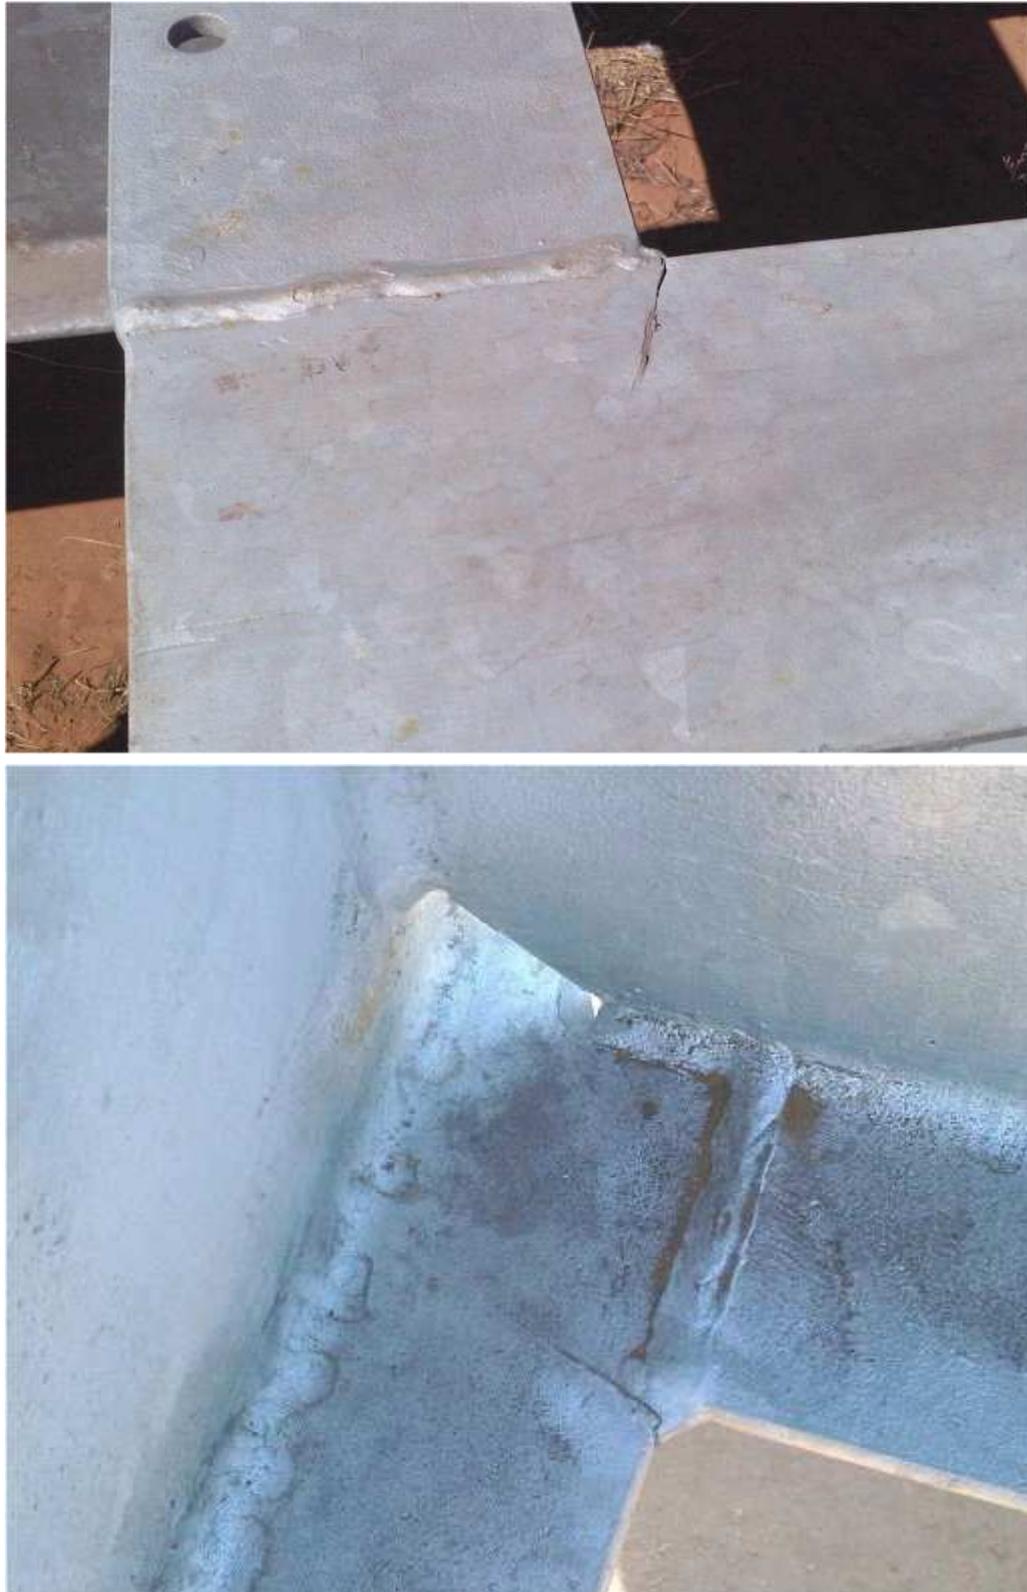
Figure 1d: Examples of cracks that had developed in I-beam flanges from 90° corners at T-joints between I-beam flanges. (Images provided by Mr Riaan Louw and annotated by Grobler.)

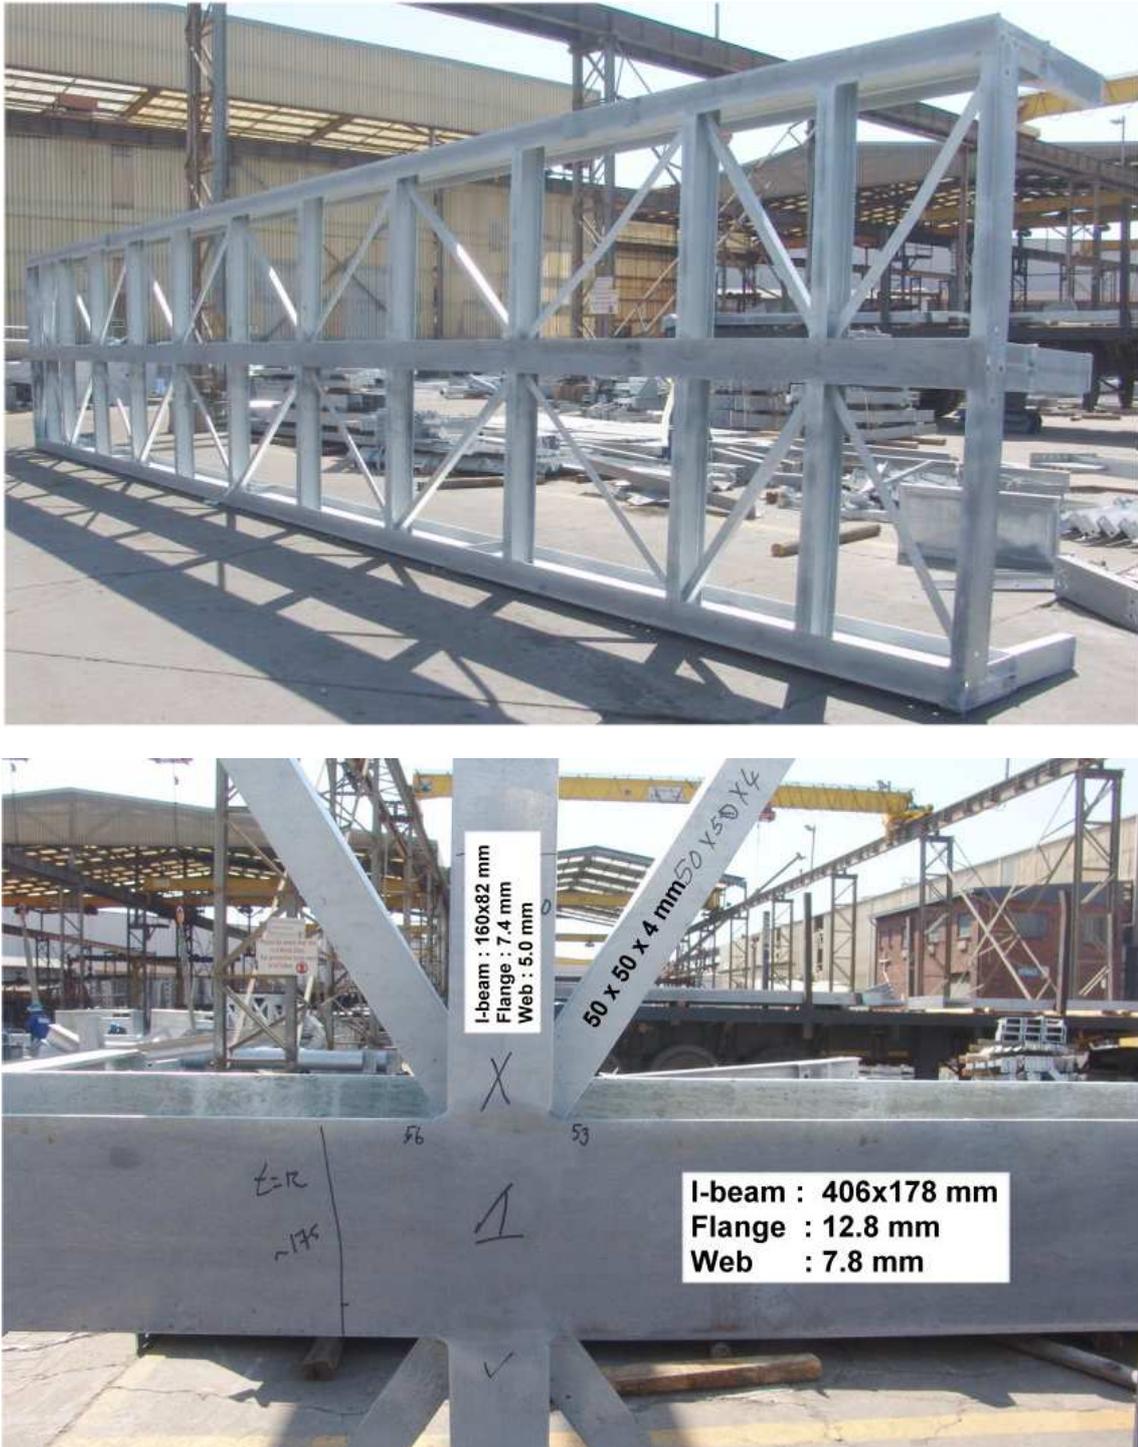
- 1.2.1 Cracks were discovered again at the angle section diagonal chord welded joints after hot dip galvanising of the first platform walkway fabricated to the new design (cf. Figure 2a to 2c).

Figure 2a: The top image shows the new walkway platform with the design of the connections between the diagonal angle section chords and the I-beam chords modified. This is the first walkway platform that had been hot dip galvanised after the modification of the connection design. Cracks were discovered at a number of the welded connections between the 50 x 50 x 4 mm diagonal angle section chords and the webs of the transverse 160 x 82 mm I-beam chords at opposite sides of the middle longitudinal 406 x 178 mm I-beam.

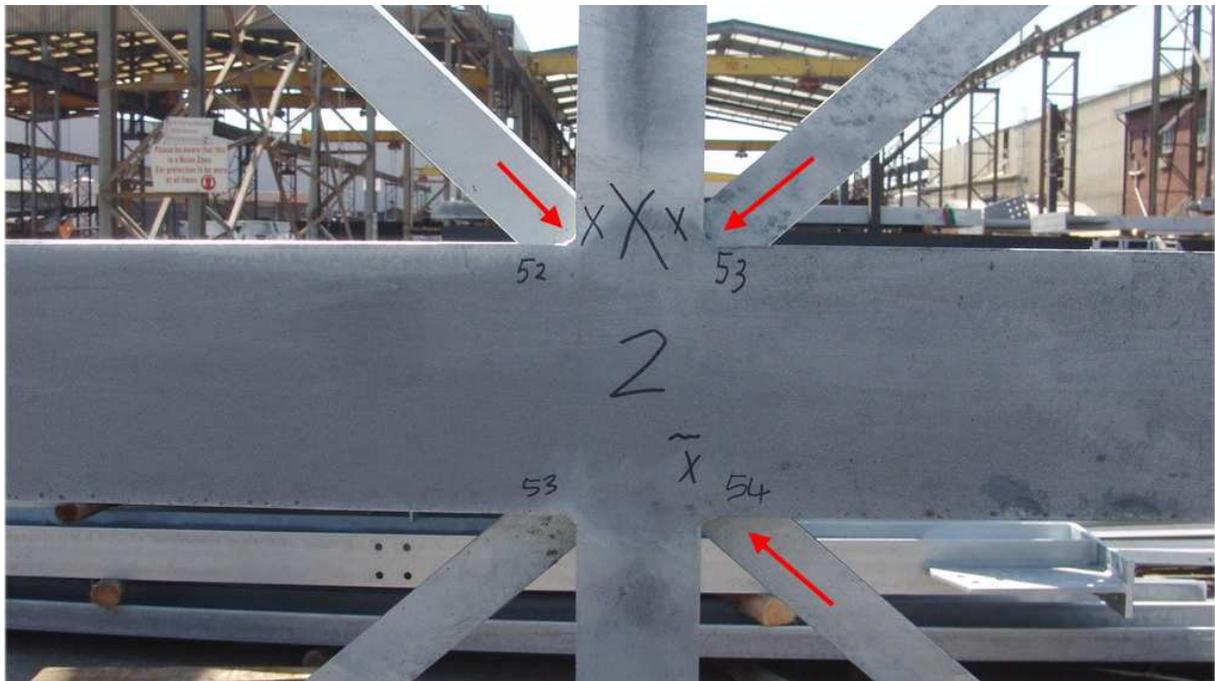
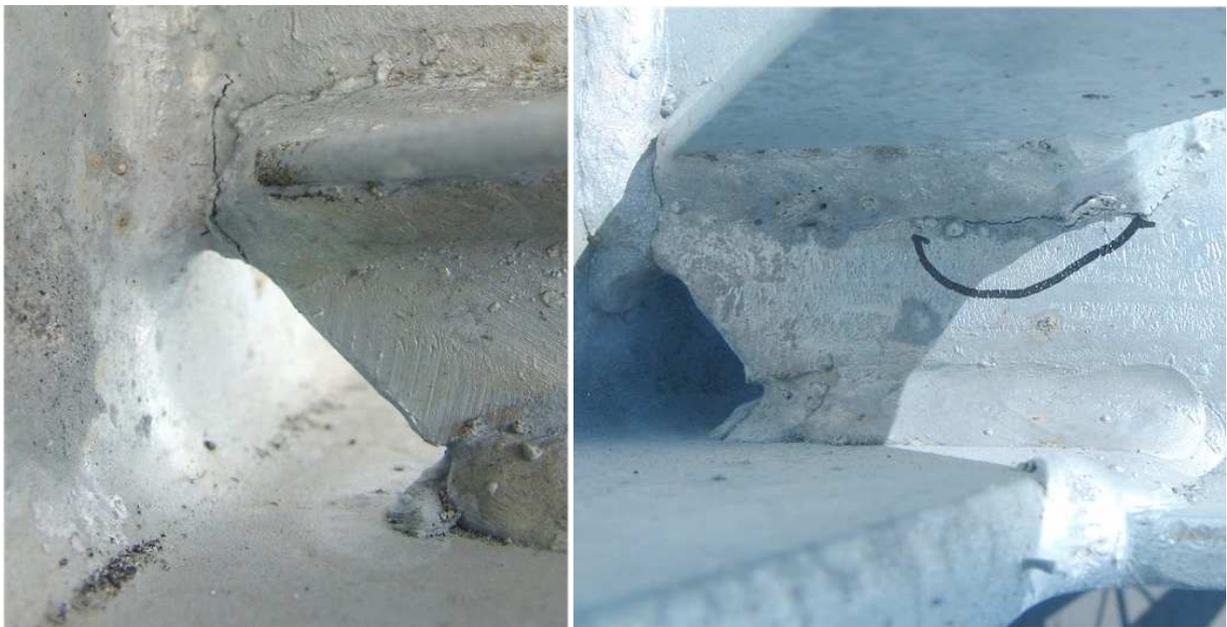
Figure 2b: Examples of cracks at welds in the web of the transverse I-beam chord at welded connections between the angle section chord and the transverse I-beam chord in the top image in Figure 2a. The cracks had developed at highly restrained welds.

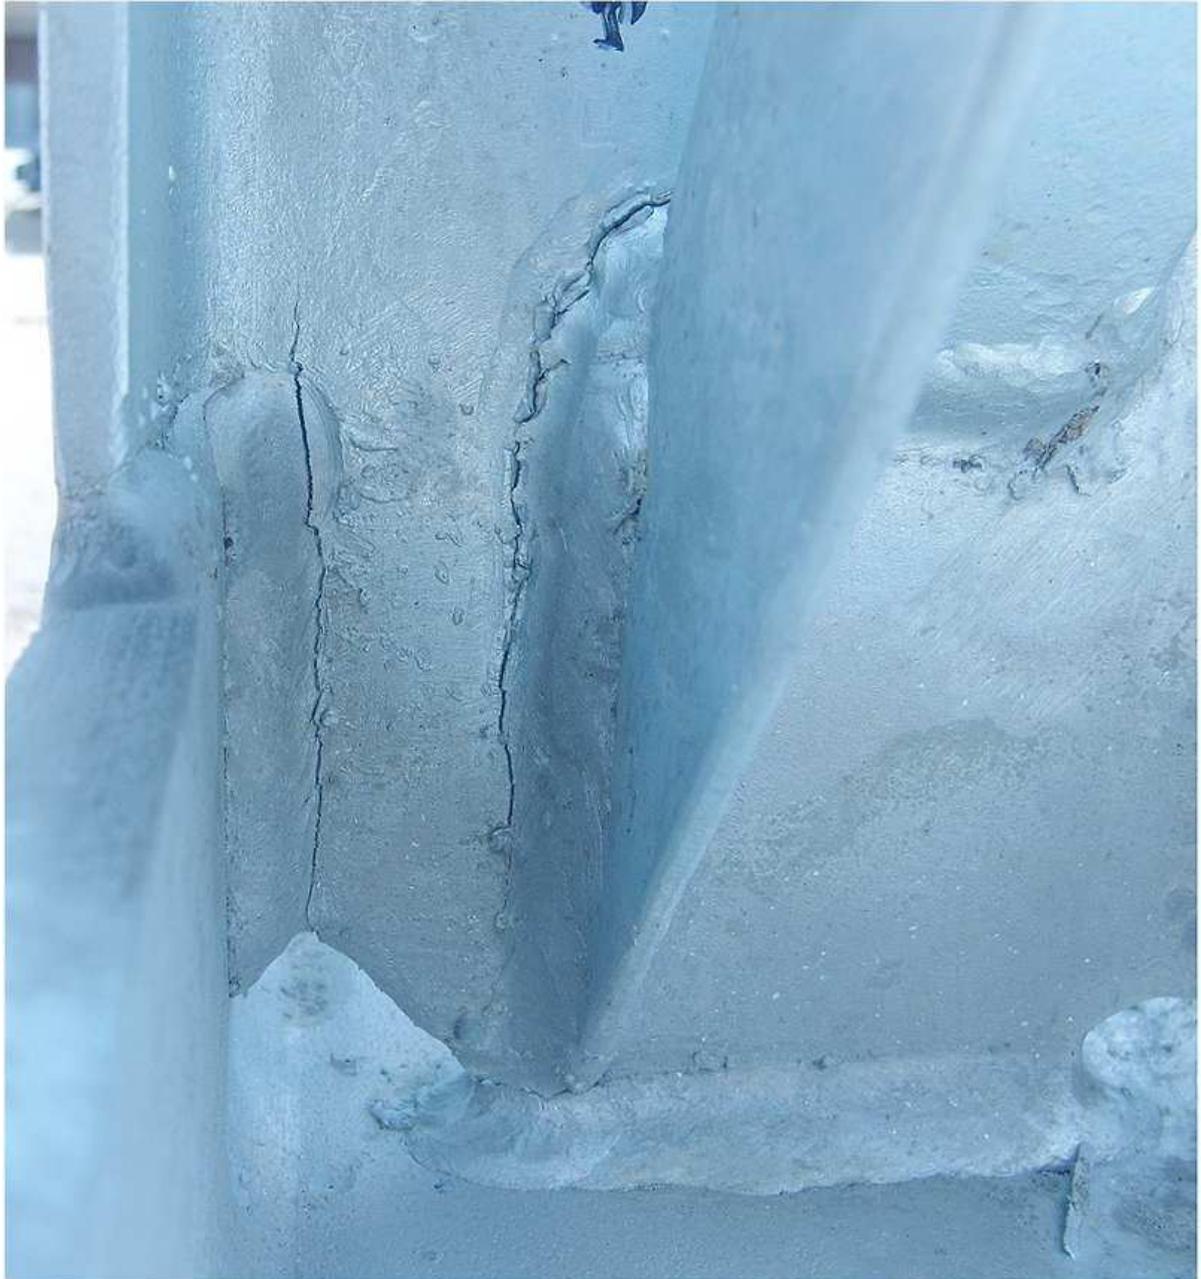
Figure 2c: Examples of cracks in the web of a transverse I-beam chord at fillet welds at the connection between a diagonal angle section chord and transverse I-beam chord in the top image in Figure 2a. The cracks had developed at highly restrained welds.

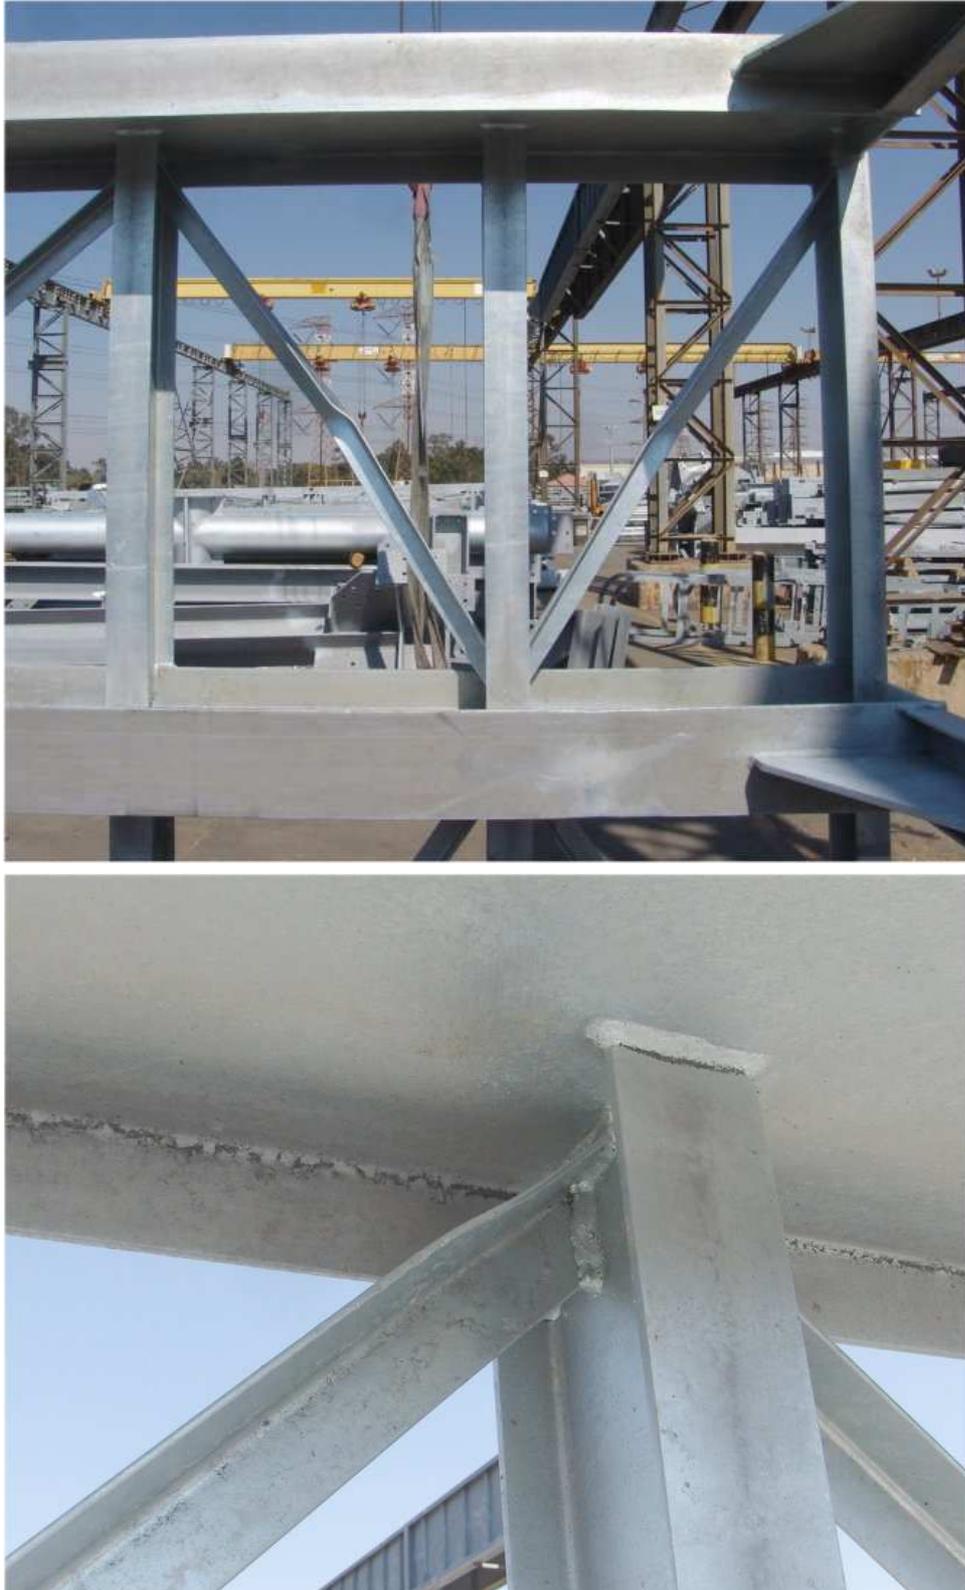
- 1.2.2 Many of the angle section diagonal chords, restrained by large section longitudinal and transverse I-beam chords, had distorted/buckled severely during hot dip galvanising (cf. Figure 2d).

Figure 2d: Examples of distorted/buckled angle section chords. The cracks were associated with the welded connections between these diagonal angle section chords and the webs of the transverse I-beam chords.

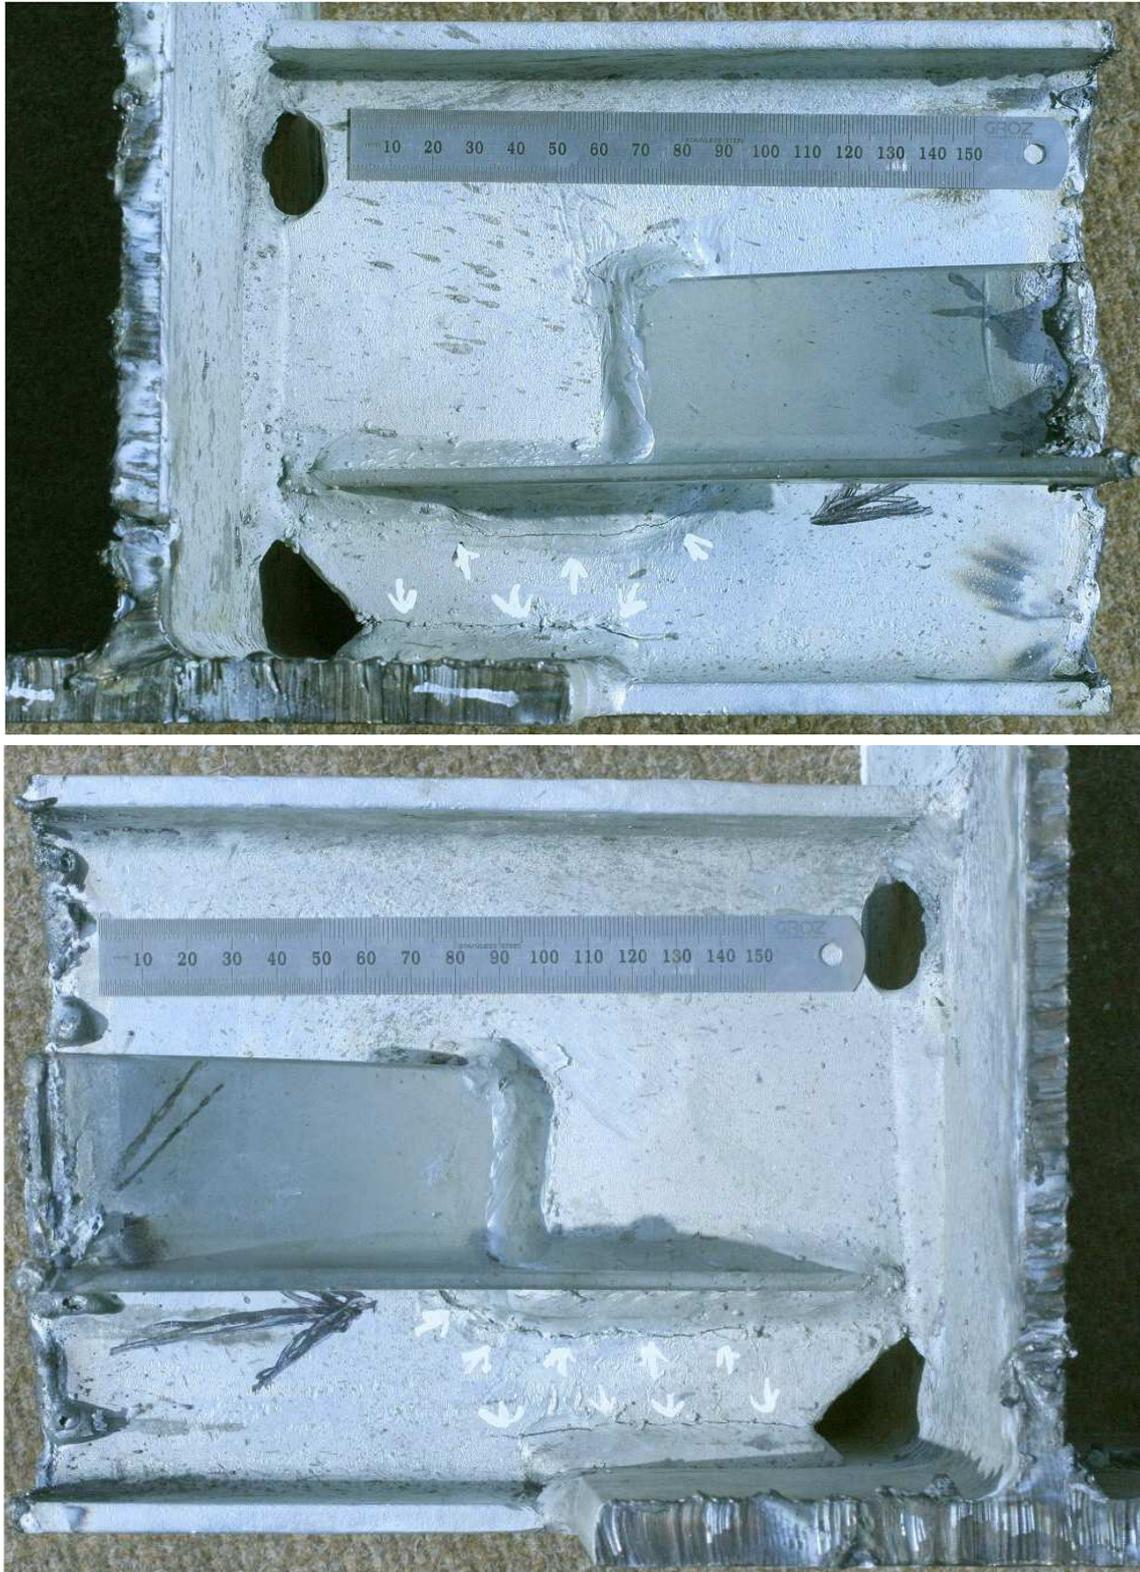
Figure 3a: Sample provided for examination by Grobler with cracks in the web of the transverse I-beam chord. The cracks had developed at both sides of the web at fillet welded connections between small angle section chords and the webs of much larger I-beam chords.

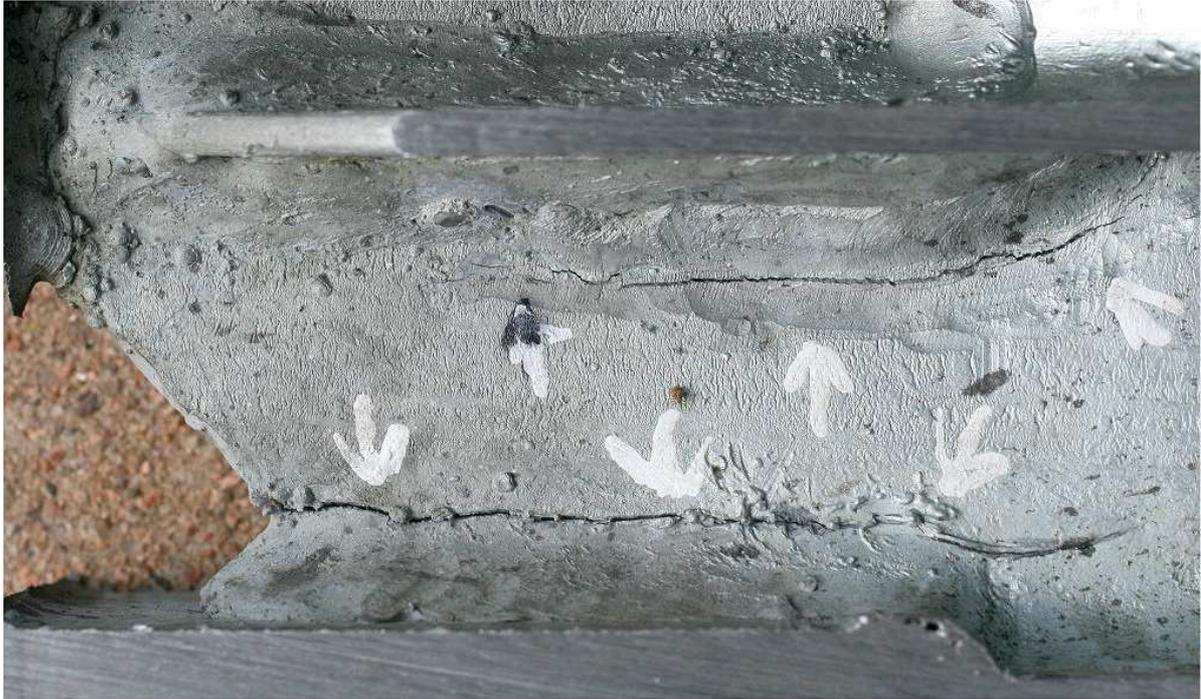
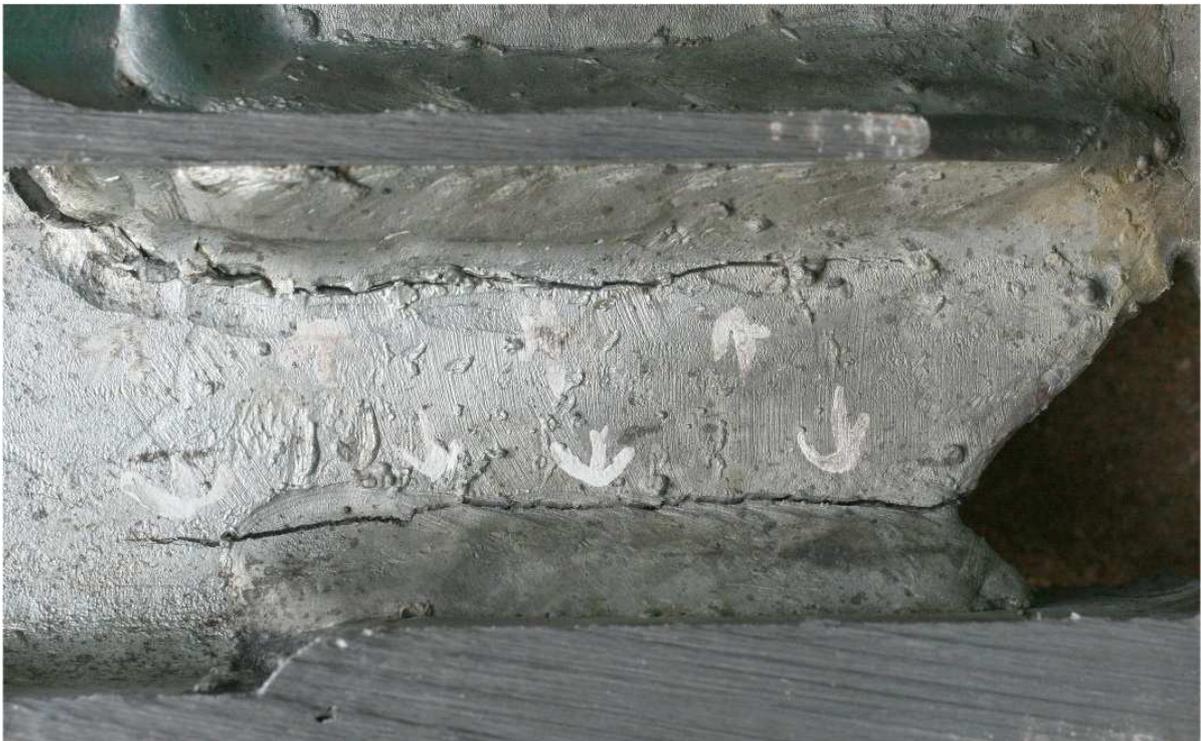
Figure 3b: Close-up views of cracks in the web of a transverse I-beam chord in Figure 3a. Note the grinding of the web at the fillet weld toe at the top crack in the top image. The findings of this investigation indicated that the grinding had probably been done by the fabricator to remove undercut at the fillet weld toe. Most of the cracks on the walkway platform were not associated with such fillet weld toe grinding.

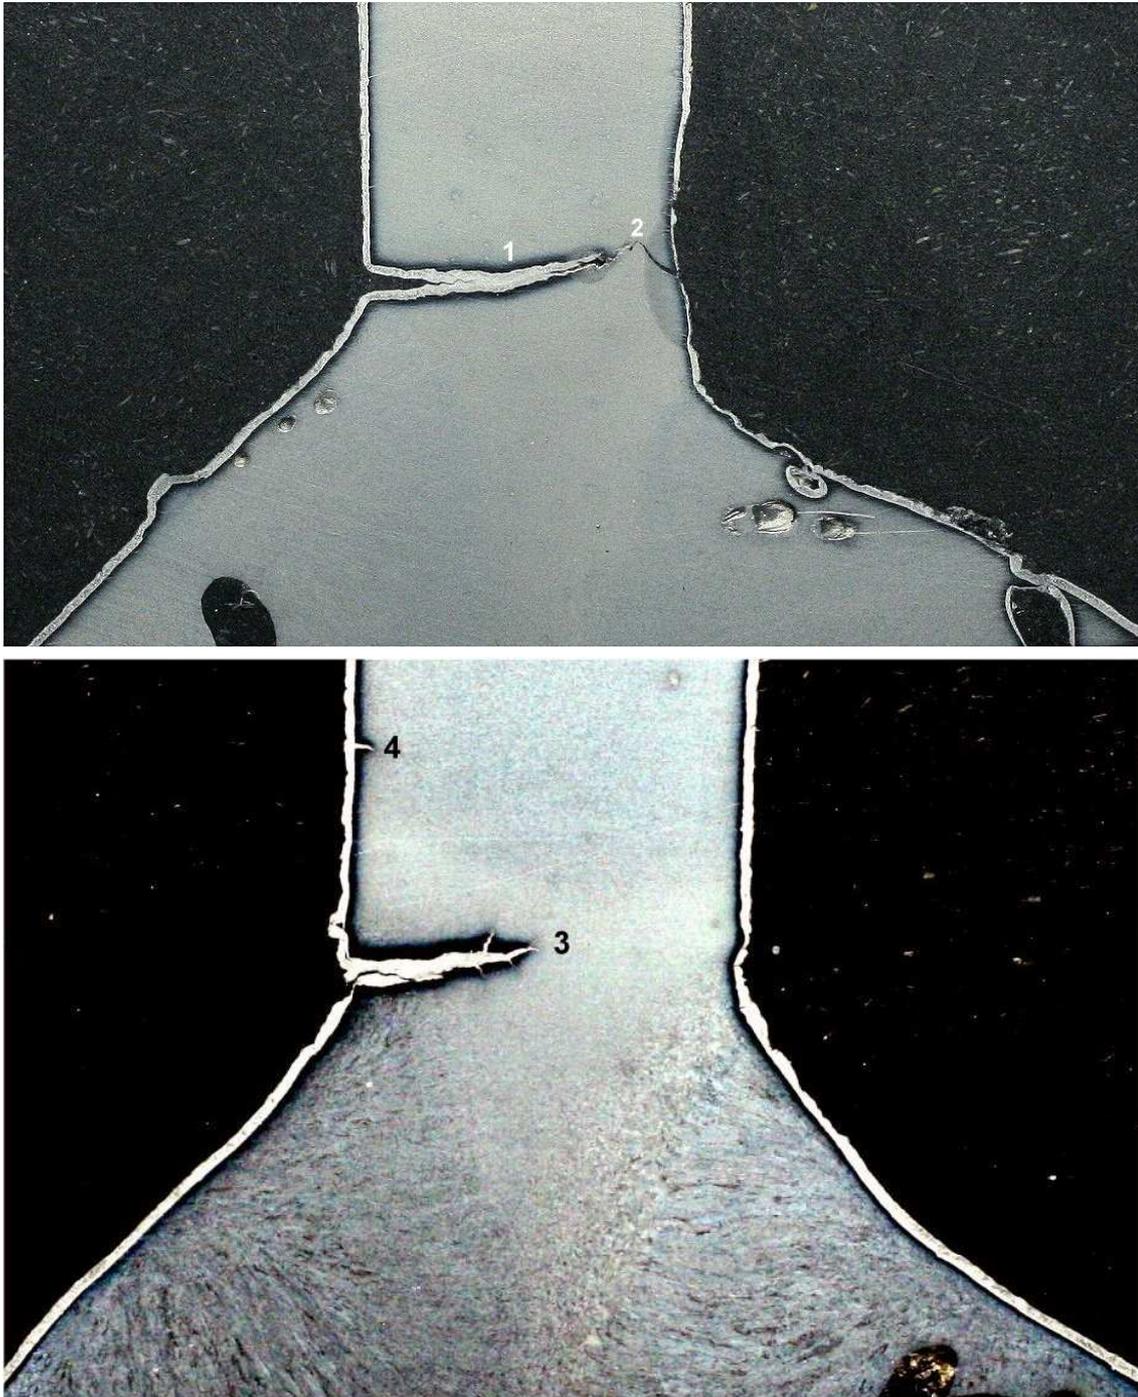
Figure 3c: Polished and etched sections through one of the cracks with the section in the bottom image closer to the crack tip than the section in the top image. **Top image:** (1) Zinc had penetrated most of the through-thickness crack, (2) the final end portion of the crack had developed by shear fracture during shrinkage during cooling after hot dip galvanising. **Bottom image:** (3) The crack had developed in the web of the I-beam chord from the fillet weld toe in the weld heat affected zone. Note the branching at the front end portion of the crack. (4) This crack had developed in the web base metal some distance from the toe of the fillet weld outside the weld heat affected zone and was also filled with zinc.

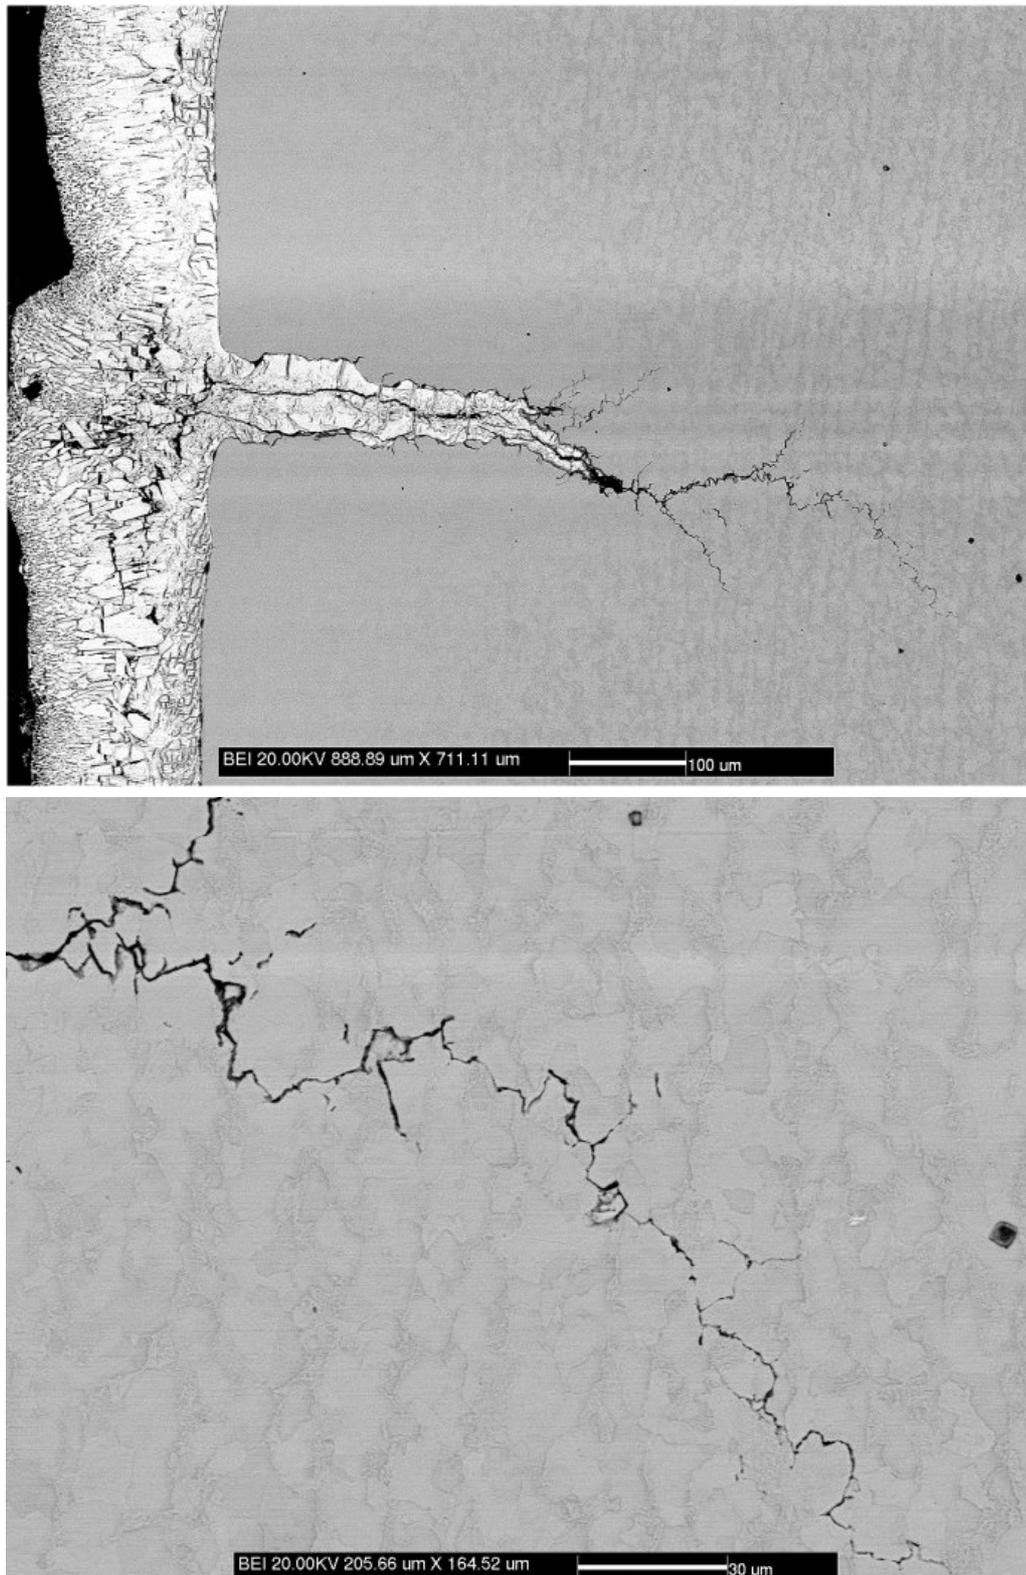
Figure 3d: Backscattered electron images of small surface crack (4) in the bottom image in Figure 3c that had developed in the base metal remote from the weld heat affected zone. The branching and intergranular crack paths are indicative of liquid metal assisted cracking (LMAC).

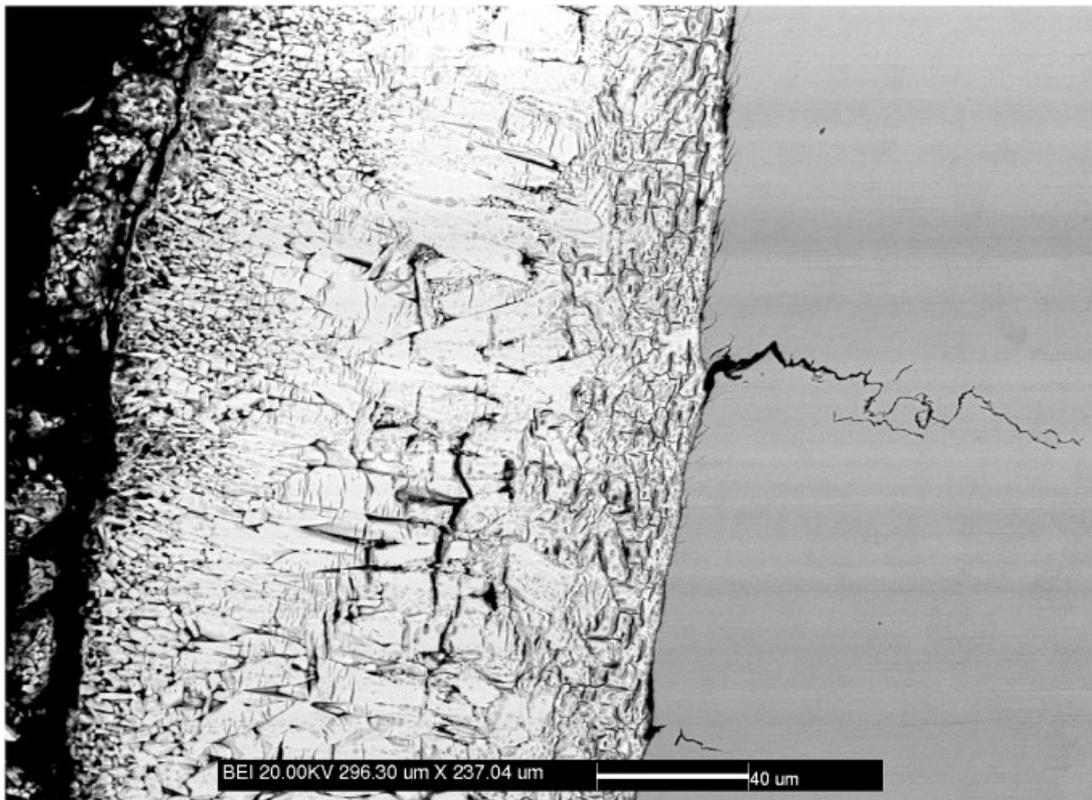
Figure 3e: Examples of small LMAC cracks at the surface of the web of the I-beam chord between the two large cracks in the bottom image in Figure 3c. These cracks had also developed in the base metal remote from the heat affected zone of the fillet welds.
