METALLURGICAL INVESTIGATION INTO THE ORIGIN OF CRACKS AT WELDED CONNECTIONS ON A HOT DIP GALVANISED FABRICATED STRUCTURAL STEEL PERIMETER WALKWAY PLATFORM FOR THE NEW KUSILE POWER STATION IN SOUTH AFRICA

Report no. 220512

22 May 2012

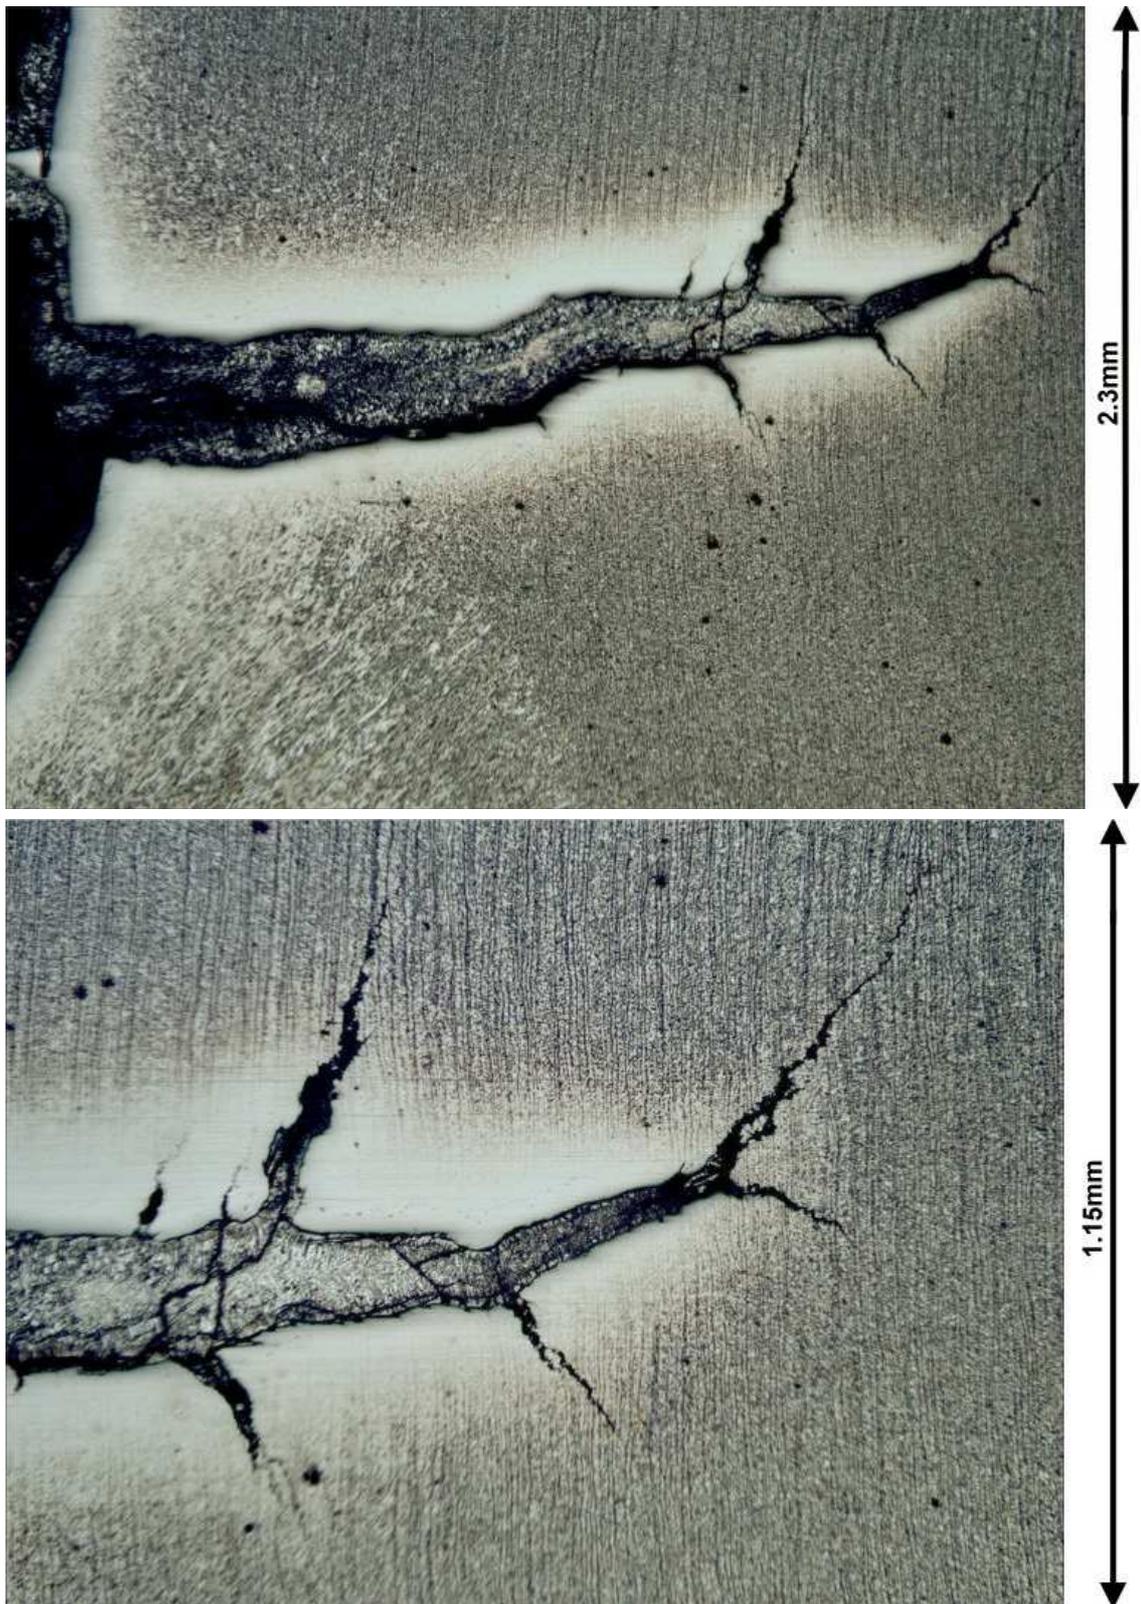
Figure 3f: Micrographs of the branched intergranular LMAC crack (3) in Figure 3c. This crack had originated at the toe of the fillet weld in the weld heat affected zone. It has, however, propagated into the unaffected base metal.

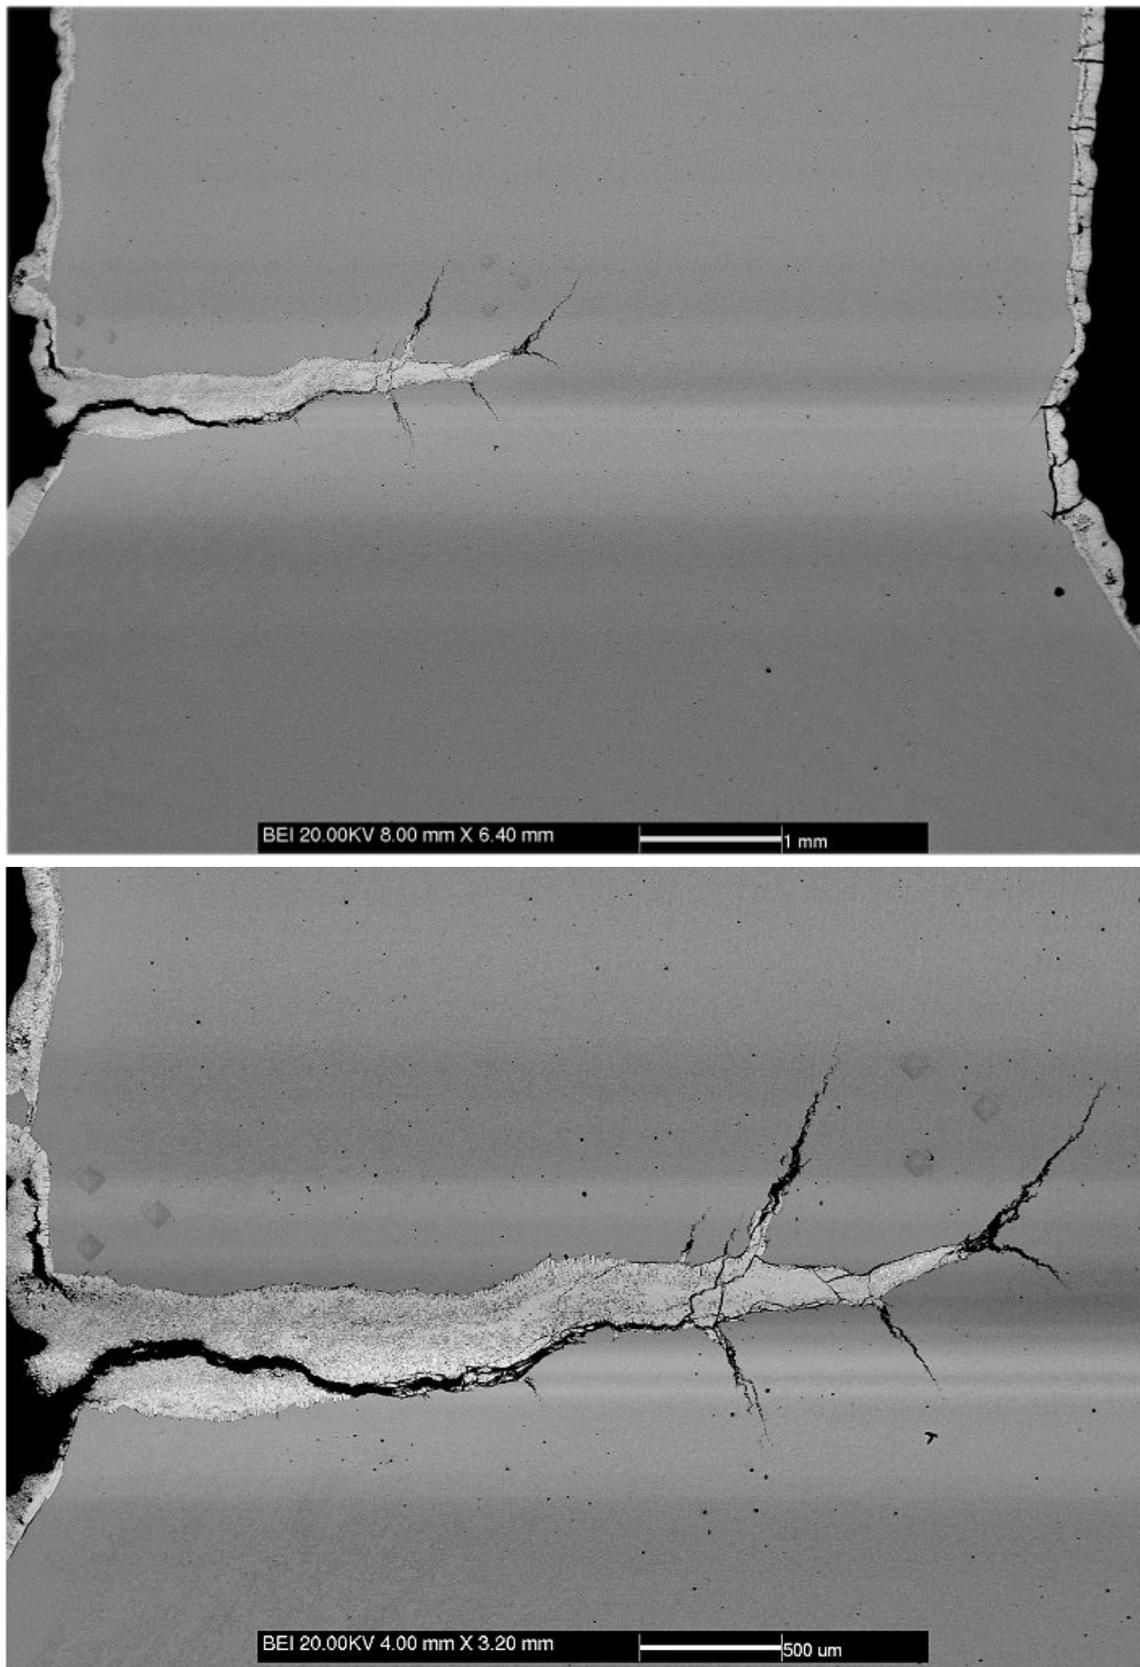
Figure 3g: Backscattered images of the branched intergranular LMAC crack (3) in Figure 3c.

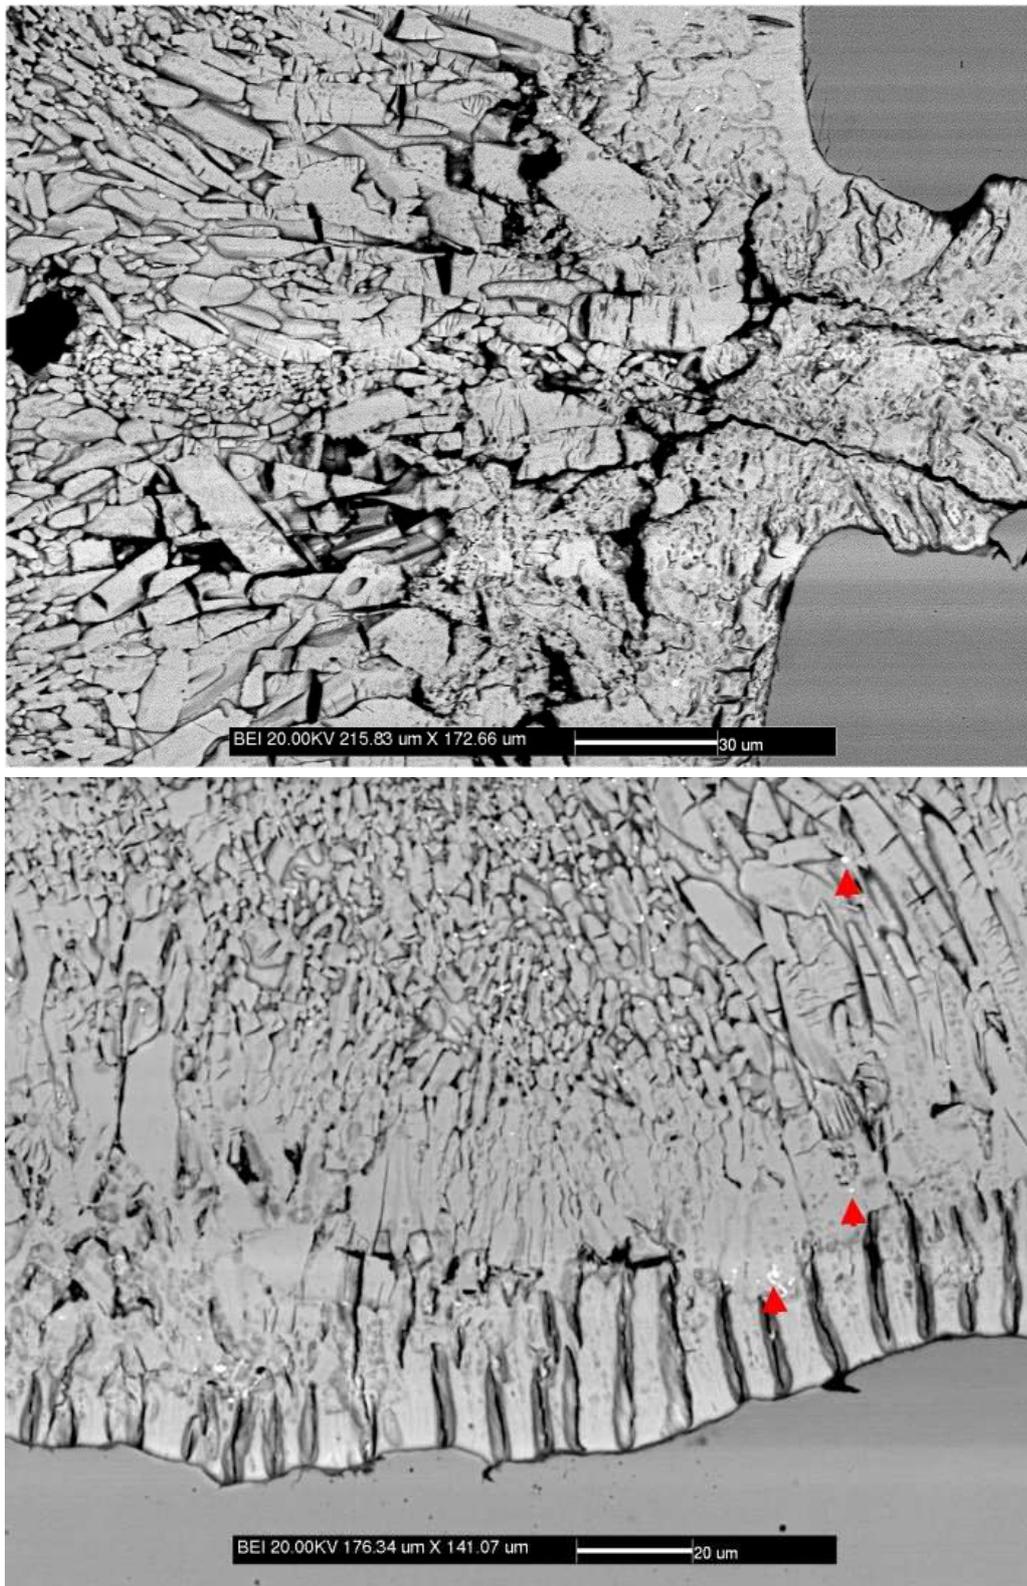
Figure 3h: Backscattered electron images showing small lead particles (white phase) in the zinc at the start of the large LMAC crack at the surface of the web at the left-hand side of the bottom image in Figure 3g.

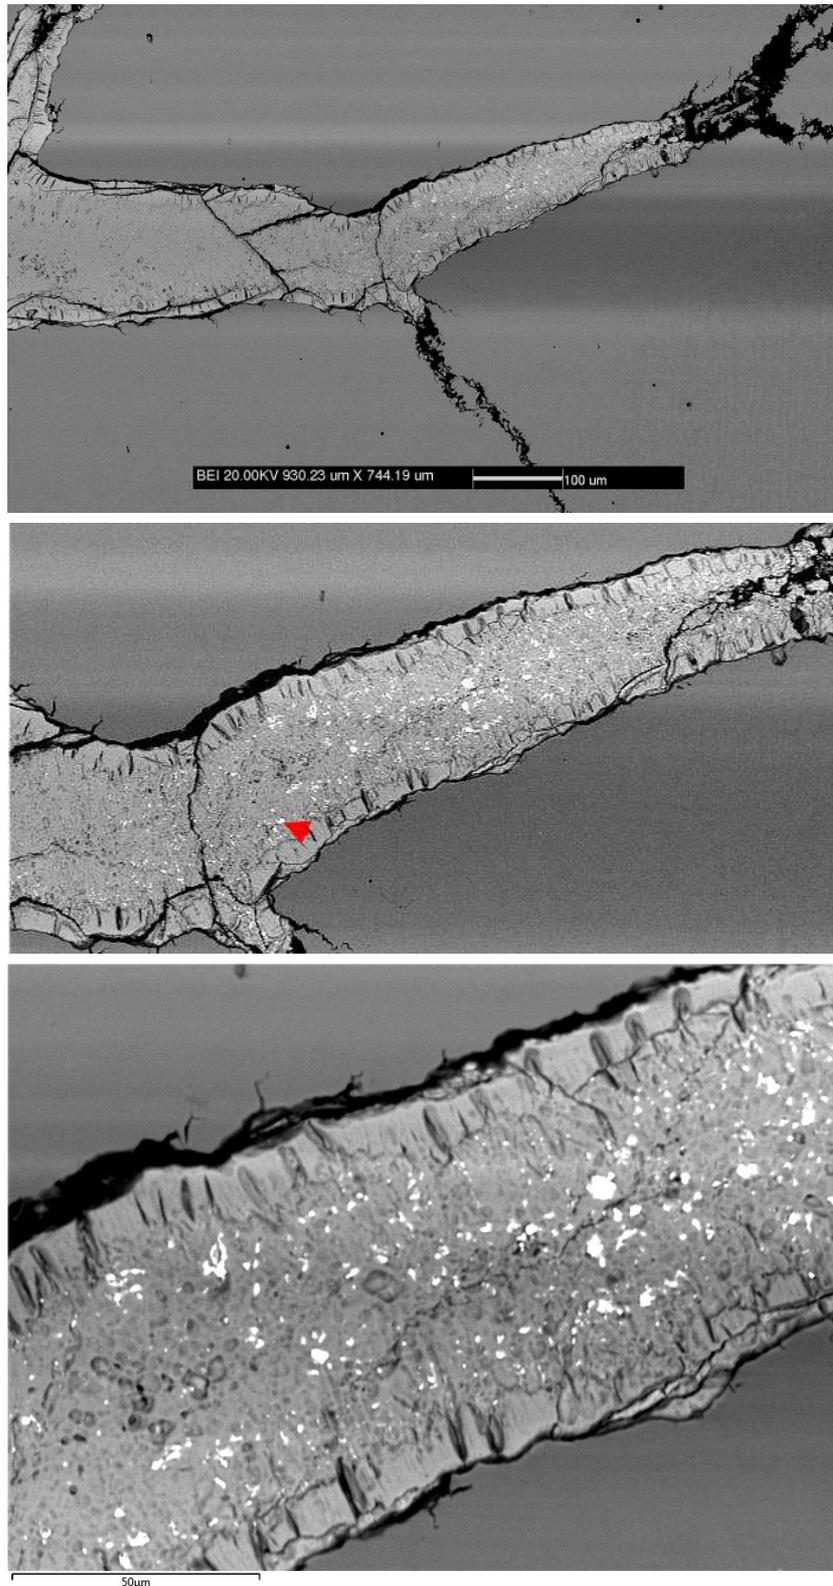
Figure 3i: Backscattered electron images showing relatively large lead particles in the zinc (white phase) in the right-hand side end portion of the LMAC crack in the bottom image in Figure 3g. The lead concentration increased towards the end of the crack.

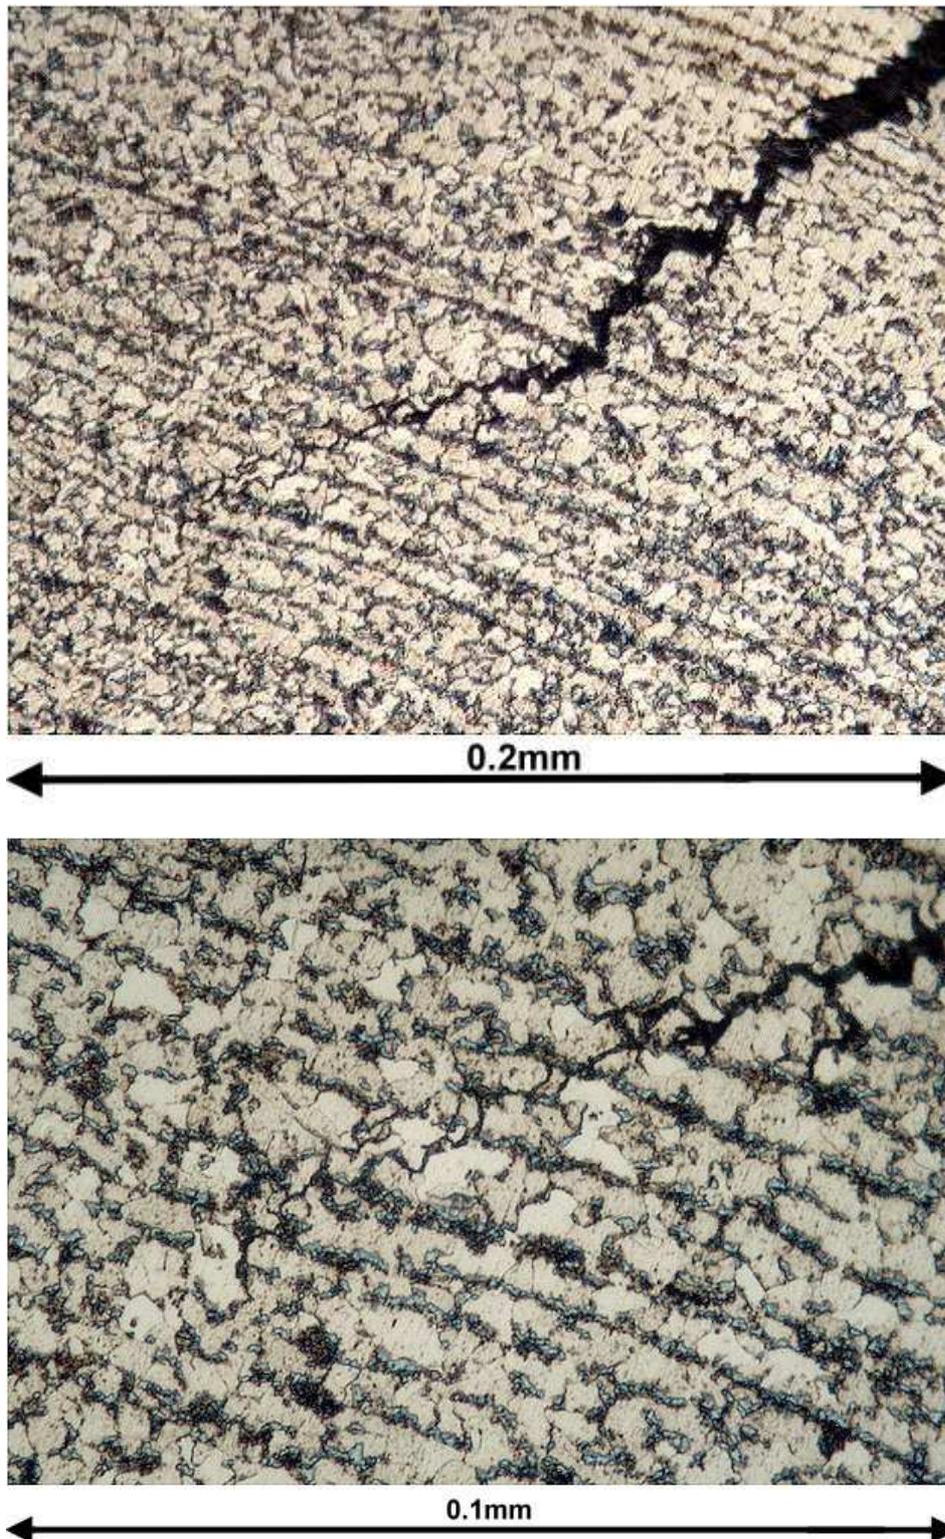
Figure 3j: Micrographs of the end portion of the bottom right-hand side branch of LMAC crack (3) in the bottom image in Figure 3f. Note the intergranular crack path and the banded ferrite-pearlite microstructure with the lighter phase ferrite and the darkish phase pearlite and the bands indicating the rolling direction.

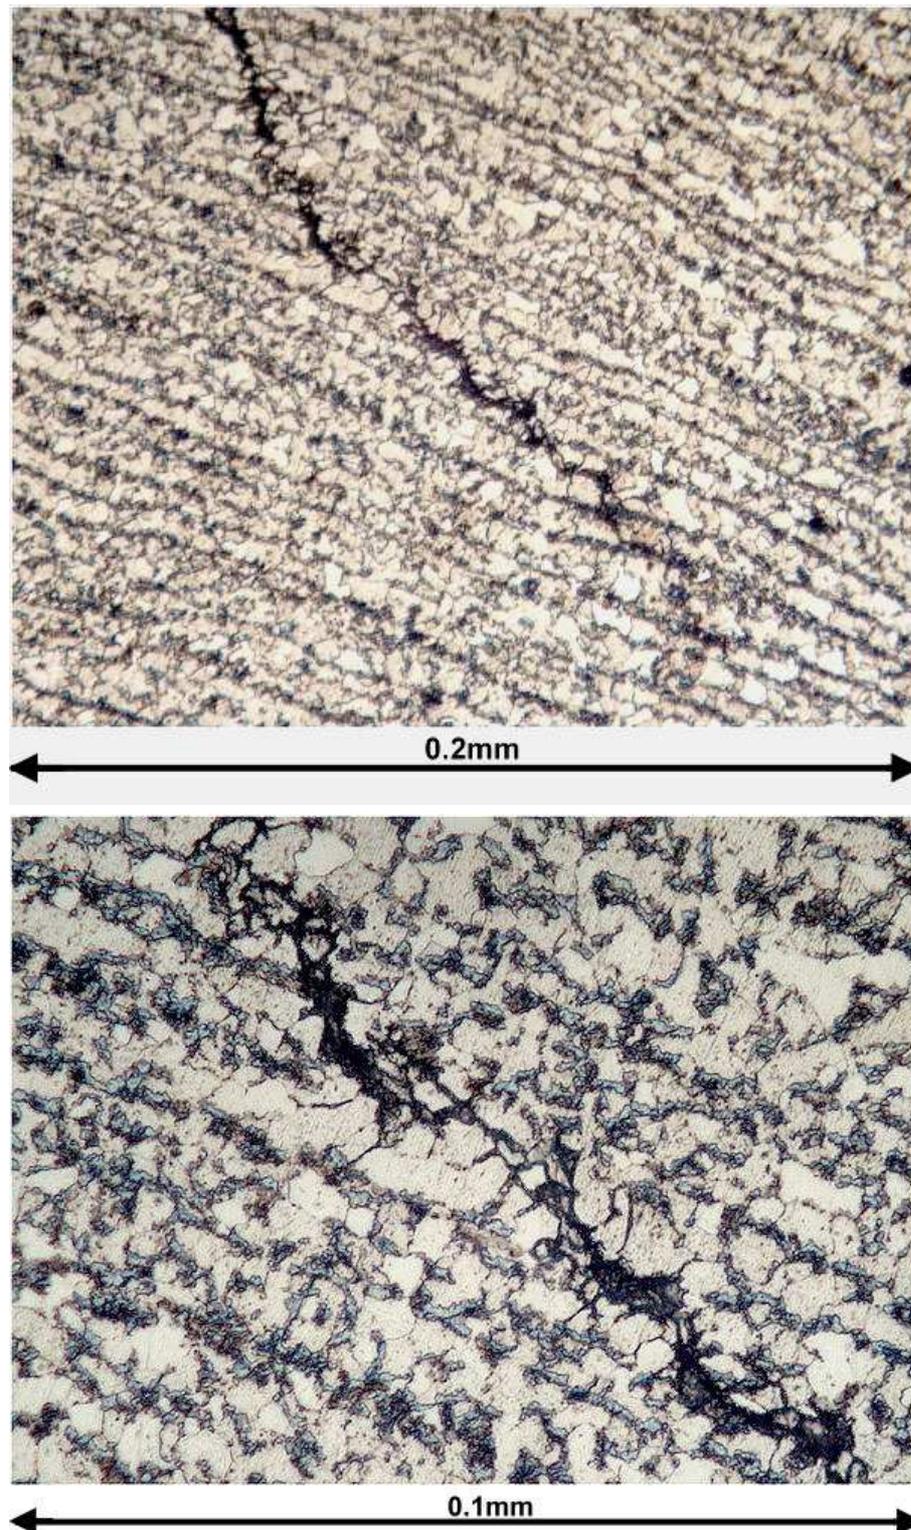
Figure 3k: Micrographs of the end portion of the top right-hand side branch of LMAC crack (3) in the bottom image in Figure 3f. Note the intergranular crack path and the banded ferrite-pearlite microstructure with the lighter phase ferrite and the darkish phase pearlite and the bands indicating the rolling direction.

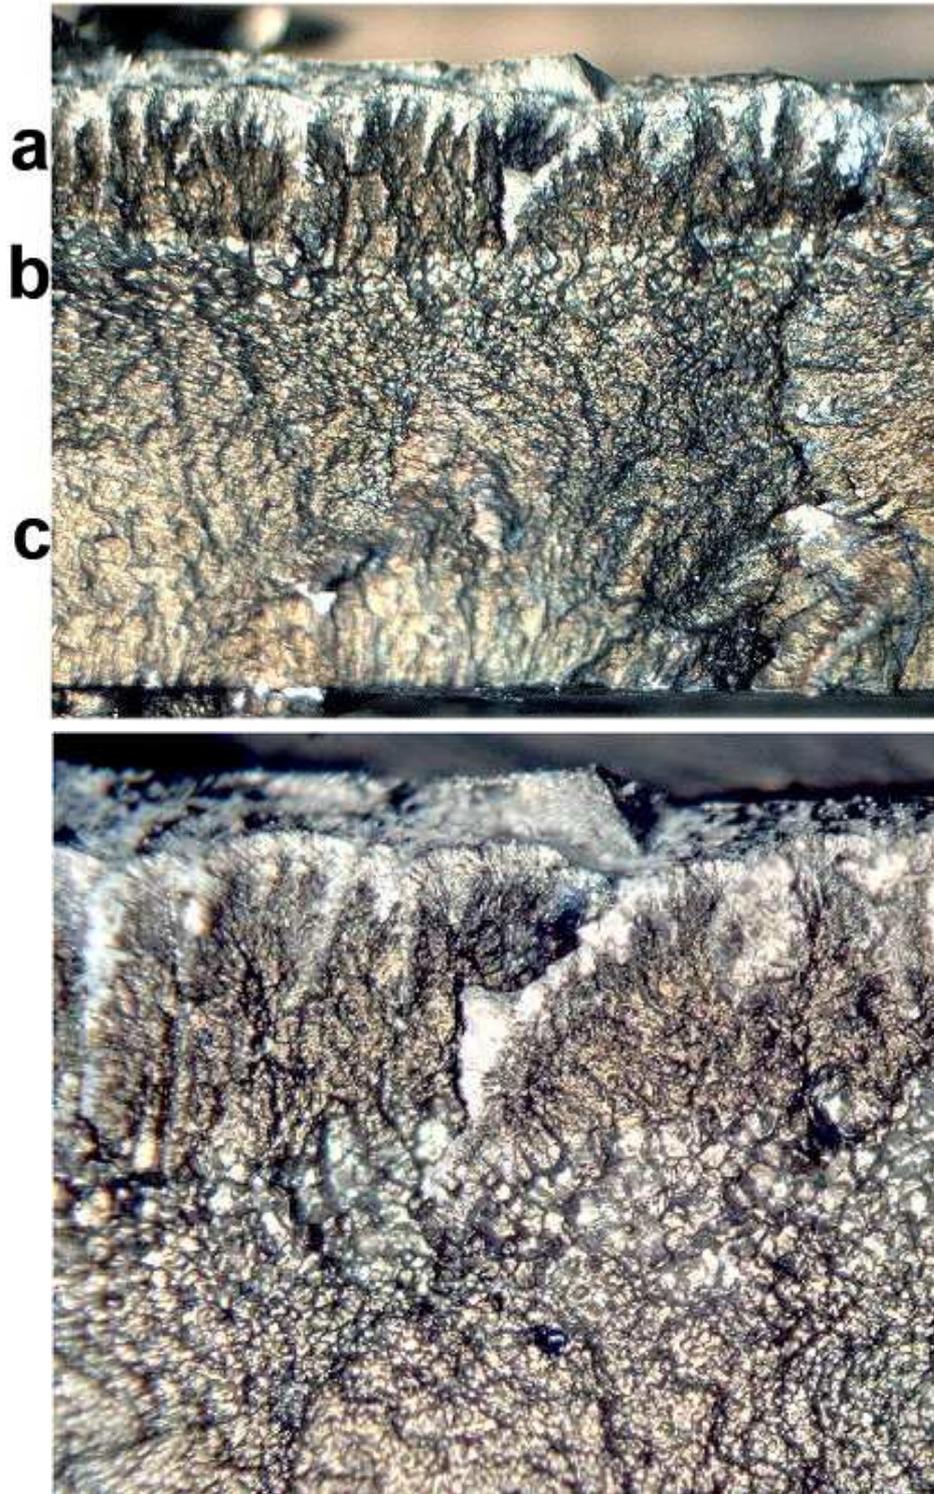
Figure 4a: Stereo microscopic images of a typical fracture surface of one of the LMAC cracks after stripping of the zinc layer with an inhibited hydrochloric acid solution with: (a) transgranular cleavage fracture through the weld metal, (b) an intergranular fracture through the heat affected zone with the grain size increasing towards the weld metal reaching a maximum at the fusion boundary, and (c) an intergranular fracture through the base metal.

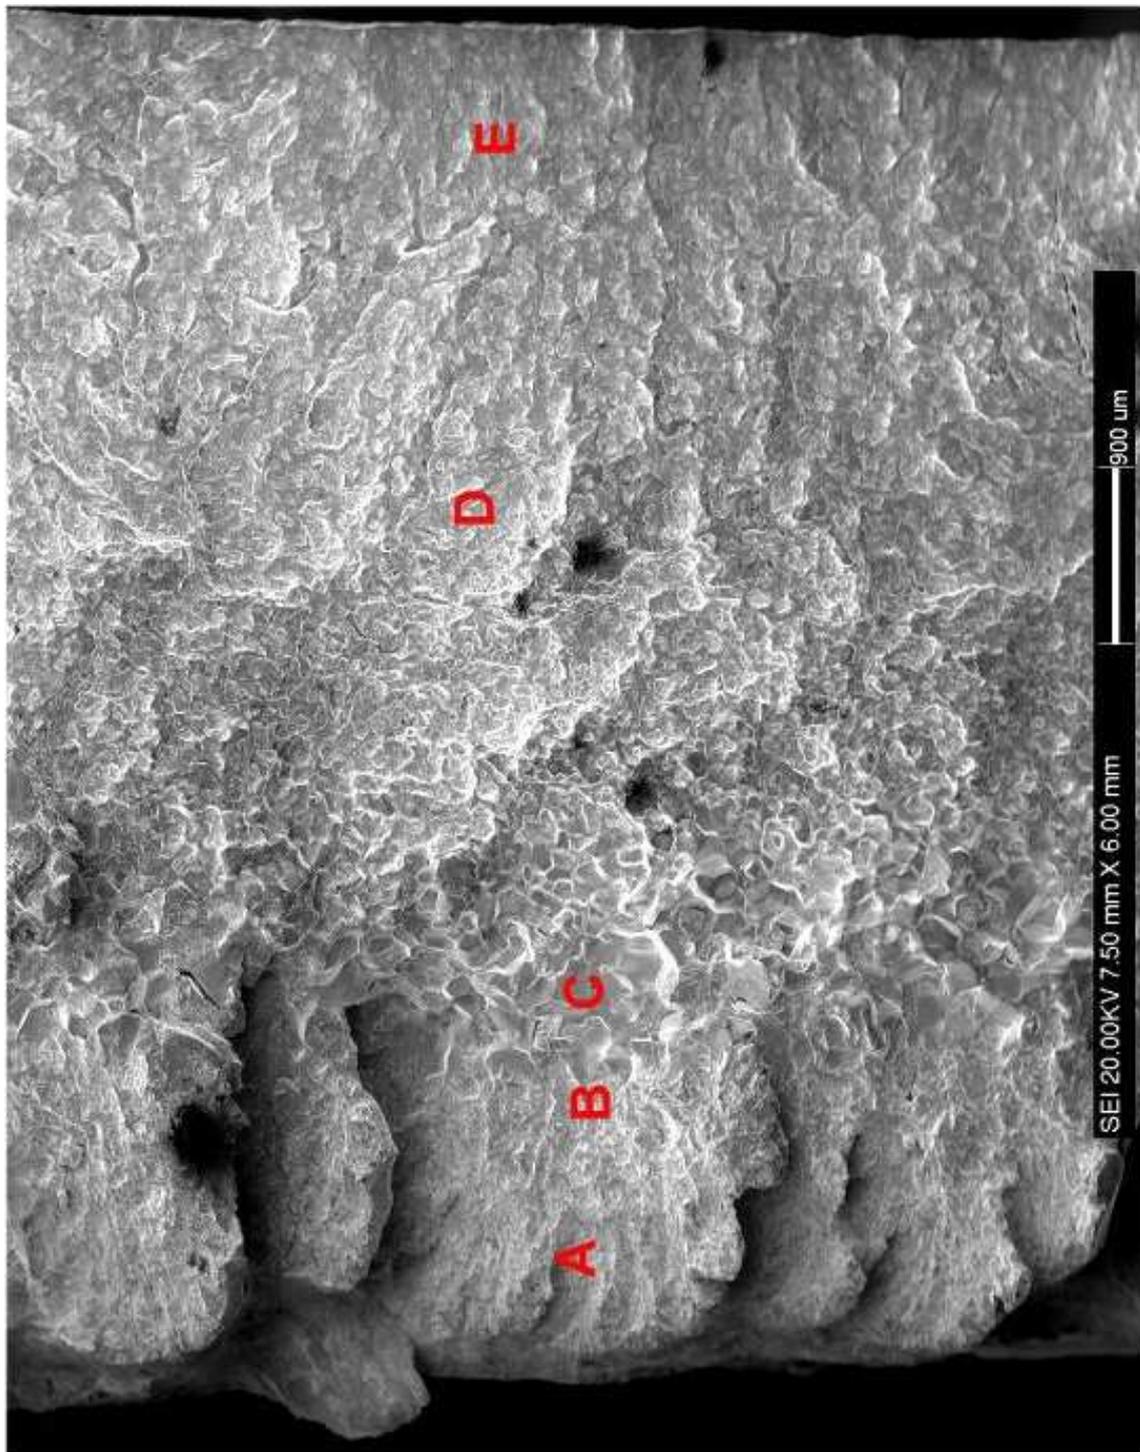
Figure 4b: Secondary electron image of the fracture surface in Figure 4a. Higher magnification images of the fracture surface at A to C are shown in the following figures.

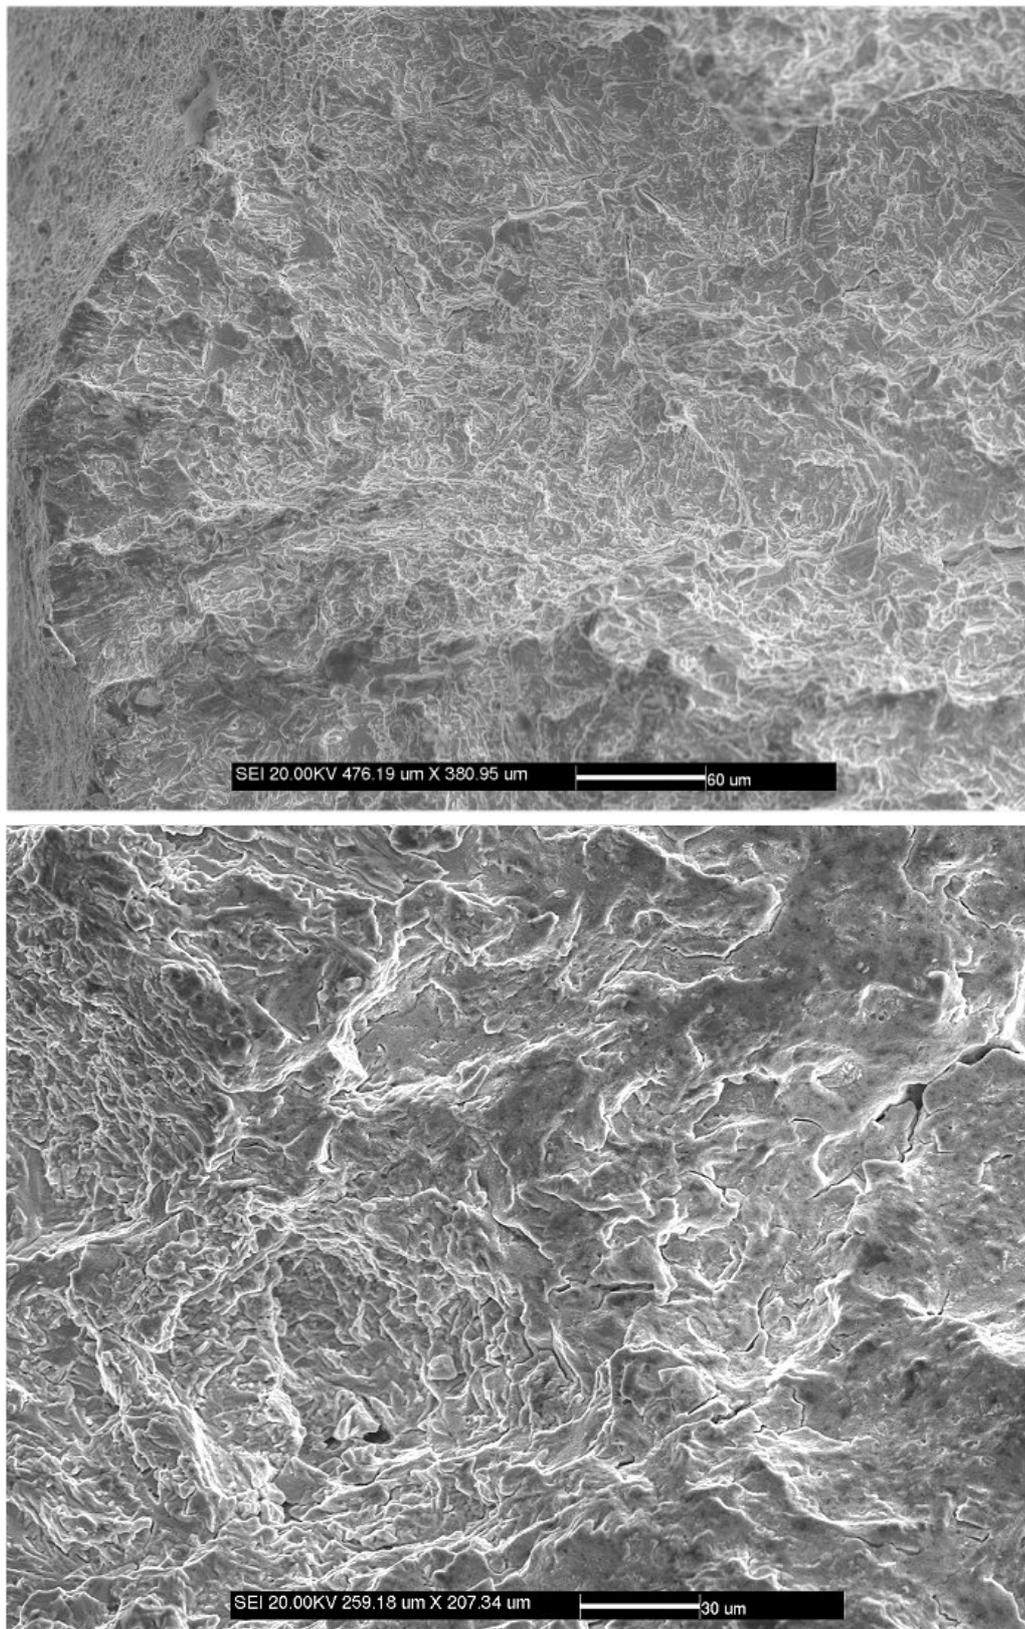
Figure 4c: Secondary electron images of transgranular quasi-cleavage fracture through the weld metal at A in Figure 4b.

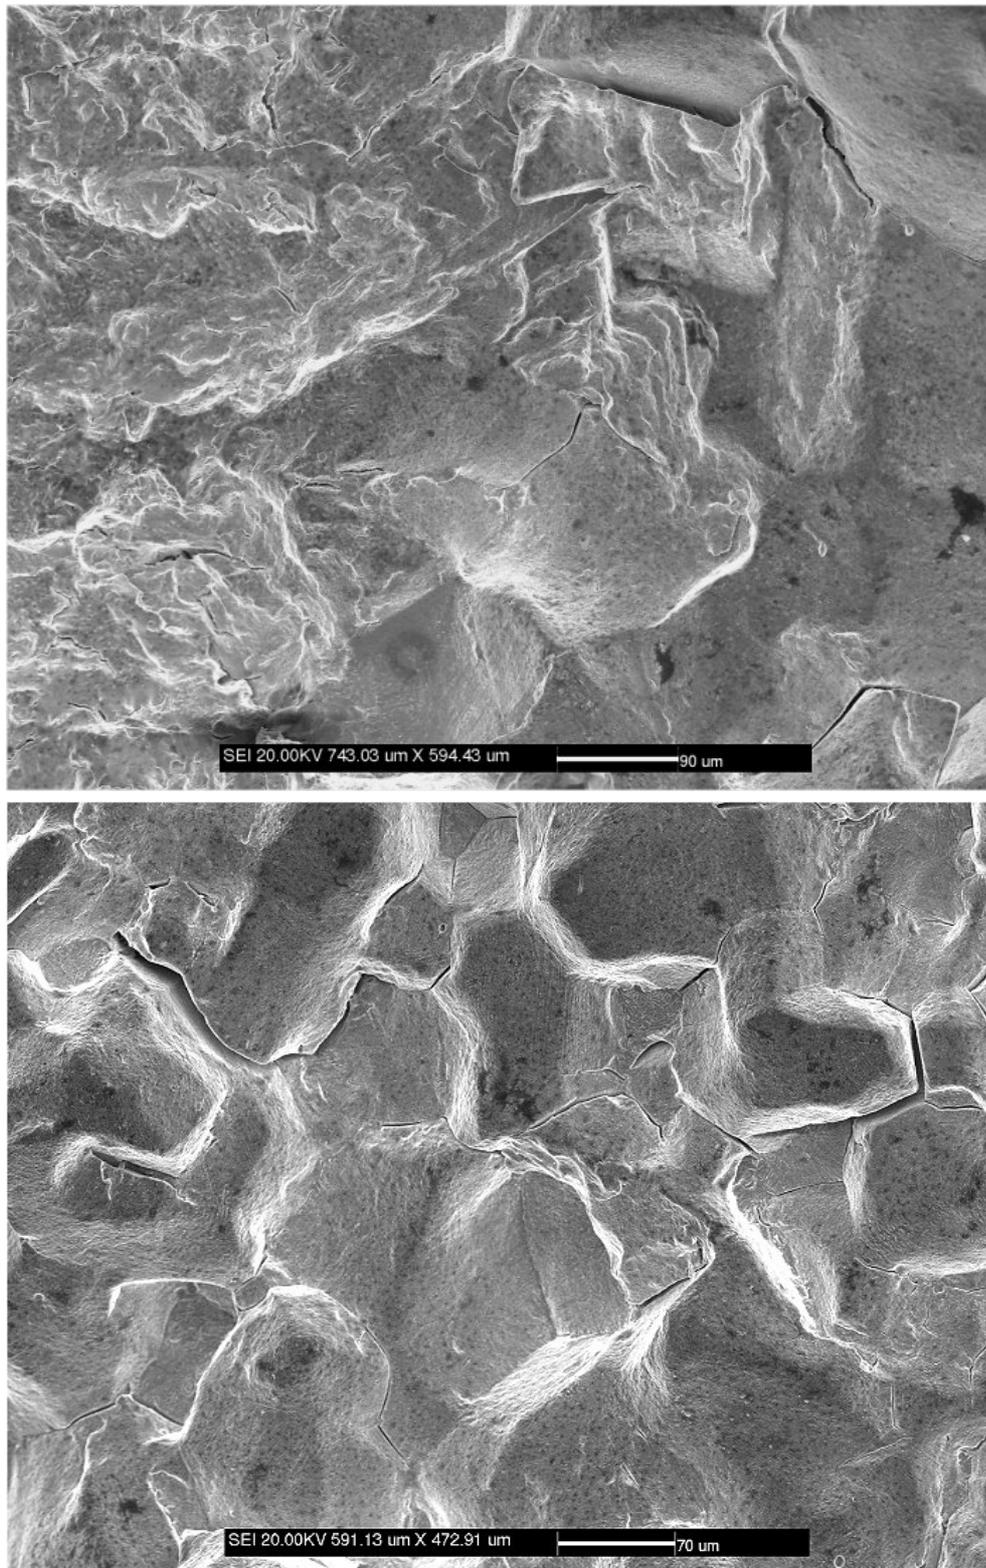
Figure 4d: Secondary electron images of an intergranular LMAC fracture at B (top image) and C (bottom image) through the heat affected zone in Figure 4b. The quasi-cleavage fracture through the weld metal is visible at the left-hand side of the top image.

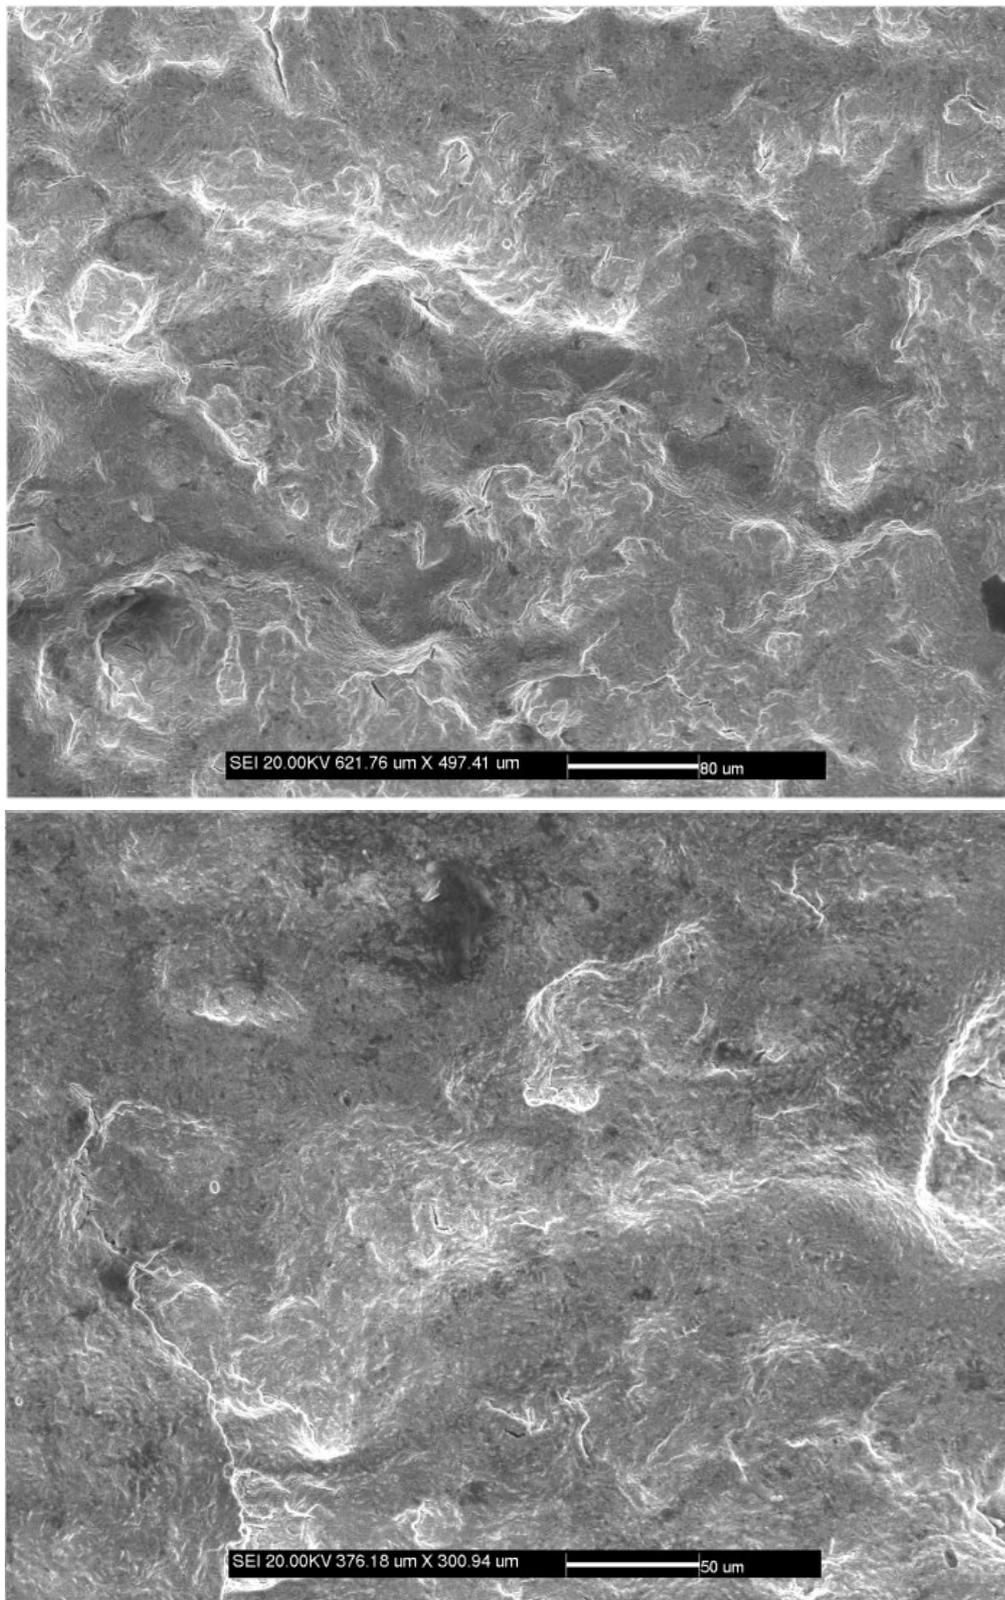
Figure 4e: Secondary electron images of an intergranular LMAC fracture at D (top image) and E (bottom image) through the base metal in Figure 4b. Refer also to the bottom images in Figures 3j and 3k.

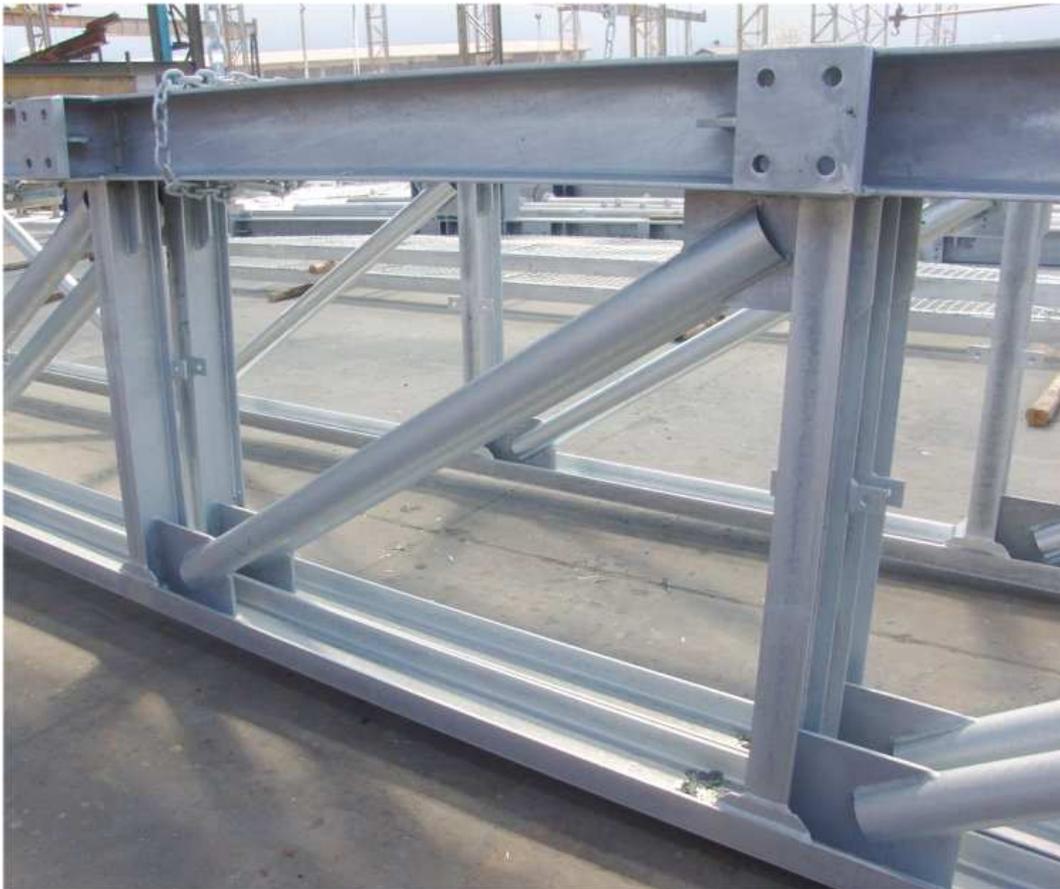
Figure 5: The risk of LMAC at the welded connections associated with the diagonal chord is relatively low because the section size of the diagonal chord is similar to that of the adjacent horizontal and vertical chords and because the rate of heating of the diagonal chord during dipping in the hot dip galvanising bath is likely to be similar to that of the surrounding chords.

3.4.7 The design of the diagonal chord of the steel girder in Figure 5 satisfied the guidelines in document No. 40/05 for limiting the risk of LMAC during hot dip galvanising:

- (1) The section size of the diagonal chord is similar to that of the horizontal and vertical chords.
- (2) The rate of heating of the diagonal chord is likely to be similar to that of the horizontal and vertical chords during dipping of the girder in the hot dip galvanising bath.

Cracks had not developed at any of the welded connections in any of these girders that had been hot dipped galvanised in the same bath as the walkway platforms with the cracks examined in this report.
