Surface Conditions (SC)

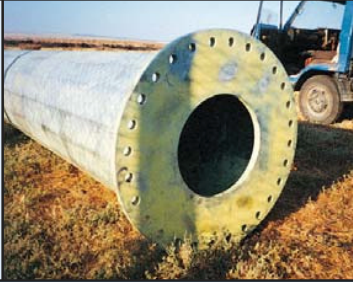
SC	DESCRIPTION	CAUSE	EFFECT / REMEDY RESPONSIBILITY	A/R/N C/REP	EXAMPLE
1	APPEARANCE OF SODIUM DICHROMATE. A small amount of sodium dichromate is generally added to the quench water bath for passivation.	Although the recommended quantity of sodium dichromate is about 0,15 to 0,3%, occasionally when topping up, more is added. This often results in a dark yellow to brown colour on the galvanized surface. The darker colour will provide enhanced initial corrosion protection.	Maintain concentration of sodium dichromate at about 0,15 to 0,3%. G	A

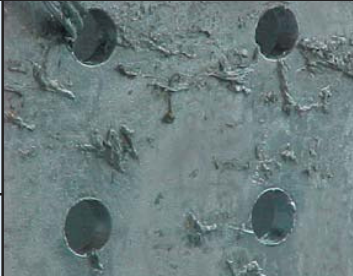
2	ASH DEPOSITS Ash deposits are grey, non-metallic deposits consisting of zinc oxide that have been deposited on the hot dip galvanized coating.	Zinc oxide deposits can take place when the component is dipped or when it is removed from the bath.	The coating is normally intact underneath the ash deposits. Ash must be removed and the coating thickness verified for conformance to the specification requirements. Remove ash from all liquid conveyance pipes. G	A / N C/REP If necessary

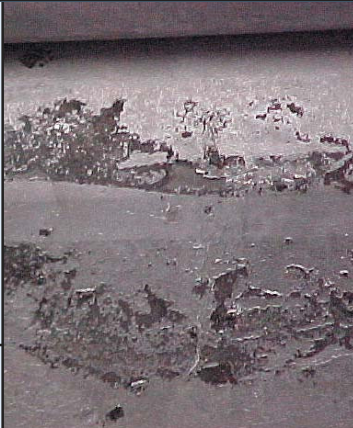
3	BARE SPOTS. Although excluded from SANS 121 / ISO 1461, bare spots of about 5mm ² (2,2 x 2,2mm), due to small localised flaws, are adequately protected by the sacrificial properties of zinc and will have very little effect on the service life of the coating. Where necessary, such spots may be repaired using one of the specified repair methods. Gross uncoated areas are a cause for rejection. See Coating Repair Procedures.	There are several causes of bare spots. These include: Overdrying. If the time between fluxing and hot dip galvanizing is prolonged or the drying temperature is too high, the barrier protection provided by the flux may be lost. This is indicated by a rusty appearance on the ungalvanized article, which can result in coating discontinuities after hot dip galvanizing. Excess Aluminium. A condition sometimes referred to as black - spots may occur if the aluminium content of a bath becomes too high. No trouble should be experienced if flux concentration is correct and the aluminium content of the bath is maintained below approximately 0,007%. Further causes are: Blowouts; flux deposits; stains and inclusions; mechanical damage; touch marks; uncoated surfaces caused by - surface contaminants, scale or sand; welds and weld spatter. See SC No's 6, 16, 19, 30, 33, 34, 35 and 37	 G G REP If necessary	A / R
