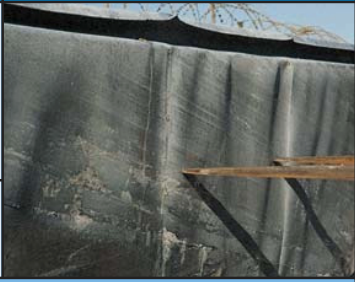
SC	DESCRIPTION	CAUSE	EFFECT / REMEDY RESPONSIBILITY	A/R/N C/REP	EXAMPLE
11	DISTORTION. Distortion is the unwanted warping that occasionally becomes evident after hot dip galvanizing	The hot dip galvanizing process occurs at a molten zinc temperature of 450 deg C. This is at the lower end of the stress relieving temperature for treating steel. Thus, any inherent rolling or welding stresses in the fabrication, are likely to be released. This may result in a dimensional change, i.e. distortion.	Use symmetrical designs; Use sections of similar thickness; Stiffen unsupported thin wall sections; Use preformed members with the correct minimum bend radii; Use balanced or staggered welding techniques; Make use of temporary braces on thin walled sections such as troughs, cylinders and angle frames. Avoid quenching after galvanizing. Components can be straightened after hot dip galvanizing.	A / N

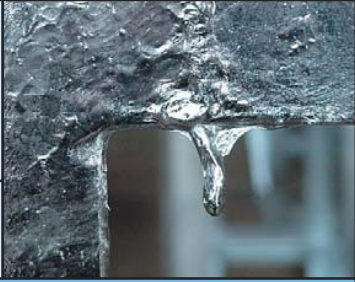
REP if possible D/G	
12	DRAINAGE SPIKES. Spikes and teardrops of zinc often appear along the edge of a component after hot dip galvanizing.	The edge most likely to have these spikes is the last to leave the bath on withdrawal. This applies particularly to complex fabrications.	Drainage spikes are easily removed at the bath while still molten but with complex fabrications, the solidified spikes will be removed by fettling by the galvanizer prior to inspection.	A / N

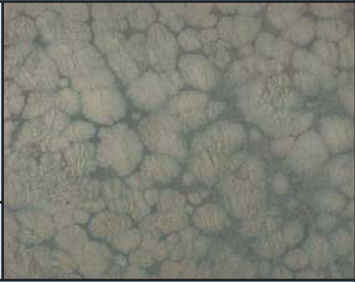
C / REP if possible G	
13	DULL GREY OR MOTTLED COATING APPEARANCE. Dull grey or mottled coatings can appear as a dark grey circular patten, a localised dull patch or, may extend over the entire surface of the component.	This appearance indicates the presence of extensive iron/zinc alloy phase growth, caused by steels with high reactive levels of Silicon and Phosphorous in steels.	Although not as aesthetically pleasing as a coating with free zinc on the surface, a dull grey coating provides similar or better corrosion protection.	A

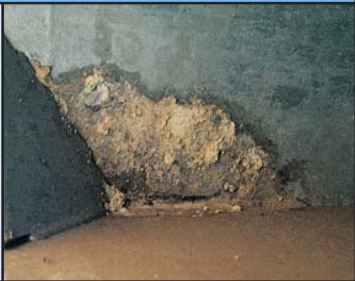
D/S	
14	ENTRAPMENT OF ASH. Ash which has not been removed from the surface of the molten zinc prior to immersion of steel can be trapped on the steel surface as it is immersed and result in an uncoated surface beneath the trapped ash.	Inadequate skimming of ash from the molten zinc surface prior to dipping.	On removal of ash, small uncoated surfaces shall be repaired according to the requirements of SANS 121 / ISO 1461. Large defects are a cause for rejection and require stripping and re-galvanizing.	REP (if small uncoated area R (if large, negotiable)

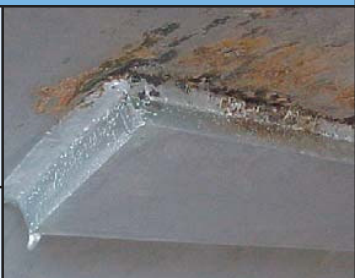
D / S	
16	FLUX DEPOSITS, STAINS AND INCLUSIONS Flux deposits or stains from the galvanizing process may adhere to the steel or become included in the coating. Flux residues are black, brown, grey or yellowish non-metallic deposits consisting mainly of ammonium chloride.	Flux deposits or stains may occur as a result of excessive "dusting" with ammonium chloride on withdrawal from the molten zinc. Flux inclusions can occur when a surface flux blanket is applied to the zinc surface (wet galvanizing). Flux blankets are normally only used for specialised processes, e.g. galvanizing of tubes and fasteners.	Flux deposits or stains should be removed and the underlying coating measured to determine whether it conforms to the minimum requirements of the specification.	A
