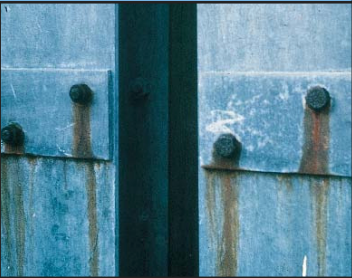
B REP	
18	COATING THICKNESS PROVIDED ON FASTENERS USED TO ASSEMBLE HOT DIP GALVANIZED STRUCTURES	No matter how the zinc coating is applied, the coating life is proportional to its thickness in a given environment. Often electroplated fasteners with insufficient coating thickness are incorrectly used in external environments.	Specify hot dip galvanized fasteners to SANS 121 / ISO 1461, where required. Alternatively overcoat fastener with an approved zinc rich paint or epoxy. See Coating Repair Procedures.	R

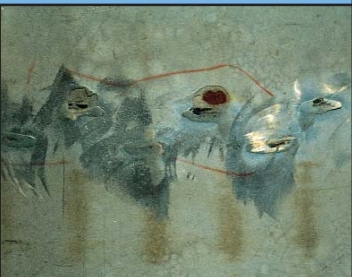
D / B REP If acceptable	
19	MECHANICAL DAMAGE. Mechanical handling or transport damage can occur, particularly with extremely thick coatings, which tend to be brittle in nature.	The use of chains, wire ropes, dragging or dropping of the component onto a hard surface, can cause mechanical damage. This is particularly relevant with thick brittle coatings.	Warning labels, highlighting a thick coating and possible damage if manhandled, should be attached by the galvanizer, before the component is transported. The use of nylon lifting slings is recommended.	A

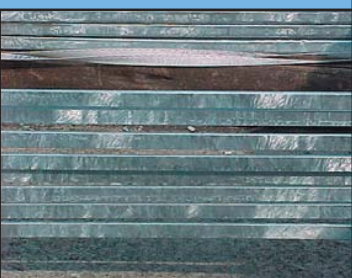
G / B REP If necessary	
20	OXIDE LINES. Light aluminium oxide film lines on a hot dip galvanized surface.	Due to the shape and / or drainage conditions of some components, the hoist crane has stopped and started upon withdrawal of the items from the molten zinc.	No effect on corrosion resistance. The overall appearance becomes uniform in time.	A

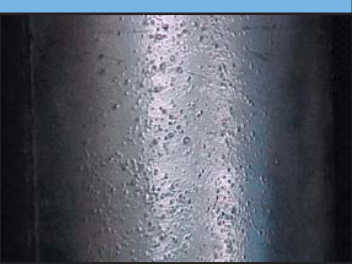
21	PIMPLES OR BLISTERS. Pimples or blisters formed during hot dip galvanizing are usually associated with surface imperfections such as dross inclusions.	Dross pimples result from agitation of the dross layer at the bottom of the bath or from dragging material through the dross layer. They appear as small, hard lumps on an otherwise normal galvanized surface. Blisters may be formed by hydrogen, which is absorbed during pickling and diffused at galvanizing temperatures.	The galvanizer should avoid disturbing the dross layer at the bottom of the bath, by controlling immersion depth and crossing regularly. Since dross pimples represent minor disturbances in coating uniformity, they do not affect corrosion resistance.	A
