Moab Khotsong (Vaal Reefs No. 11 shaft)

Case History No. 10/2006

Case History

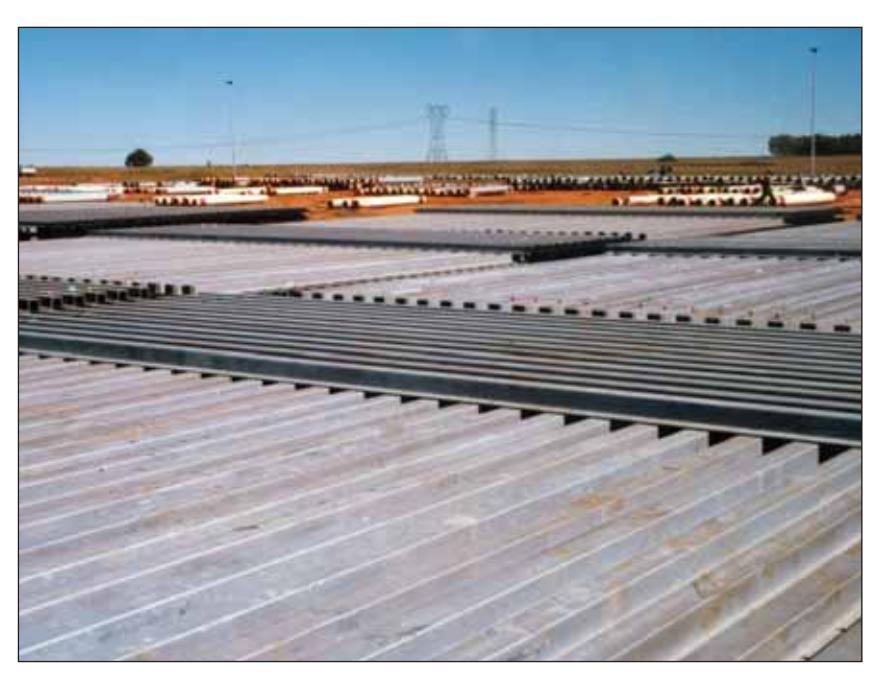
Hot dip galvanized shaft guides correctly laid out on site, awaiting installation in the shaft.

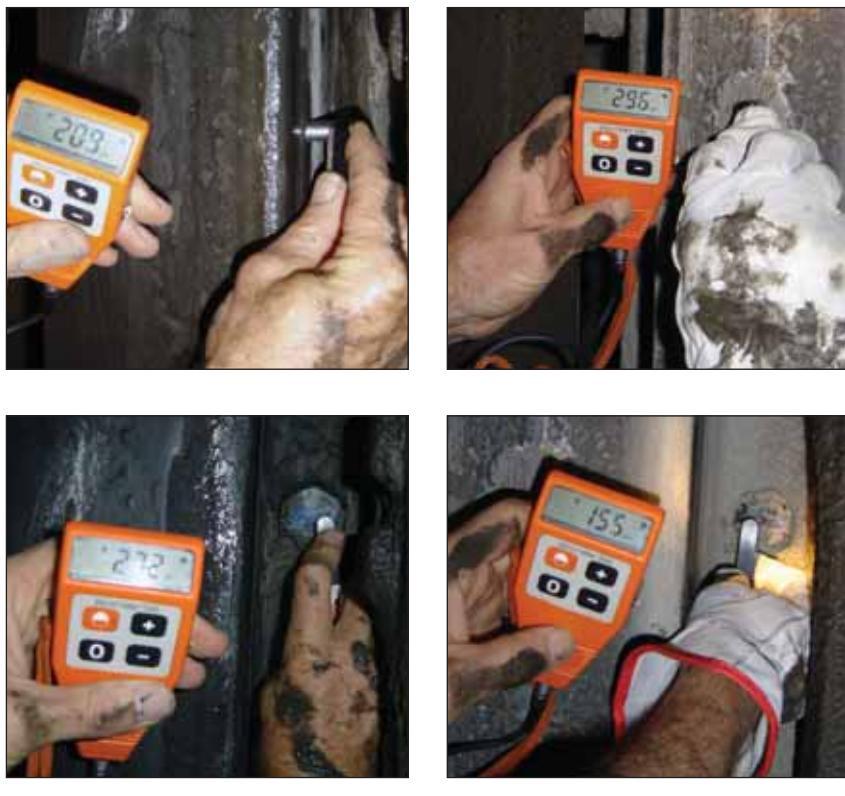
Coating thickness indicated on various parts of the shaft guides, proved that the original predicted service life of 25 years would be achieved.

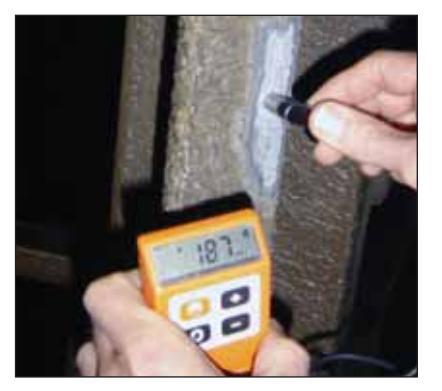
The hot dip galvanized coating thickness on station steelwork proved to be in good condition.

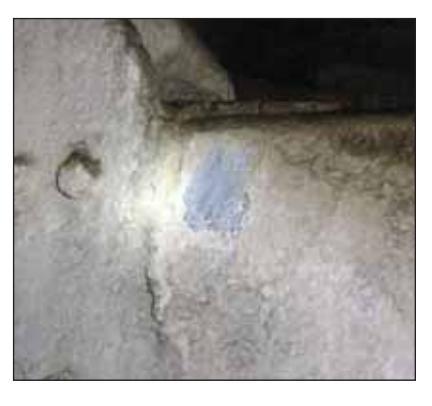
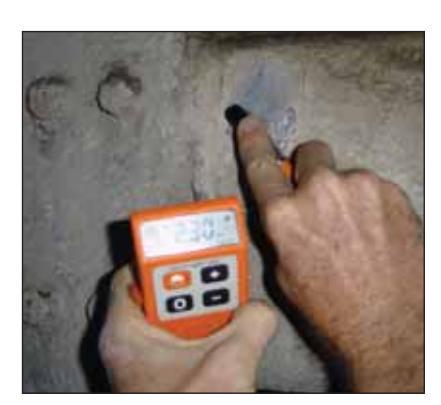
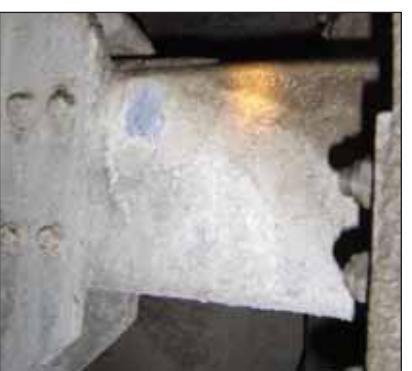
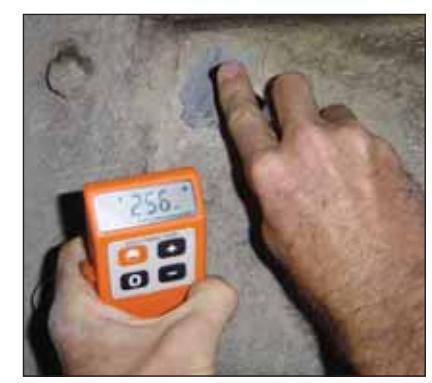
The coating thickness on shaft buntons at four different levels were inspected but as they were similar in residual coating thickness, only two have been reported. The calcerous growth in most instances was removed prior to measuring the residual coating thickness.
