Hot Dip Galvanized Case Study No. 4

Hot dip galvanized Reinforcement in Concrete

This case study is the result of a detailed investigation of a pedestrian bridge situated along the foreshore of Algoa bay. The stairway was rebuilt in 1980 using galvanized reinforcement due to spalling concrete.

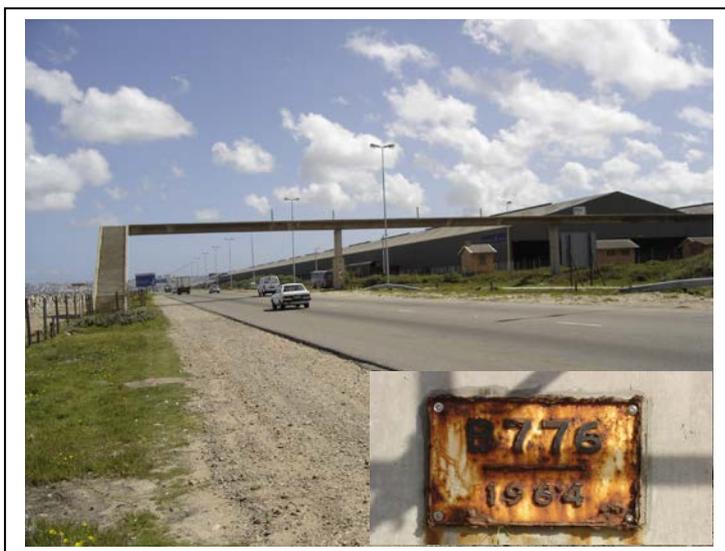
The site an old pedestrian bridge (No B776) that was demolished in April 2005

Hot dip galvanized reinforcement was used in the sea side (left hand side) approach stairway that was rebuilt 25 years earlier than the demolition date

The surf was 50 meters to the left of the photograph

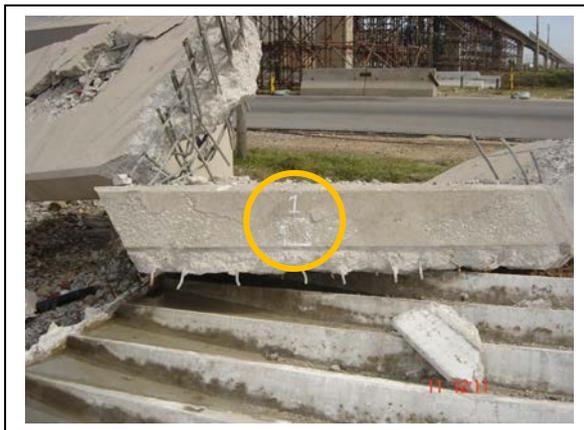
**2 Core Samples
from the side facing inland**

Carbonation was found to be more severe on the landside of the structure, with penetration depths of 18 to 22 mm.

**Carbonation penetration 18 to 22 mm,
chloride level at 45 to 60 mm 0.15% to
0.65% of concrete mass**

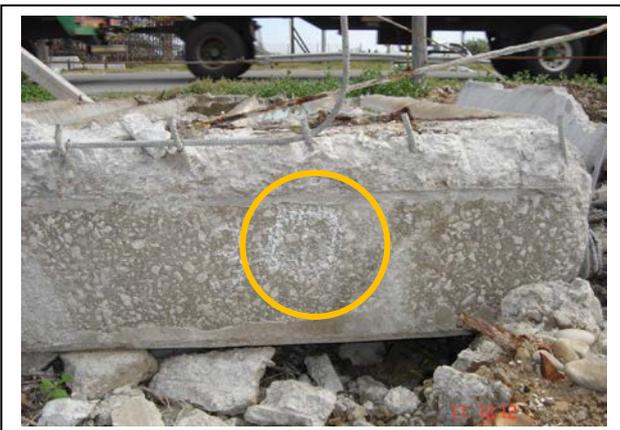
**2 Core Samples
from the sea facing side**

Chloride concentrations (% as mass of cement) at a depth of 45 to 60 mm ranged between 0.15 & 0.65% on side facing inland, and 0.27 & 1.26% on the sea facing side. At a depth of 30 to 45 mm the chloride concentrations ranged between 0.19 and 2.6%. Chloride levels at a depth of 15 to 30 mm rose to between 0.49 to 8.8% of cement mass.

**Carbonation penetration 5 to 23 mm,
chloride levels at 45 to 60 mm 0.27% to
1.26% of concrete mass**

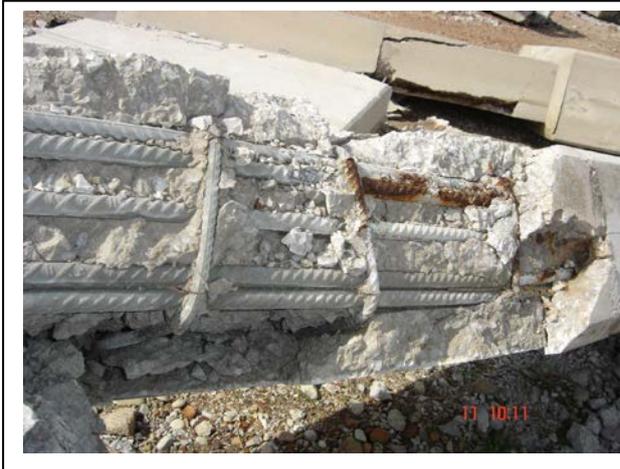
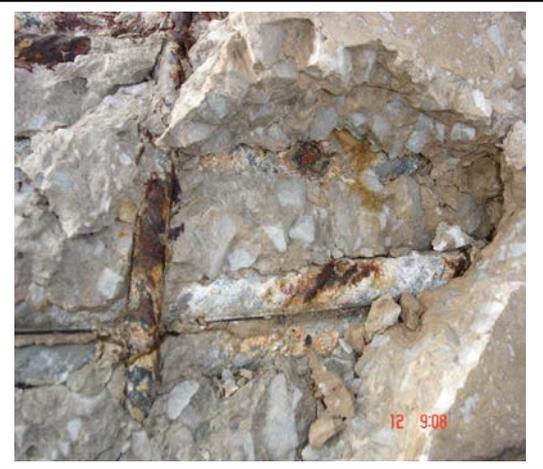
In certain isolated cases where the corrosive conditions had penetrated to the steel, due to very limited cover, the zinc had been sacrificed and some attack was evident on the carbon steel.

Isolated red rust was found, usually associated with minimum concrete cover and/or mechanical damage to the concrete cover

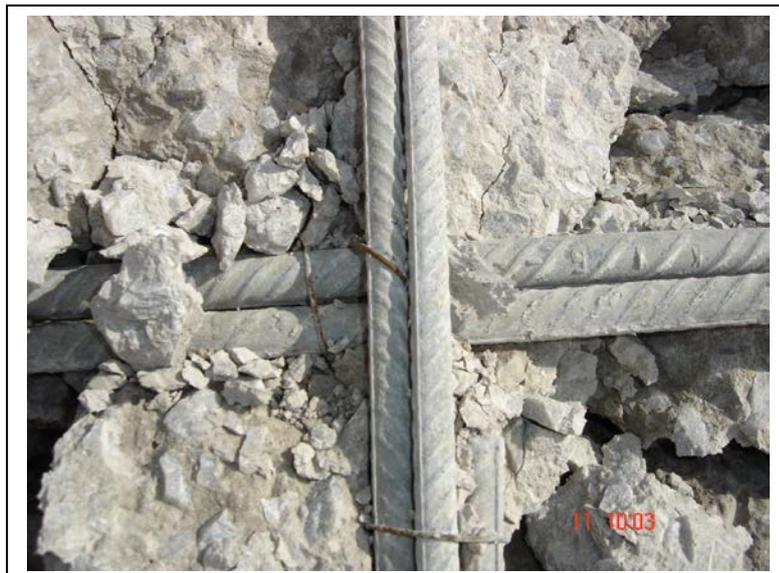
The condition of exposed hot dip galvanized reinforcement found during the demolition of the 40 year old bridge was, with isolated exceptions, found to be exceptional condition

Typically 98% of that inspected was similar to that shown in the photograph

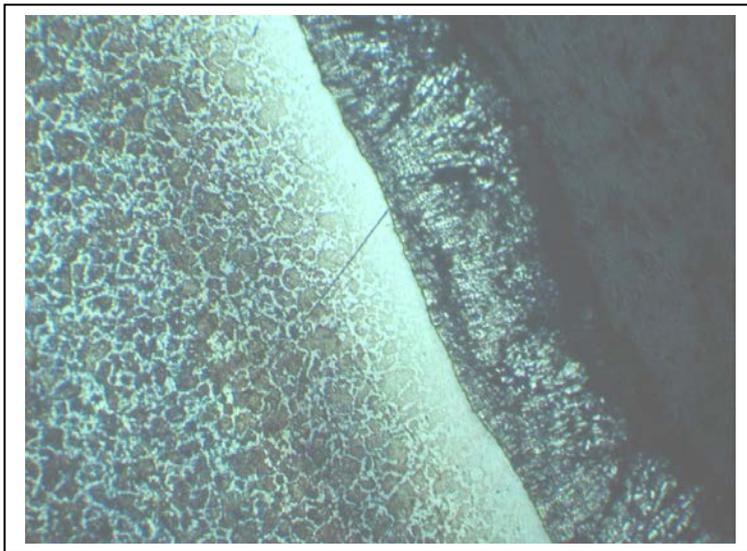
Figure 1

The outer appearance of the bar section demonstrated a dull grey colouration with no significant zinc layer degradation.

A transverse cross section through the bar revealed a 'normal' galvanized zinc and inter-metallic layers, clearly delineated in Figures 1 and 2. The galvanized coating thickness was between 240 and 260µm.

**Hot dip galvanized coating
on the reinforcement bar
Coating thickness of 70 to
90µm**

(magnification100X)

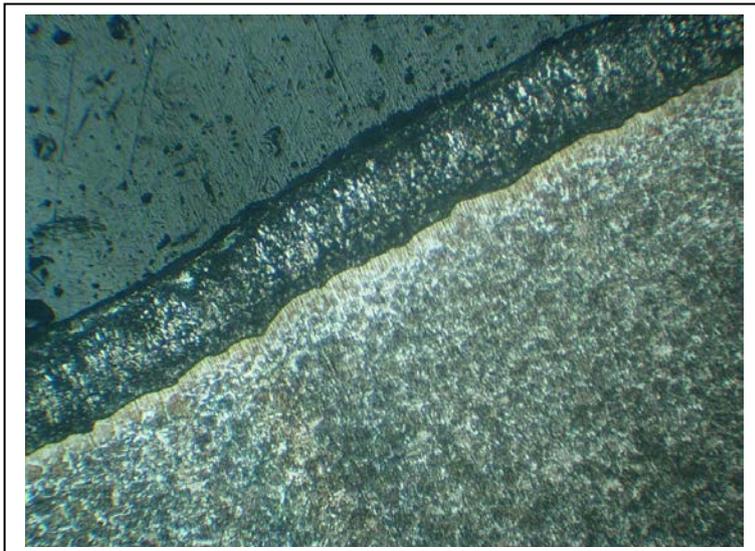
Figure 2

**Hot dip galvanized
reinforcement at a depth of
cover measured in a range
from 45 to 50 mm**

**All test samples were
recovered from the
demolished bridge**
