# **Mitchelsplein Train Station / Transport Interchange**

Case History No. 03/2005

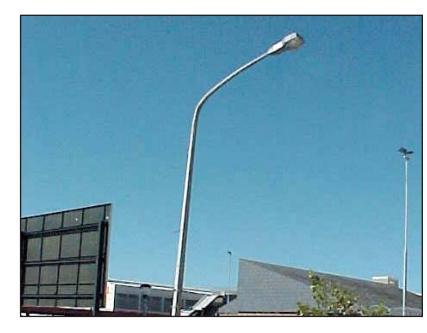
General view of the light pole that has been exposed to the elements for 26 years.

The residual coating thickness on the light pole  $(95\mu m)$  and on the diagonal fence support  $(98\mu m)$  is still in excess of the coating thickness required by the specification (SANS 121) after 26 years of exposure. The specification requires

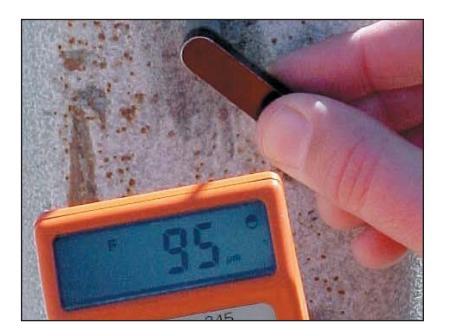
Coating thickness (95 $\mu m)$  on the scraped surface.

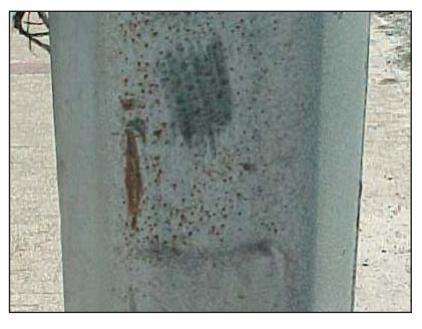
Close-up of the coating on the marine side showing the scraped surface.

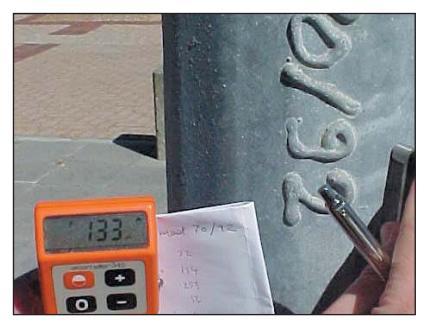
Residual coating thickness (133 $\mu$ m) on the light pole installed in 1992.

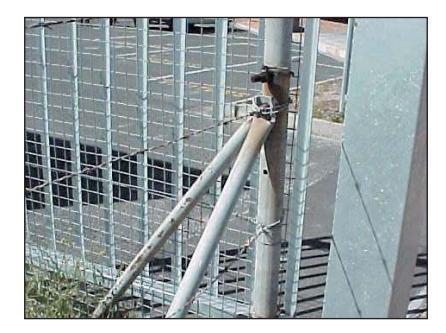
General view of the hot dip galvanized fence support installed in 1979 (26 years old).
