MISCONCEPTIONS

"Miss Conception" rectifies incorrect impressions concerning hot dip galvanizing.

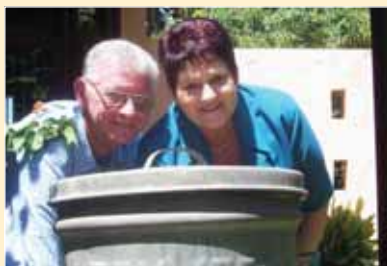
This remarkable piece of hardware has withstood the test of time. Recent coating thickness tests reveal that the hot dip galvanized coating is still in a remarkably good condition and the bin, unlike its pensioner owners, will not be going on retirement anytime soon. The trusty bin will be celebrating its 40th year of service a week before the Strydom couple’s ruby wedding anniversary in June 2008. Our warmest congratulations to all concerned!

A week before Steph Strydom wed Tilly Kritzinger in June 1968, he made a trip down to Port Elizabeth Municipality to purchase an item that they would need for their new home – a hot dip galvanized metal rubbish bin. The pressed metal bin, embossed with the date “1968 and PEM” (Port Elizabeth Municipality) has been with the family ever since.

The couple recalls that the bin got “no special treatment” and stood exposed in Port Elizabeth for its first 7 years of service. The bin relocated with the family to Durban in 1975 where, after some home renovations, it finally got a “roof over its head” (or shall we say lid?). The bin however did not stay put all the time – thanks to the couple’s only son Alex. Now aged 35, Alex fondly recalls the rubbish bin doubling up as wickets in his childhood during neighbourhood cricket matches and target practice during a “Ninja Star” phase. He laughs that history will probably repeat itself soon with the Strydom couple’s grandchildren now aged 9 & 10.
