# Stratfords Guest House and Conference Centre

Besides Al's love of hot dip galvanizing for its honest appeal, he also used it for its potential maintenance free life. In this case history, we do an inspection of the building after 10 years and report back our findings not only in terms of the coatings longevity but also highlight a few areas on the building that due to construction imperfections and nature requires some premature roof and fascia maintenance.

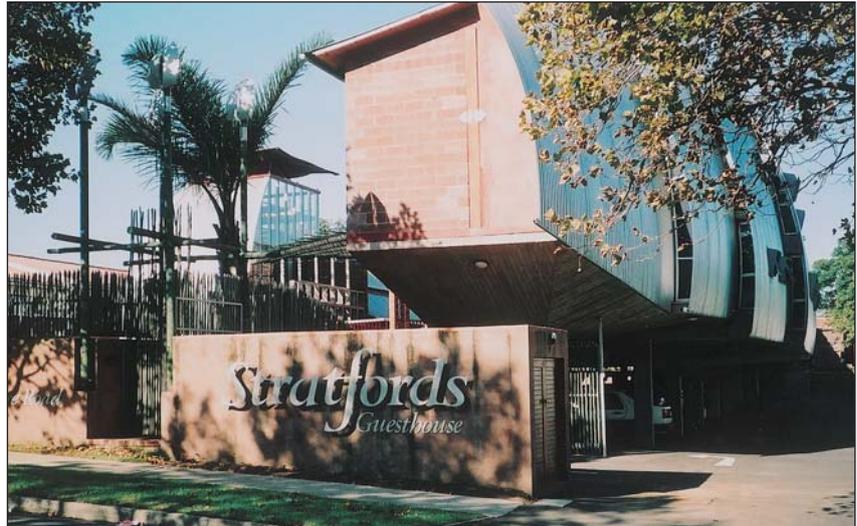
Entrance view showing the front laser cut hot dip galvanized signage, which has back lighting for illumination at night (photo taken in 2001).

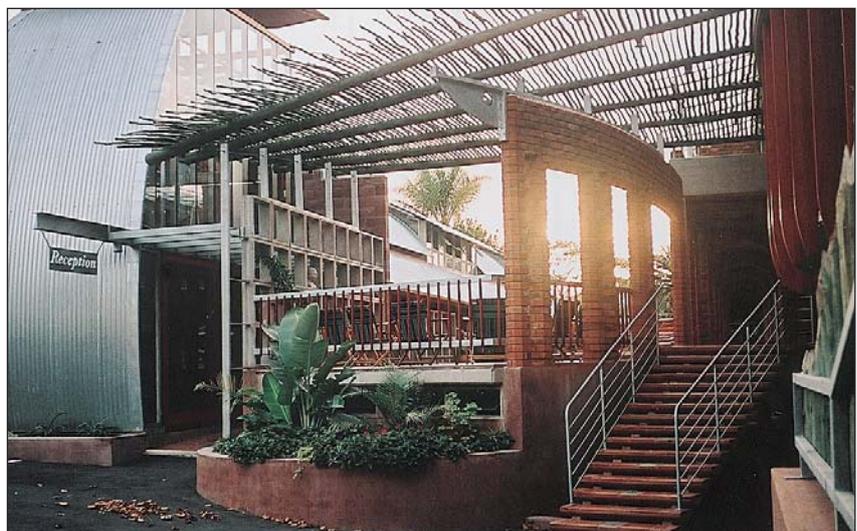
The north and south wing run parallel to each other and enclose a cloistered garden that terminates in a covered patio centre. The main dining room is on the right and the reception offices on the left. Note the timber banisters used to connect the hot dip galvanized steel hand rails (photo taken in 2001).

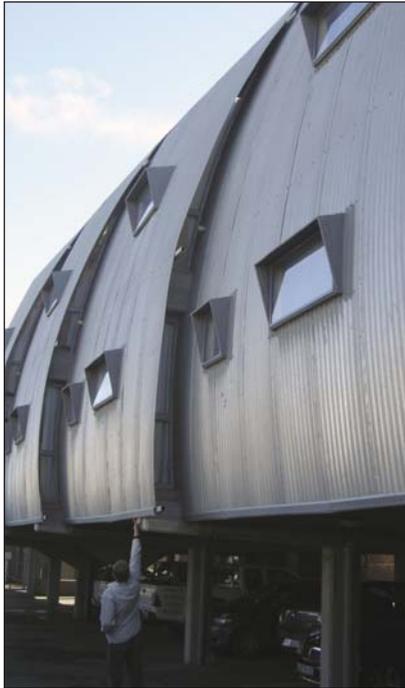
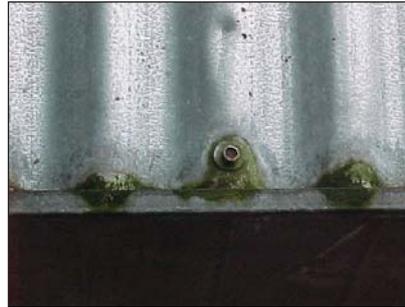
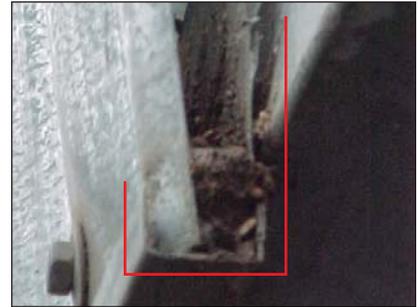
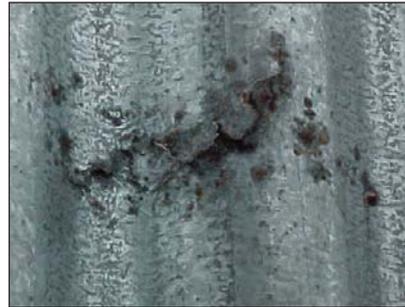
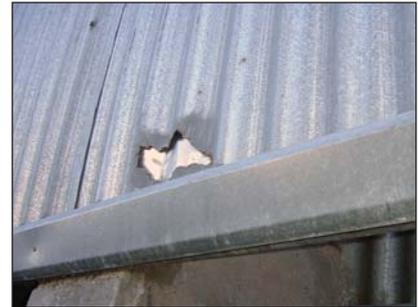
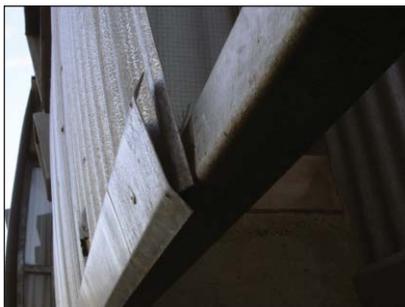
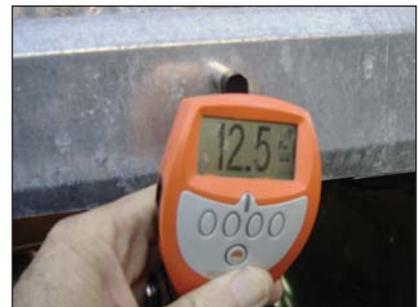
The novel rainwater anti-drip fascia at the bottom of the stressed skin façade in 2004 was showing localised corrosion – see photos 1 - 7.

The u-shaped novel rainwater anti-drip fascia (see red outline following the shape in photo 3), had collected some cement

on the inside while the building was being constructed. This prevented the natural exit of any retained water. The solid cement therefore remained wet. This continued wetness facilitated the formation of soluble zinc hydroxide (or wet storage stain), which in turn resulted in some localised corrosion of the sheeting (*photo 4*). The area where the sheeting corroded was fixed and a new fascia (of different shape and in a Z275 coating class – spot coating thickness 12.5µm) was added. See *photos 5 - 7*.

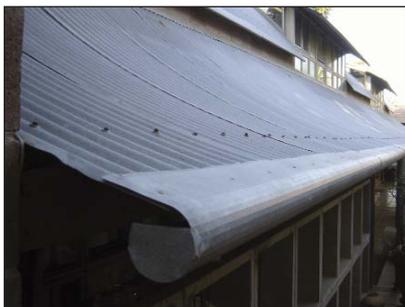
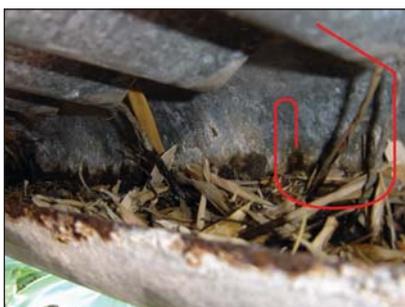
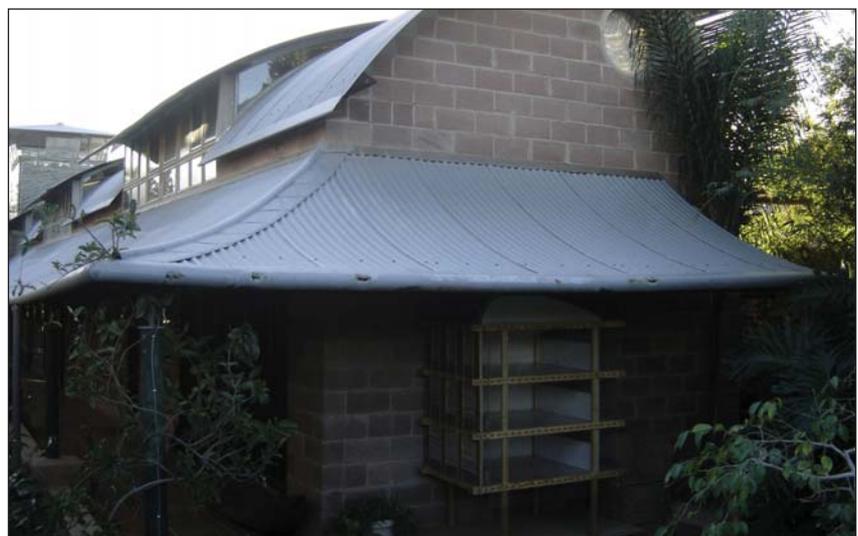
This novel shaped gutter also played the role of a fascia and to add strength a 180° return lip was added on the inside, see *gutter shape in red in photo 9*. This lip together with dust, debris and leaf deposits from the closest tree together with the normal rainfall, created the conditions for under deposit corrosion and the gutter over these 10 years corroded through in a few areas (*photo 10*).

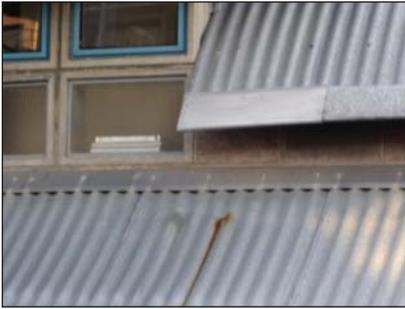
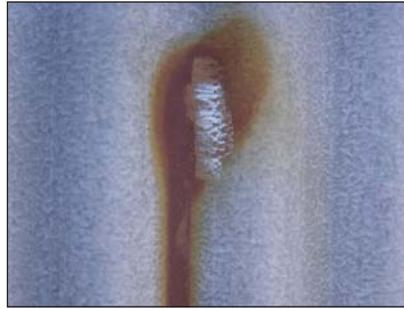
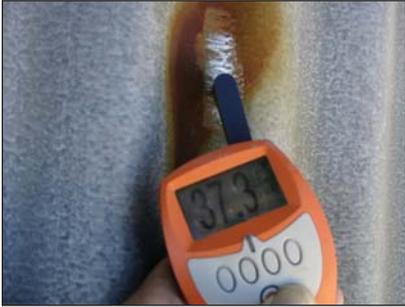
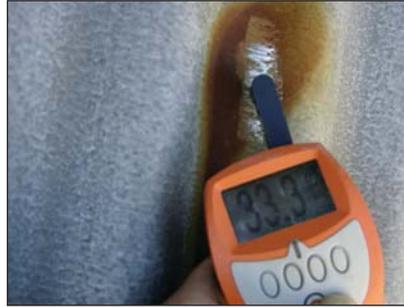
One particular spot on the roof sheet on the North Wing of the building was concerning, however, we found that the discolouration on the roof sheet was as a result of an inappropriately coated fastener, which had corroded to a point that the corrosion products now dripped onto the roof sheeting and caused staining. The coating at the discoloured area, however, proved to be intact. See *photos 11 - 14*.

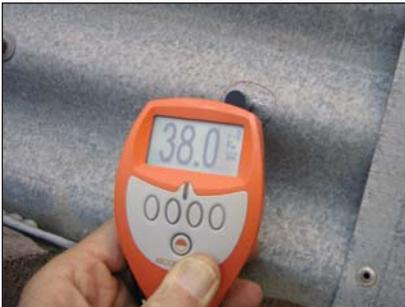
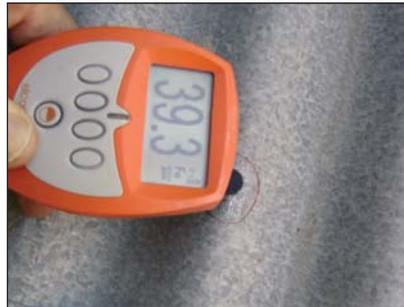
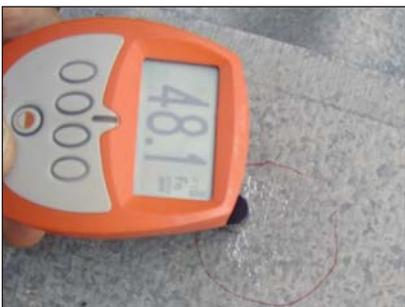
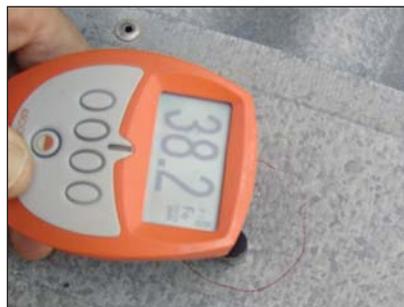
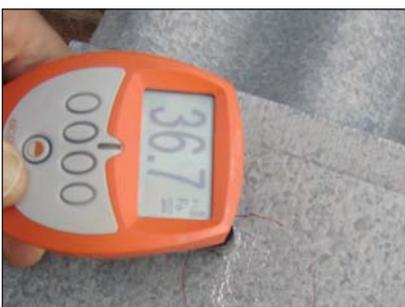
The sheeting and rain water gutter with return lip in general appeared to

be performing well against the environmental conditions at hand, see photos 15 - 19.

coating thickness, 600 must be divided by 7 (Specific Gravity of zinc) and by 2 (includes both faces), ie.  $600/2 \times 7 = 43\mu\text{m}$ . The fine print in the specification allows not less than 40% of the individual value (510 gm/sqm) to be found on one surface, ie.  $29\mu\text{m}$ . Coating thickness on roof and gutter averaged about  $40\mu\text{m}$ .

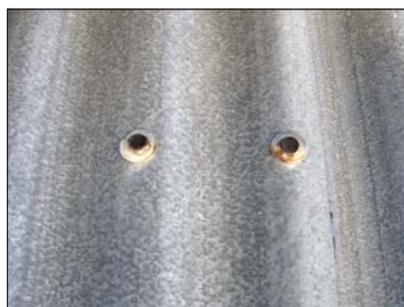
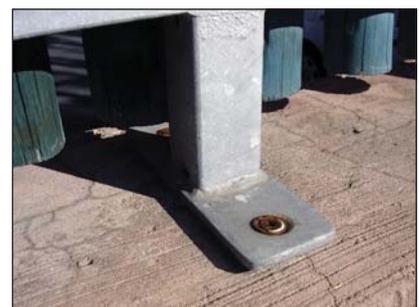
Some of the original fasteners, which were unfortunately zinc electroplated, were showing signs of discolouration and rust (see photos 20 - 21).

Bear in mind that coating life is proportional to its thickness and for this reason the thinner zinc electroplated coatings on the various screws highlighted, should be suitably cleaned and touched up with an appropriate paint, to ensure a longer durable life span.

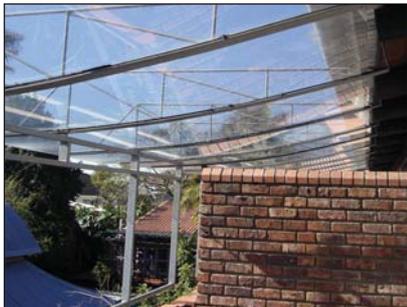
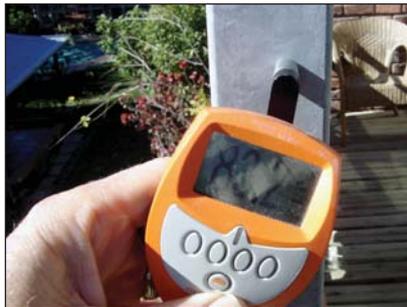
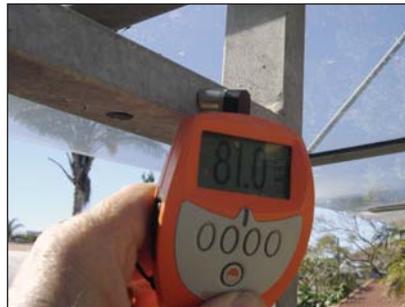
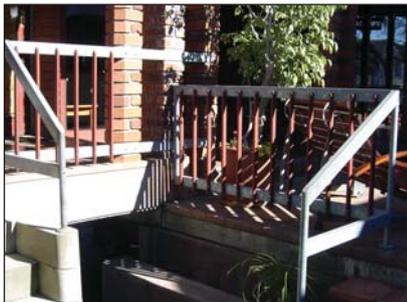
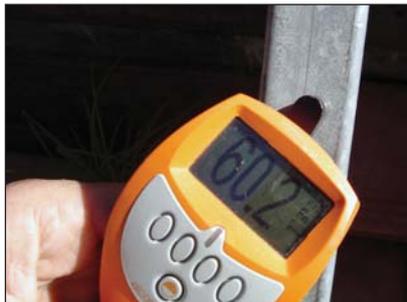
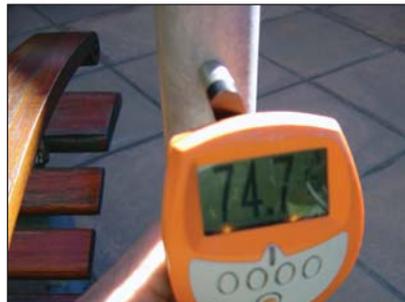
- Hot dip galvanized roofing steelwork and handrails (see photos 22 - 27).
- Hot dip galvanized entrance signage (see photos 28 - 30).
- Hot dip galvanized visitor's signage – the electroplated shackles were showing signs of rusting (see photos 31 - 33).
