# Bellville Transport Interchange upgrade built in 2002 stands the test of time

Following a meeting early in 2002 with Henry Fagan of Henry Fagan & Partners (engineer for the structure), in association with GAPP Architects & Urban Designers, who were responsible for the concept and ideas of the interchange at the time, I became involved in the project, a rather unusually shaped transport interchange in Bellville, Cape Town.

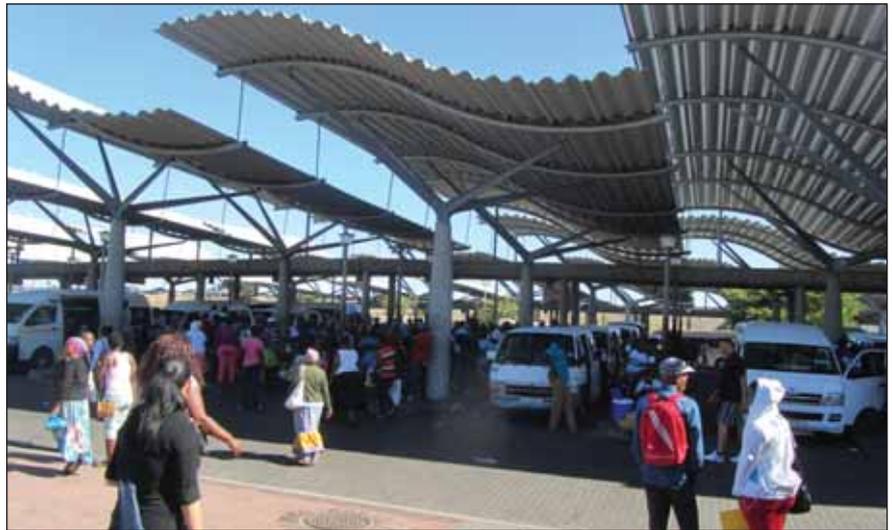
My role was to advise Henry on how to hot dip galvanize the 'upside down spiders'. These were too large for a single immersion in the largest bath in Cape Town and due to a major amount of cutting of the I-Beams, double end dipping may have resulted in unacceptable distortion, so we decided to try something different.

This entailed cutting off two of the 'upside down spider' roofing legs and masking the

ends that were to be welded with "Galvstop". After galvanizing, the ends were cleaned off to achieve a zinc free surface.

The ends were then welded and the welds repaired using a layer of Zincfix neatly applied between two strips of masking tape. We knew then that although Zincfix was a

recommended repair product, the weld area would be the first to show corrosion over time, especially if applied too thinly (sometimes achieved if ones finger is used to spread the product).

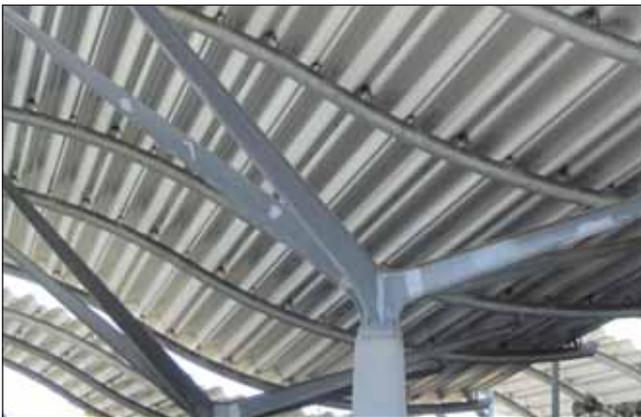
Some silver zinc rich spray paint was used, which is irritatingly highlighted against the stable hot dip galvanized zinc carbonate patina.

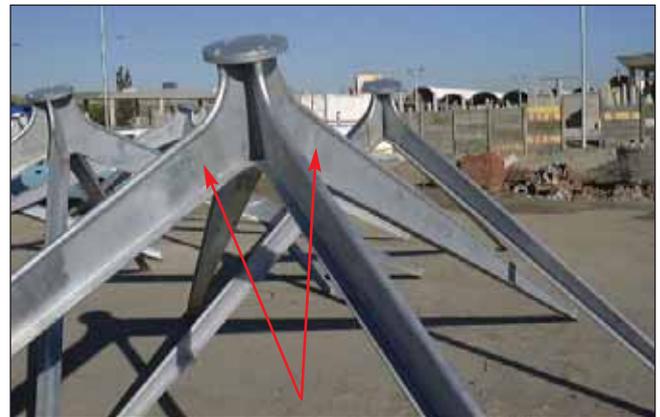
The "upside down spiders" on site following delivery. Notice the similarly grey tones of coating repair by "Zincfix".

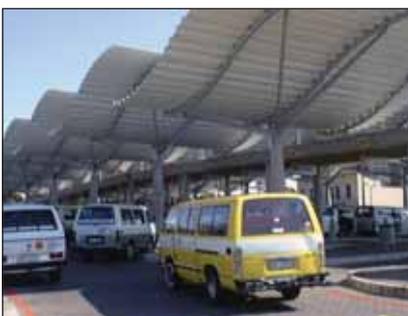
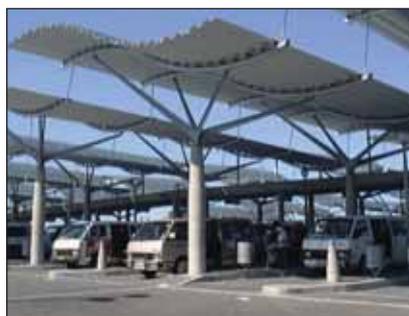
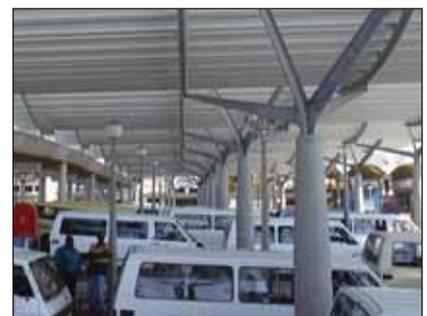
Varying views of the transport interchange upgrade showing the curved tubular purlins.

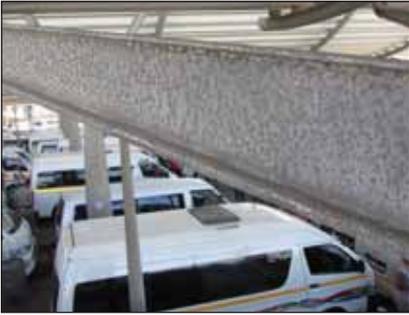
The "upside down spiders" showing atmospheric surface contamination.

Marine chlorides seem to be present (see photos). Bellville is considered to be a C3 environment (an environment with a zinc corrosion rate of 2µm or less) in accordance with ISO 9223 or the Association's Information Sheet No 11, Corrosivity of Zinc.

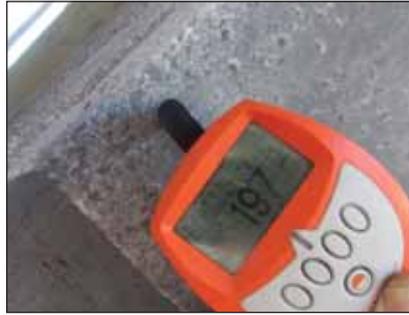
The surface contamination removed and residual coating thickness of 197µm taken on the structure and 187µm on the holding down nut.

The hot dip galvanizing is performing to specifications. Judging by the residual coating thickness on the structure as well as the holding down bolts and nuts, we predict the galvanizing will provide a further 30 to 50 years of service-free life.

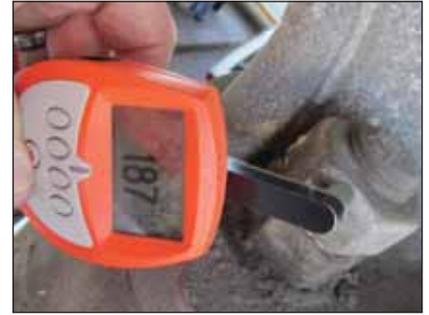
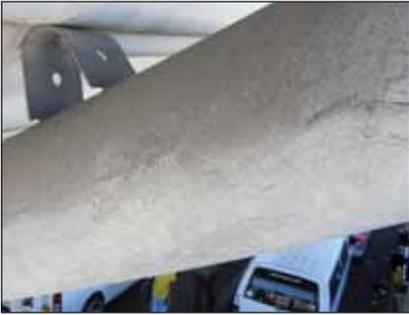
The curved hot dip galvanized tubular purlins are in excellent condition with a residual hot dip galvanized coating thickness of 134µm.

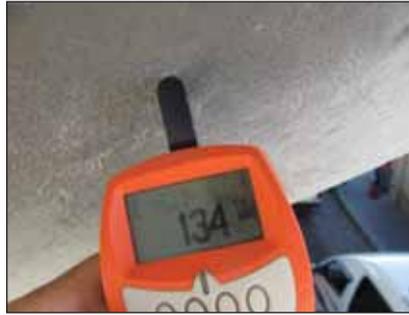
rank last week and found the coating was performing as predicted after 12 years of exposure.

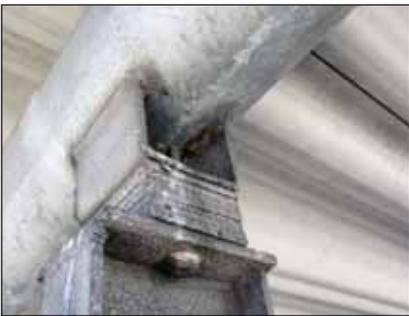
Hot dip galvanized I-Beam tubular purlin support, showing a residual coating thickness of 252µm.

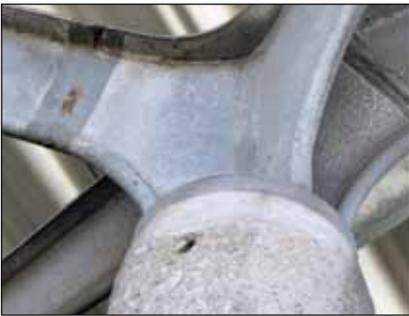
Due to the application thinness of Zincfix (achievable by thinly spreading the product with one's finger) the welded area is showing signs of premature corrosion.

The areas where the 'upside down spiders' were welded and originally repaired using Zincfix should be cleaned and recoated with either Zincfix or Galpatch as required.

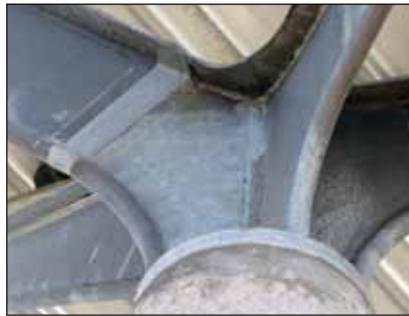
Where Zincfix has been correctly applied there are no signs of premature failure.

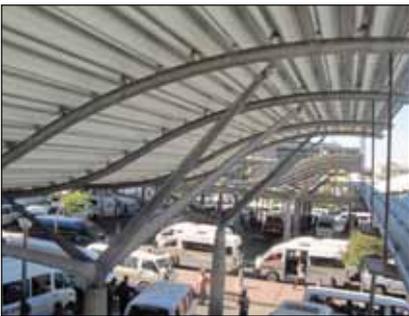
A row of pipe bracings which were originally only painted were showing signs of some corrosion and will also require future maintenance over time, or replacement.

The connection pipe from one roof to the next was for some reason only painted, see condition left, which will in a short period of time have to be re-coated or replaced.
