# Eskom's Saldanha Blouwater Substation

**Eskom's Saldana Blouwater Sub-Station**  
Blouwater Substation lattice steel structures were examined in order to establish the condition of the hot dip galvanized coating after 34 years in service.

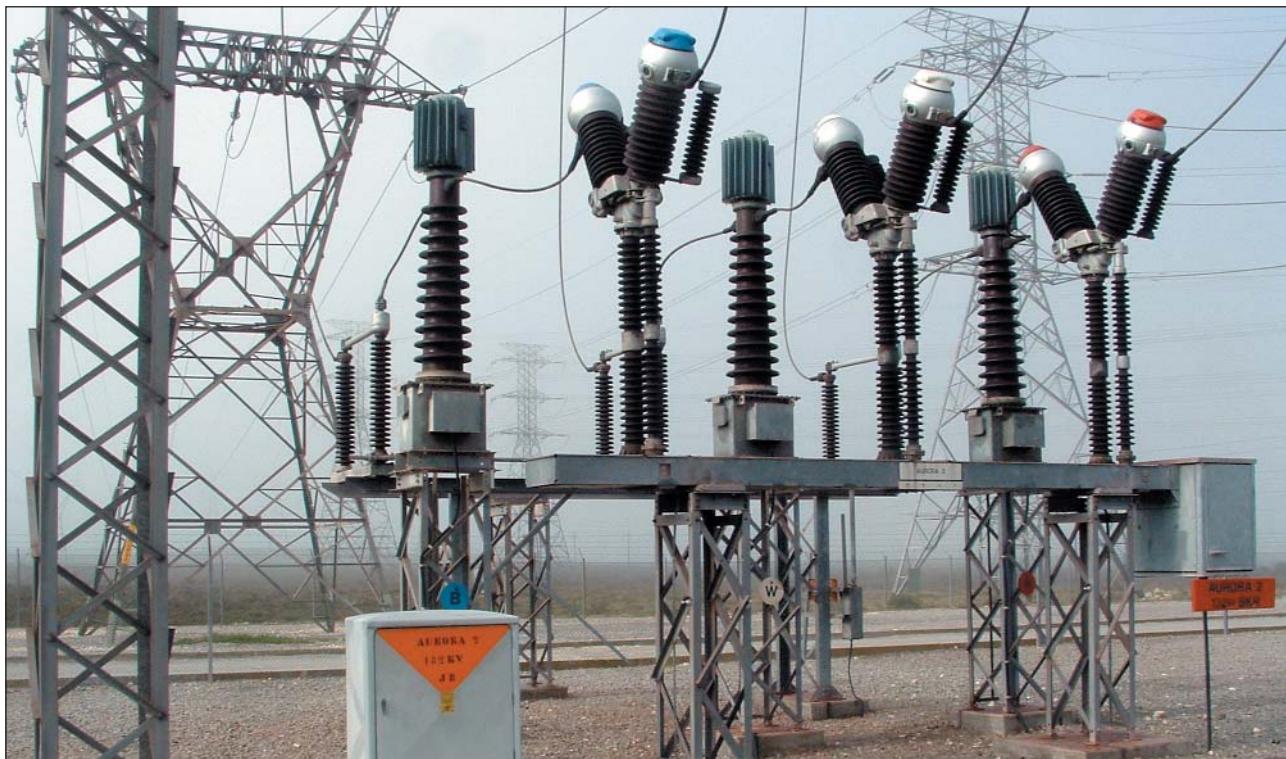
General View of a section of the Blouwater Substation that was inspected on 22 July 2004.

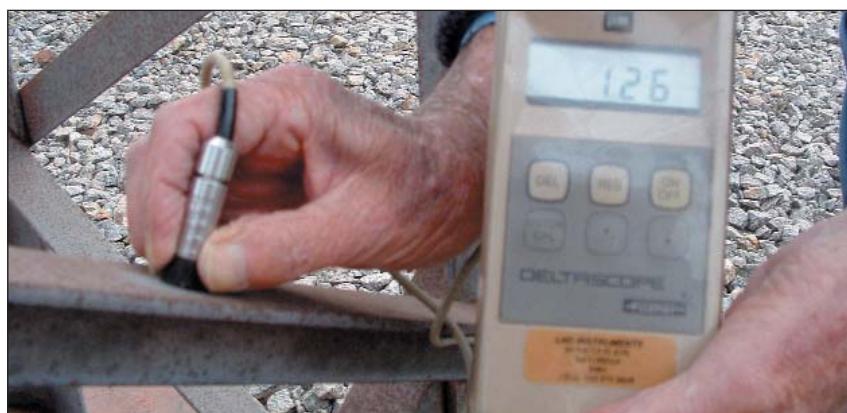
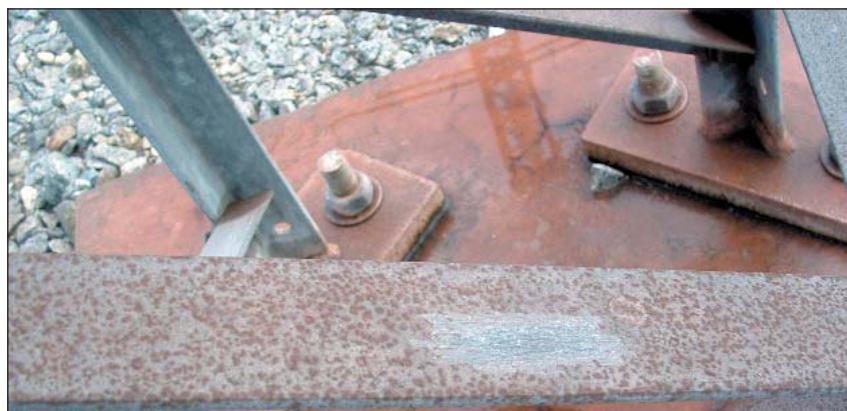
Despite the apparent "rust" contamination of the galvanized surface, once removed the galvanized coating measured 126µm.

**PS.** It is interesting to note that even where the hot dip galvanized steel appears to exhibit "red rust", once the contaminated surface has been cleaned a substantial amount of zinc and zinc iron alloys remain. It is an established fact that the zinc iron alloy layers provide approximately 30% greater corrosion protection than that of pure zinc on its own. However, as the zinc iron alloys corrode, speckles of red rust appear due to the iron content within the alloys. This is sometimes seen as representing a potential failure of the structure, but in reality the steel remains unaffected and capable of performing the functions for which it was originally designed.

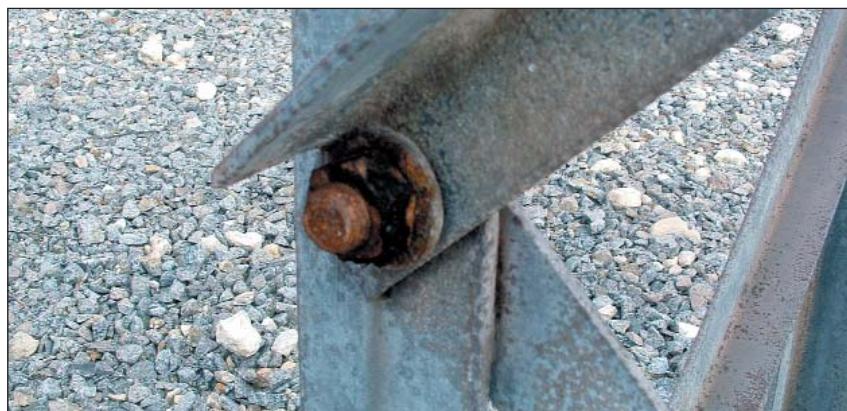
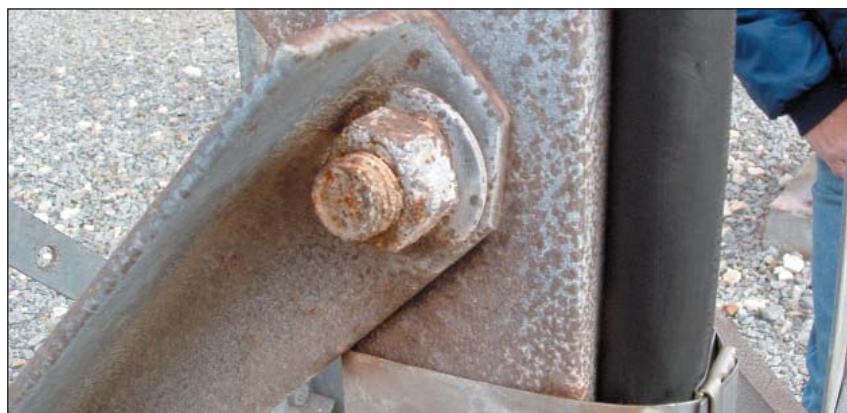
In general, the coating is in remarkably good condition despite misleading surface contamination. Interestingly, some of the bolts and nuts showed signs of distress. This appeared to be limited to fastener assemblies underneath the lower end of the inverted diagonal angle bracings. The reason for this is due to an extended period of accumulated wetness and being shielded from the sunlight.

Condition of the "upper" and "lower" fastener assembly illustrating the differential rate of corrosion due to the "Time of Wetness".

The use of zinc-electroplated fasteners (electro-galvanizing) is unacceptable due to the extremely thin zinc coating obtained (normally  $< 10\mu\text{m}$ , compared to  $55\mu\text{m}$  of hot dip galvanized fasteners). The
