This case study is the result of a detailed investigation of a pedestrian bridge situated along the foreshore of Algoa bay.

# Hot Dip Galvanized Case Study No.4 (Revised)

## Hot Dip Galvanized Reinforcement in Concrete

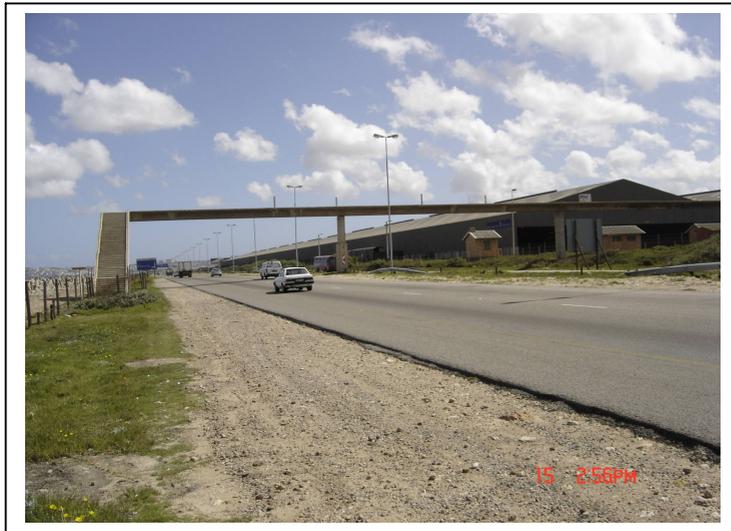
The site of the 40-year-old pedestrian bridge (No B776) that was demolished in April 2005. It was established that hot dip galvanized reinforcement was used in the approach stairway, which was on the sea facing side, indicated on the left of the photograph, with the sea some 50 meters further left. This stairway was part of a refurbishment of the seriously corroding structure in 1985.

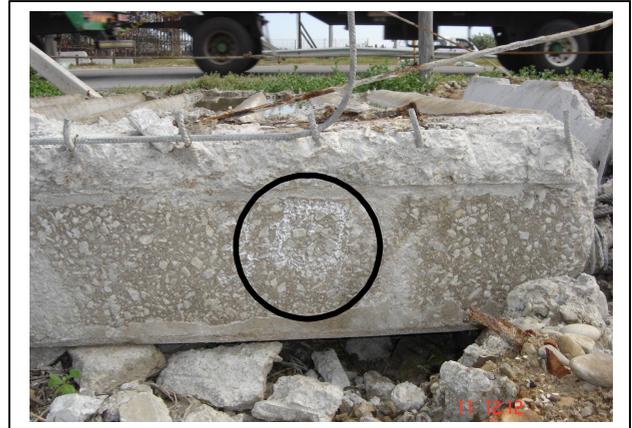
### 2 Core Samples

Taken on the sea facing side. Carbonation penetration 5 to 23 mm, chloride levels at 45 to 60 mm 0.27% to 1.26% as mass of cement.

Notwithstanding the findings at the 45 to 60 mm depth of cover, numerous reinforcing bars were found at depths of 15 to 45mm. Even at the reduced concrete cover depths and increased chloride levels, the hot dip galvanized coating was continuing to protect the reinforcing bars. In certain isolated cases where the corrosive conditions had penetrated to the steel, due to very limited cover, the zinc had been sacrificed and some attack of the carbon steel was evident.

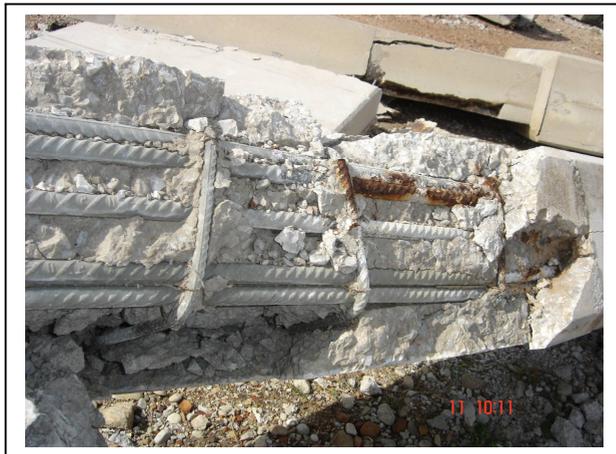
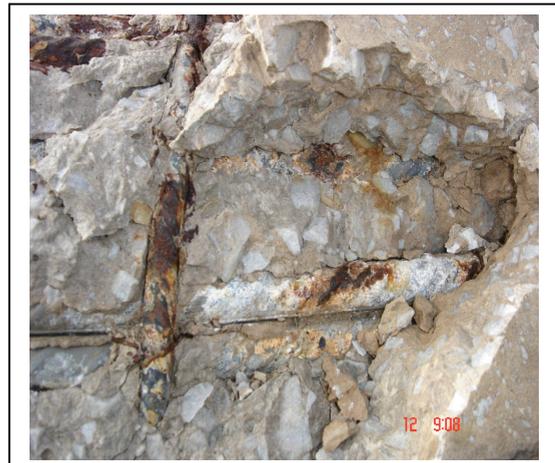
Isolated red rust was found, usually associated with minimum concrete cover and/or mechanical damage to the concrete cover.

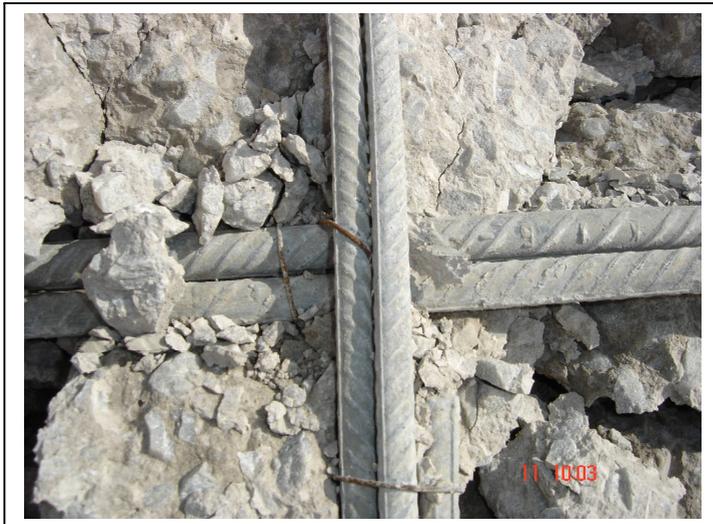
Condition of exposed hot dip galvanized reinforcement found during the demolition of the 20 year old approach stairway.

With isolated exceptions, the hot dip galvanized reinforcing shown, in this photograph, is typical of 98% of that inspected.

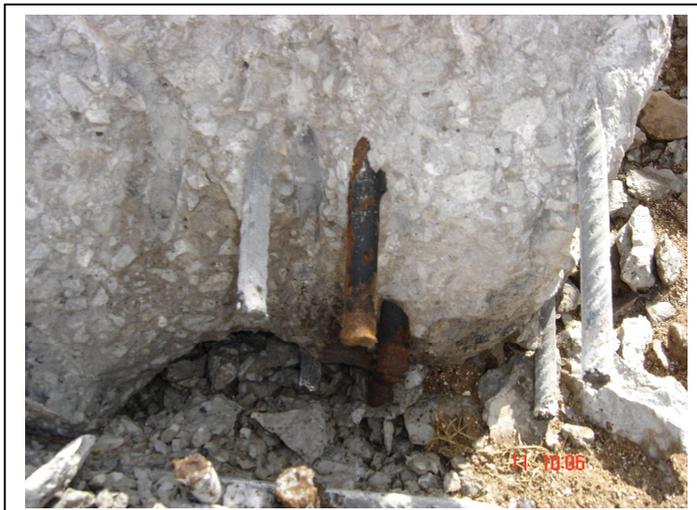
This photograph shows two uncoated reinforcing bars that were used in the stairway without being hot dip galvanizing. The corrosive attack is clearly evident, while the hot dip galvanized bars located alongside are performing with complete satisfaction.

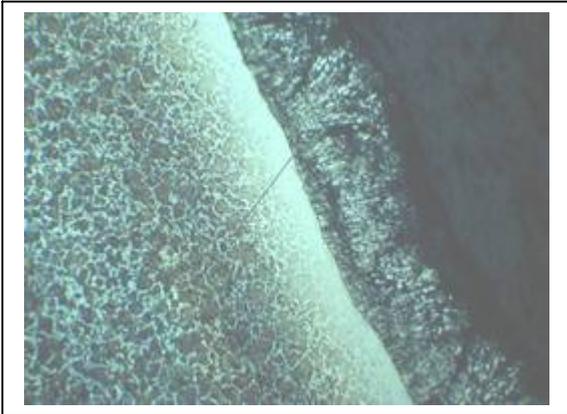
A transverse cross section through the bar revealed a 'normal' galvanized zinc skin with the constituent sub-layers clearly delineated (Figures 1 and 2). The galvanized skin thickness was 240-260µm.

Figure 1.  
Galvanized layer (70 to 90 $\mu$ m) on  
the reinforcement bar (100X).

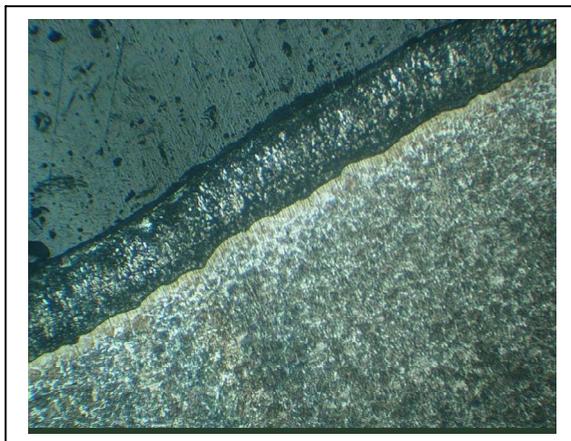
Figure 2.  
Galvanized layer on the  
reinforcement bar 45 to 50 mm  
cover. (100X)

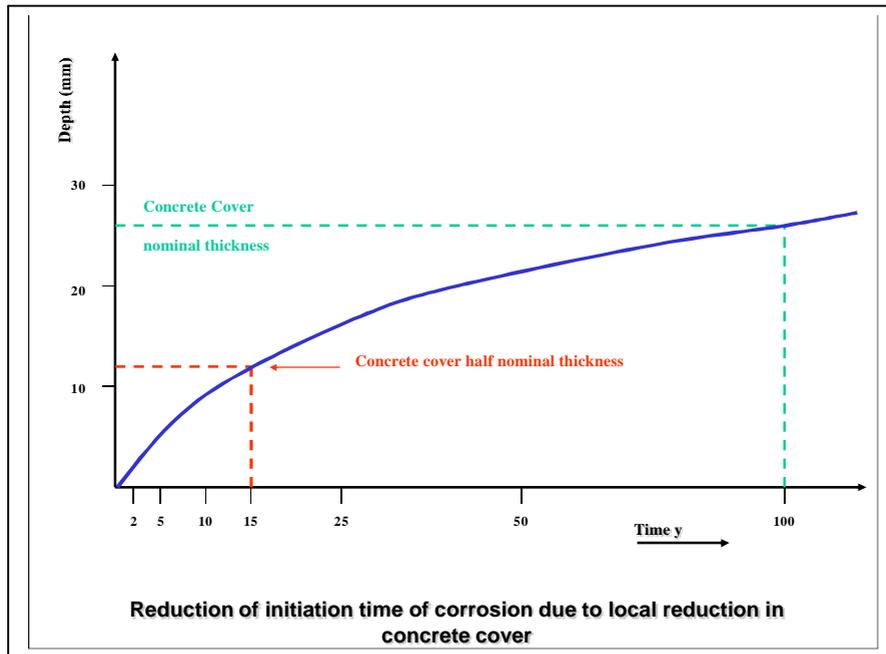
This diagram illustrates the importance of concrete cover. The concrete cover represents a form of “barrier protection” through which the corrosive elements must pass before attack on the reinforcement can commence.
