# Phalaborwa Copper Mine

## Our findings

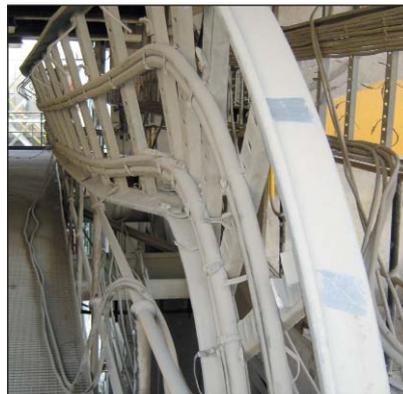
be located. However, we did find a cable ladder system that was installed in the mid eighties, using the proprietary powder coated duplex system. The cable ladders were reported to be the original O-line system, which was hot dip galvanized and then overcoated with an epoxy polyester powder. The cable ladders are no longer in use due to the building being declared redundant.

Insitu cable ladders in the redundant Transfer Station No. 1.

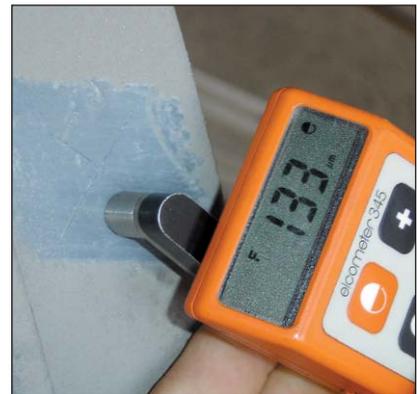
Total coating thickness reading on the cleaned up side rail of the cable ladder.

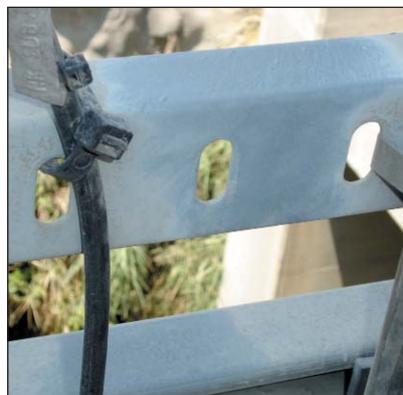
Cable ladder cross rung.

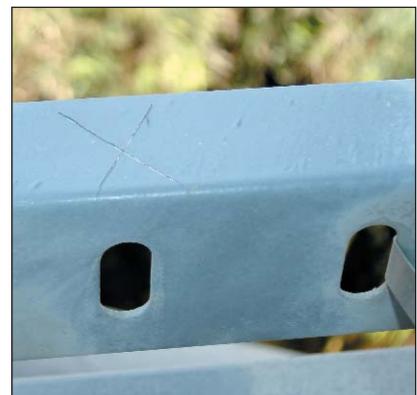
In spite of the relatively non-corrosive environment in this instance, the powder paint is still adhering to the hot dip galvanized substrate and on cross-cutting the coating to ascertain paint adhesion, the coating remained intact despite trying to lift it at the cross-cut. There were however, several other coatings on components located at the site that were in the process of breaking down.

Exposed powder coating subjected to a cross cut adhesion test.
