Lion's Den, disused old zoo, Groote Schuur Estate, Cape Town

A hot dip galvanized case history

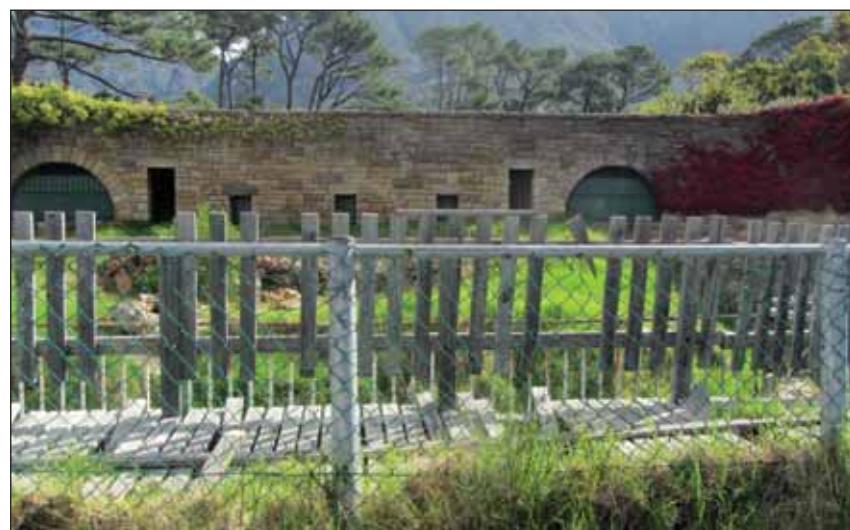
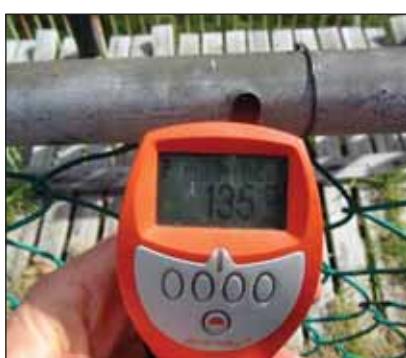
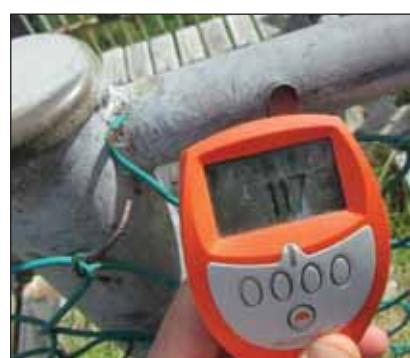
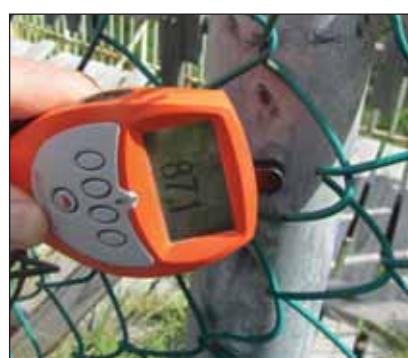
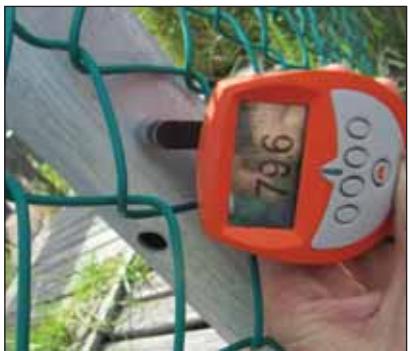
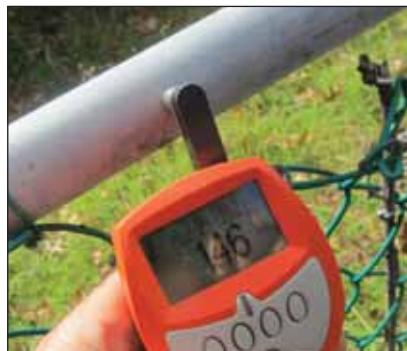
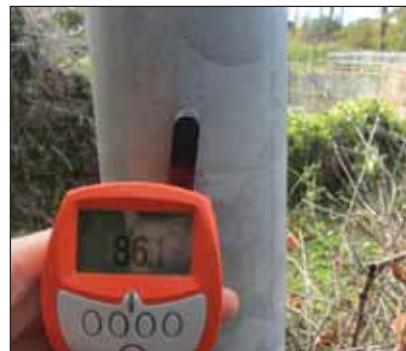
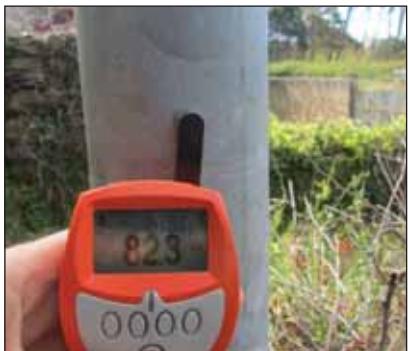
When and why the hot dip galvanized balustrade and handrailing was installed is anyone's guess. As the lion's enclosure was revamped a little after 1930 and the Zoo was vacated in 1975, it's logical to conclude that it was installed possibly somewhere between these two dates. This would mean the galvanizing is over 50 years old.

Looking at the condition of the hot dip galvanized coating it clearly shows it is still very much intact despite being exposed to an environment which is classified as possibly a C3 in accordance with ISO 9223/ ISO 14713 part 1! (*Photos 2 - 9*).

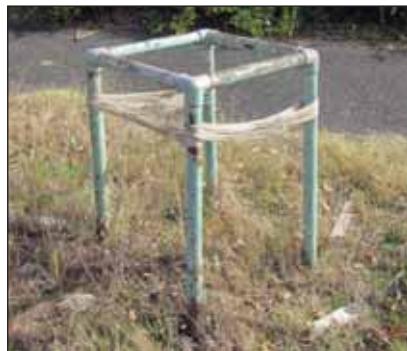
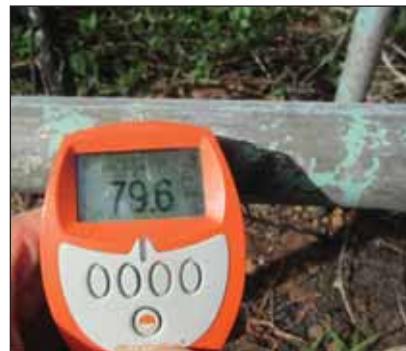
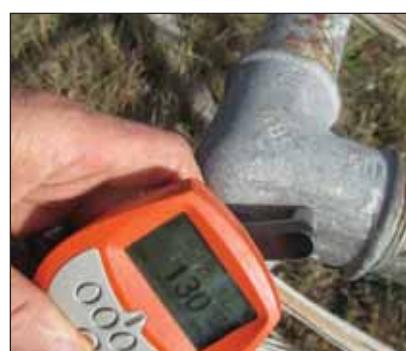
There were several pipe stands made up using hot dip galvanized screwed and socketed tubing on the site and here the hot dip galvanizing was also in excellent condition (*photos 10 - 12*).

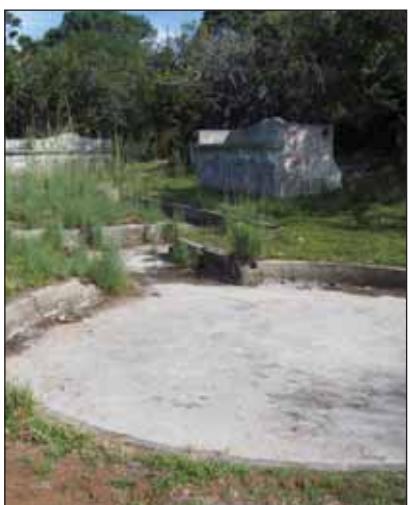
Photo 13.

What we can do is imagine where the animals used to be. This looks like a funny shaped concrete swimming pool; there used to be water in here and crocodiles (*photo 13*).
