# RaiseTech W50 mining drilling machine

This case study traces the results of a new innovative prototype rock drilling machine that was hot dip galvanized in order to improve its service life performance within the harsh and corrosive mining environment. The use of hot dip galvanizing for corrosion control of close tolerance machine components (rock drilling machine) is a relatively new and innovative development. The results achieved during the initial trials are very encouraging and performance indicators are well within the original parameter set during the project development. Current expectations are that new development will generate greater efficiencies, longer maintenance free shifts and corresponding economic benefits.

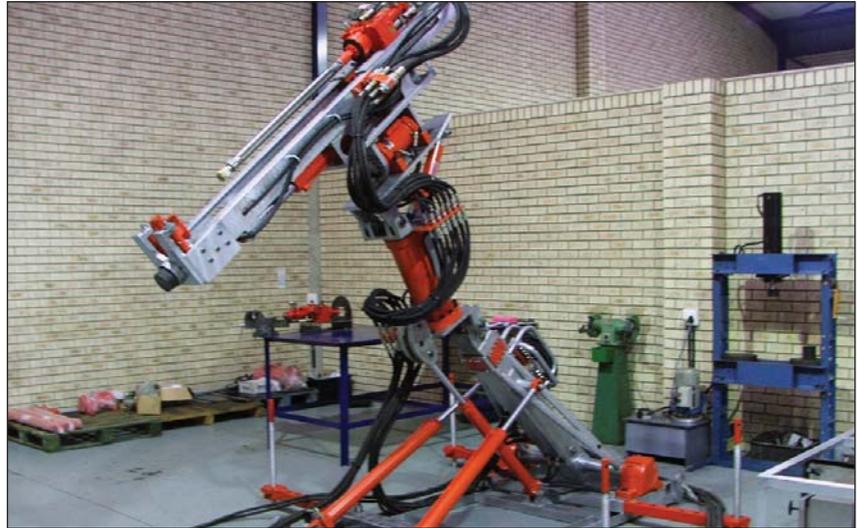
The hot dip galvanized prototype rock drilling machine as supplied.

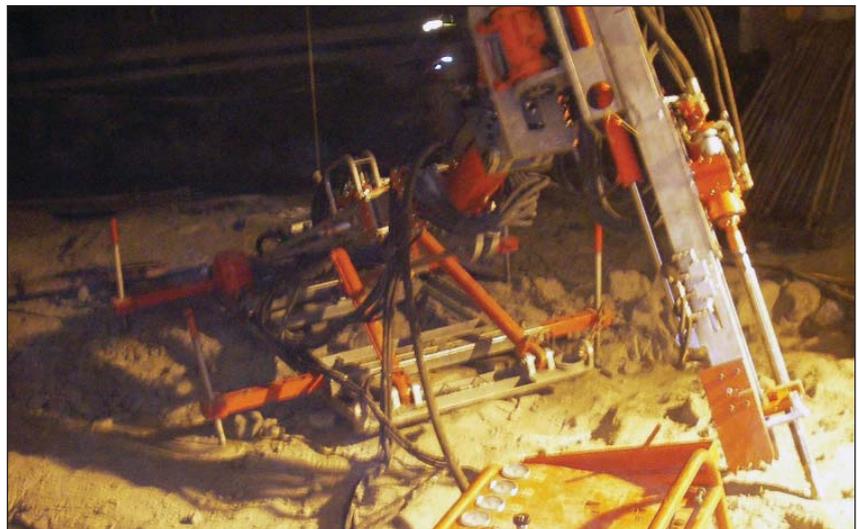
The machine in operation.

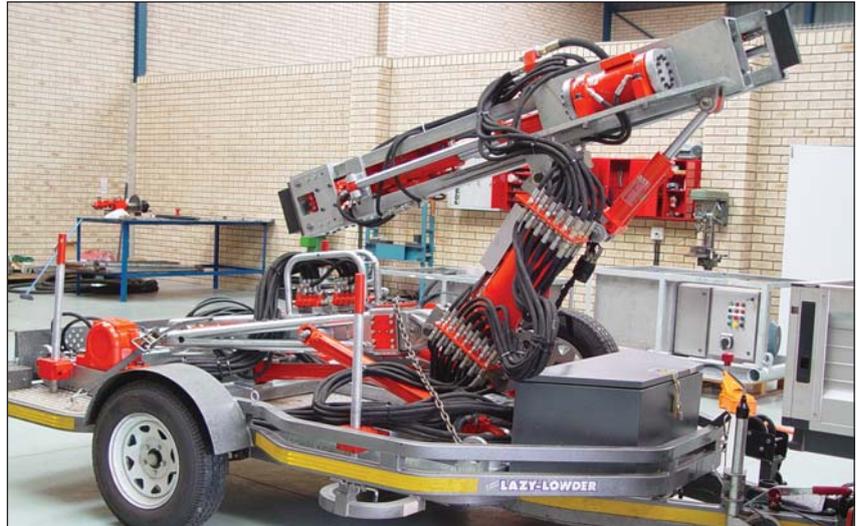
Mobility of the equipment, to the mine site as well as underground, was an important feature and therefore incorporated into the design.

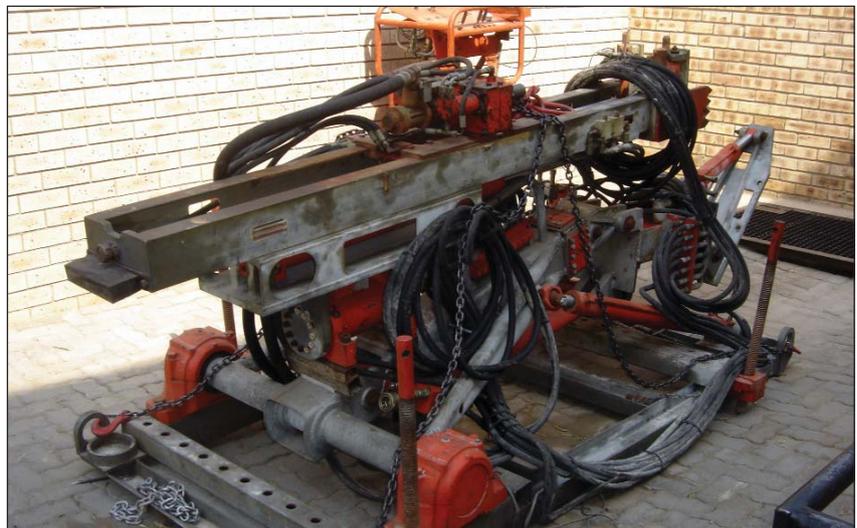
Photograph taken of the drilling machine after 4 months operational conditions, illustrating the comparisons between uncoated bolts, painted surfaces and the hot dip galvanized machine components.

The hot dip galvanized steel components were standing up to the condition extremely well with no discernable deterioration. Comparisons to painted and uncoated components on the machine, clearly demonstrated the differences in corrosion control performance. Early performance indications were very encouraging and that potential economic benefits could be significant.

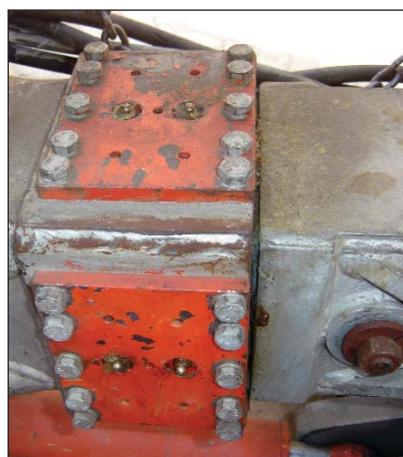
Where hot dip galvanized fasteners were used the comparison to uncoated fasteners is clearly evident.

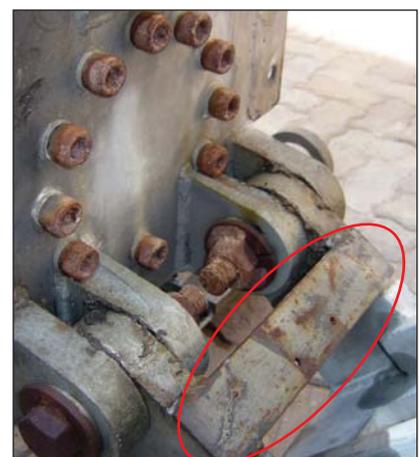
Steel components, added after hot dip galvanizing, were silver painted, again illustrating the corrosive effect relative to the hot dip galvanized surfaces.
