Hot Dip Galvanized Case Study No. 3 Mitchelsplein transport interchange

The Application

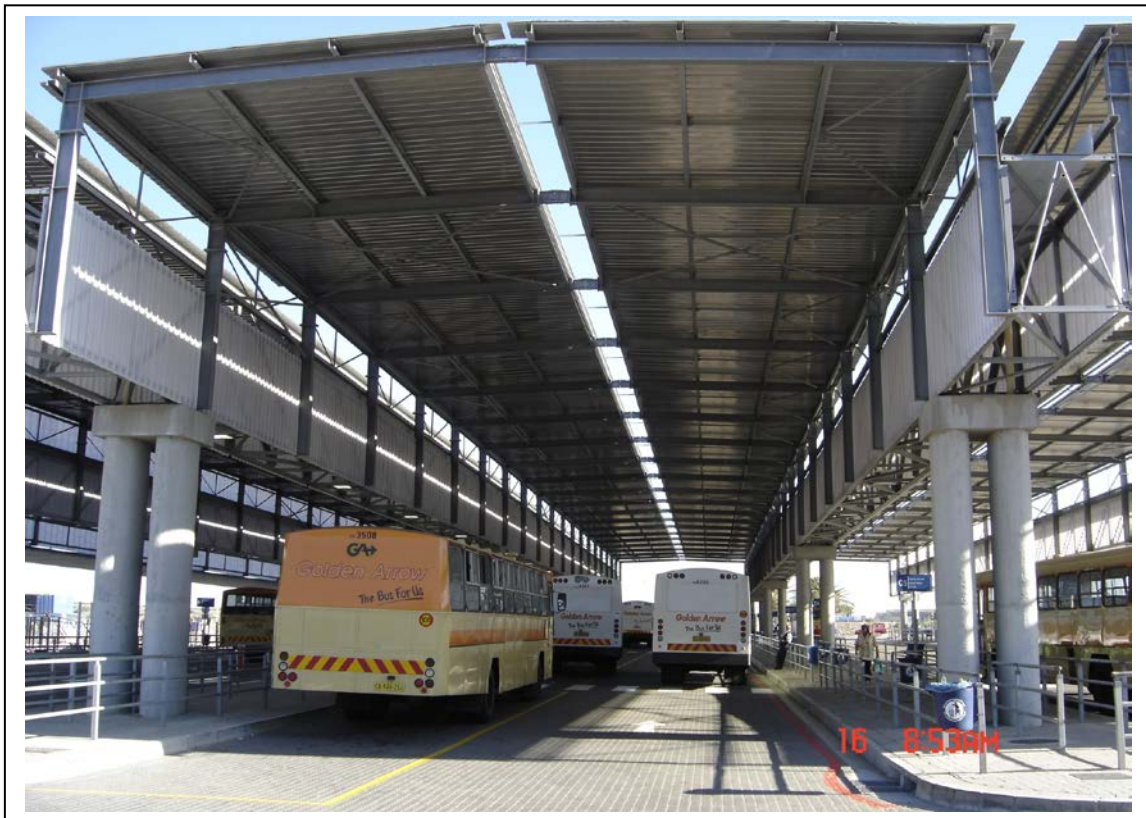
Photo 1

**General view of the Mitchelsplein Transport
Interchange**

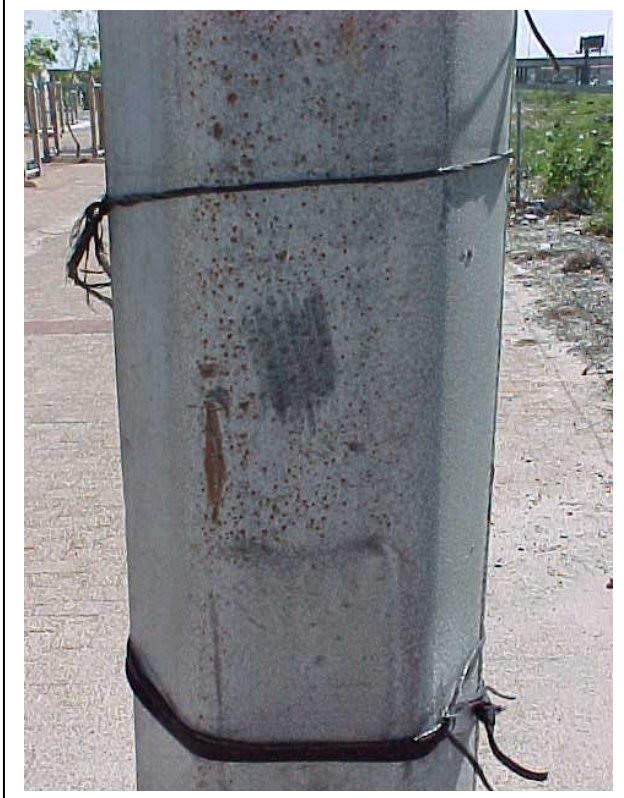
Hot dip galvanized mast appears to be corroding with indications of rust staining

Photo 2 indicates the same surface before cleaning with photo 3 indicating a zinc coating thickness of 95μm once cleaned.

After approximately 26 years of service, the hot dip galvanized coatings on the light poles (photos 2 & 3) and fence supports (photos 4 & 5) installed at Mitchelsplein Train Station, will continue to provide adequate and effective corrosion control for at least another 25 years.

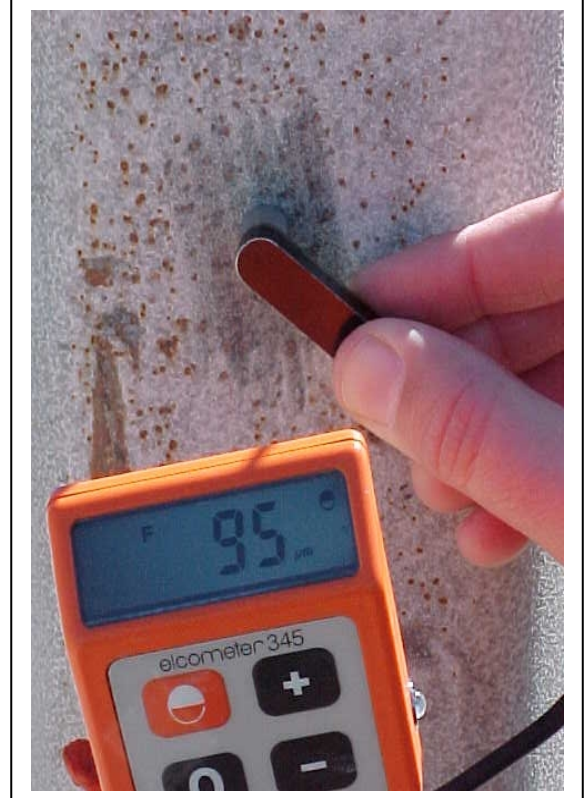
Photo3

An area is cleaned and measured with an Elcometer indicating a coating thickness of 95μm

SANS 121 (ISO 1461:2009) requires a mean coating thickness of 70μm for material thicknesses greater than (>) 3mm to equal and less than (• • • • • • • • • •) exceeding 6mm the specified mean coating thickness is given as 85μm.

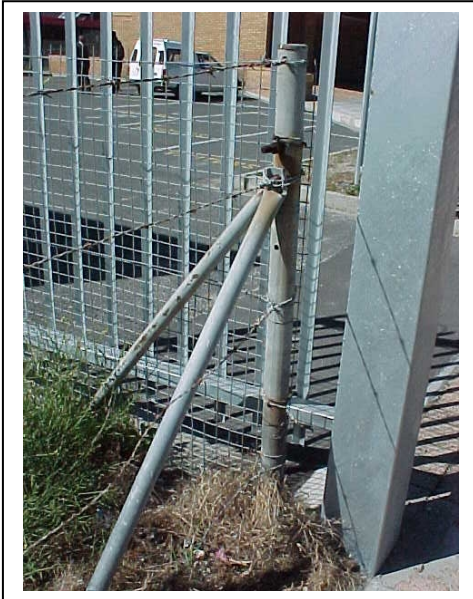
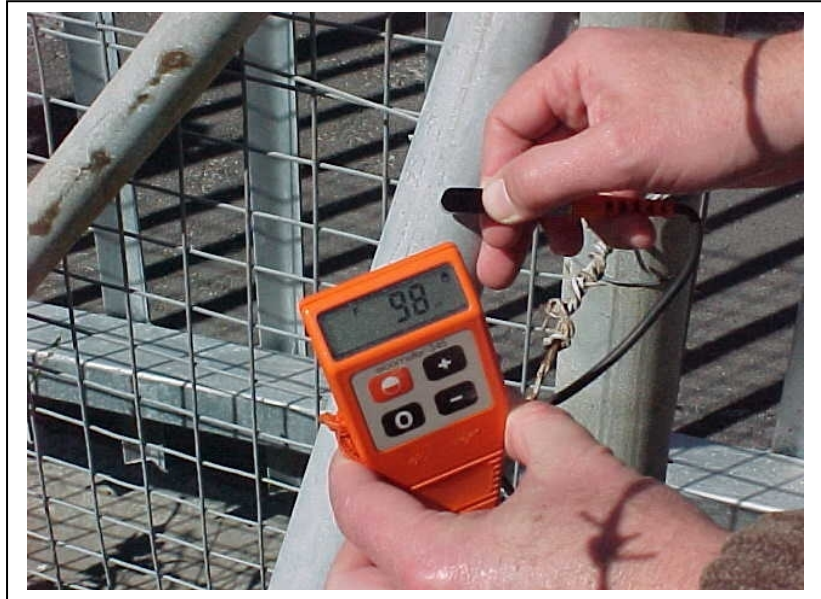
Photos 4 & 5

Examination of an existing fence installation hot dip galvanized coating measurements recorded exceeded 90 μ m
