Hot Dip Galvanized Case Study No. 13 Pressed steel plate water storage tanks

Two large water storage tanks mounted on structural supports and constructed of the “Braithwaite” design is the subject of this case study. There are many similar installations of this type of tank, but this particular example has been selected in order to examine the corrosion control performance of the hot dip galvanized coating after an estimated service life of more than 70 years.

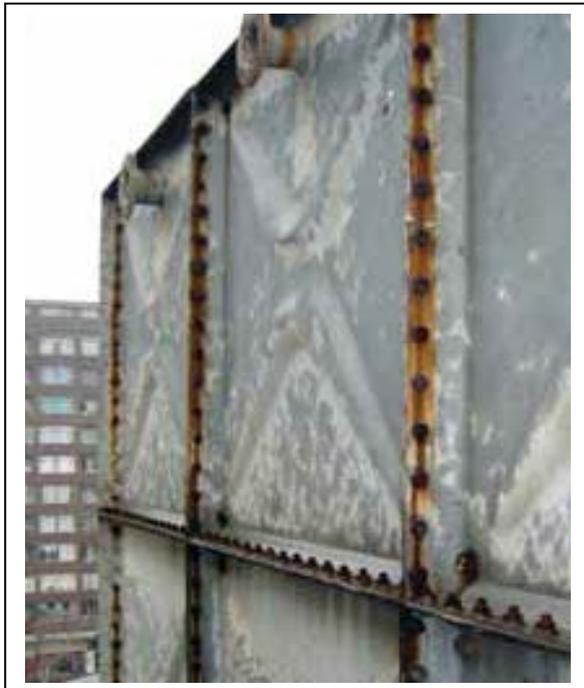
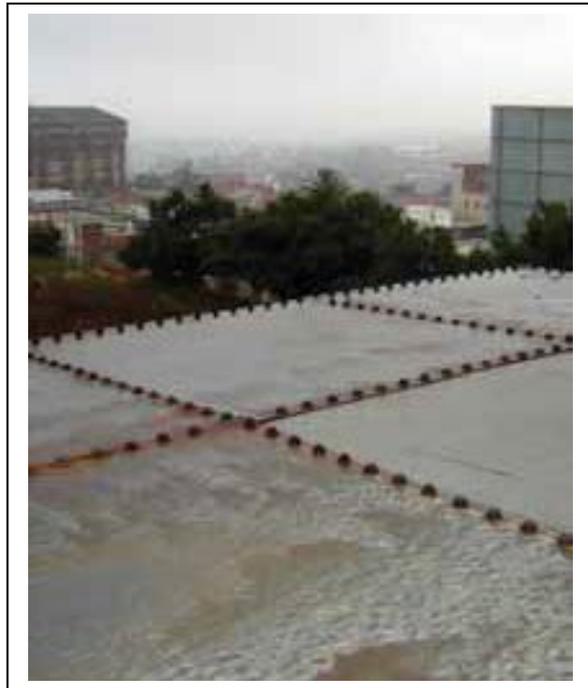
Photographs of the tanks taken in 2006

The fasteners, assumed to have been hot dip galvanized, are in an advanced state of corrosion with red rust causing discolouration (rust staining) of the hot dip galvanized pressed steel panels. The fasteners remain structurally sound, but require maintenance by over coating or replacement.

Had the original fasteners been hot dip galvanized the zinc coating would have been in the order of 65 to 75 μ m. Assuming the average corrosion of say 2 μ m per year the bolts would have lost all their coating after approximately 30 to 40 years. It is therefore possible that the fasteners may not have been hot dip galvanized or the tank is not as old as first believed.

Fasteners have corroded to the point where no zinc remains, while the tank plates continue to provide an excellent service

In 2006 the zinc coating on the pressed steel panels was measured and found to be in a range of 68µm to 91µm. In terms of the assumed service life of more than 70 years, the tanks would have had been originally supplied with a hot dip galvanized coating in the order of 200µm. At the time of supply from the UK this could well have been the norm.

It is however most important that when fasteners are used to assembly hot dip galvanized steel components, the fasteners must be specified as hot dip galvanized in order to achieve a balanced design.

These assumptions further illustrate the need to ensure a balanced corrosion control design between such plates and the fasteners.

Should maintenance be undertaken, and with specific reference to the fasteners, the installation will continue to provide excellent service for years into the future.

The supporting structure to the water tanks is showing signs of corrosion, but could and should be considered for restoration. Should this process be undertaken, it would afford the authorities with an opportunity to re-galvanize the tank plates and replace all fasteners. Once such a process has been completed the installation would be returned to an “as new” condition.
