Hot Dip Galvanized Case Study No. 19 Newlands rugby stadium – Railway stand

Hot Dip Galvanized Case Study No. 18 Newlands rugby stadium

This case study reviews the condition of the hot dip galvanized seat support brackets and hand railings of the East Railway stand built in 1979. The build date of the East Stand indicates a service life of the hot dip galvanized seat support brackets and hand rails of approximately 30 years.

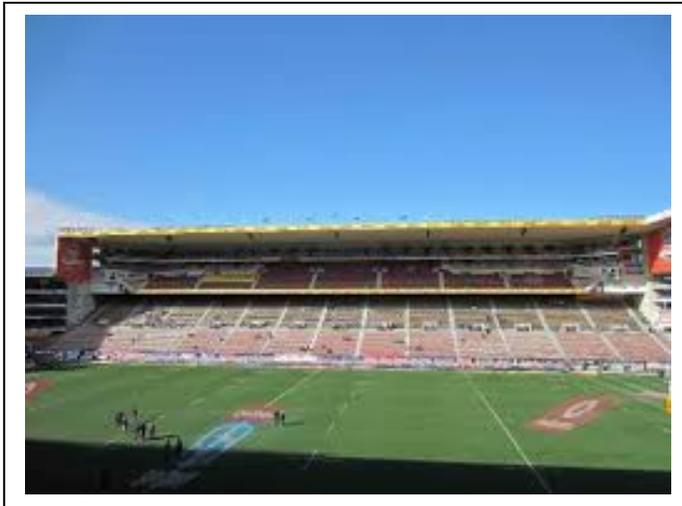
**Eastern Railway Stand built
in 1979**

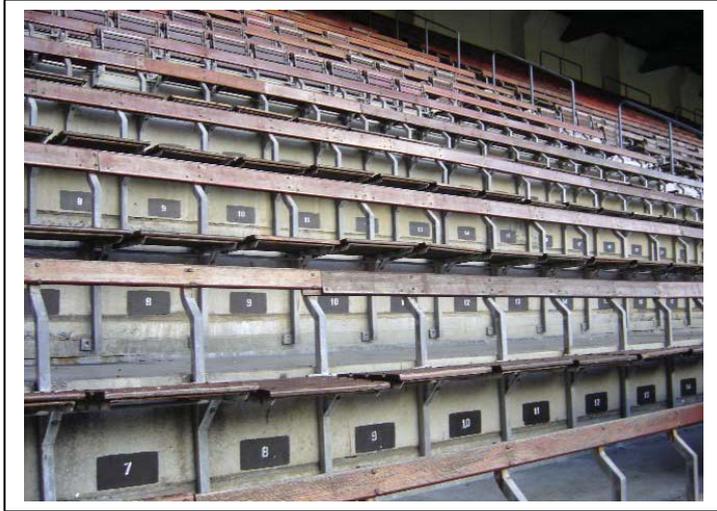
General view of the hot dip galvanized seat support brackets of the Railway Stand

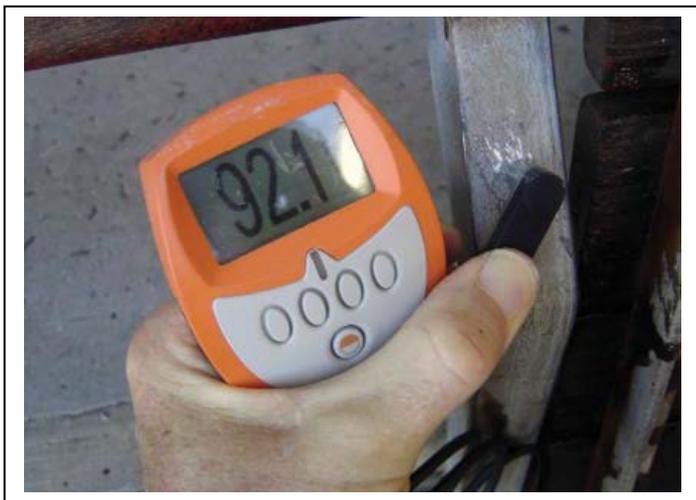
The hot dip galvanized coating thickness readings measured on the support seat brackets and hand railings were in excess of 90 μ m. The following photograph is an illustration of a typical measurement being taken.

Typical measurement of a hot dip galvanized seat support bracket

Zinc coating thicknesses range from 90 μ m to 140 μ m

The instrument used is an Elcometer 456 that measures the thickness of a non-magnetic coating on a magnetic substrate. (Carbon steel)

Based on coating thickness measurements (more than 90µm) and a zinc corrosion rate of less than 2µm per year, the seat brackets and hand railings will continue to provide corrosion control for well in excess of further 40 years.

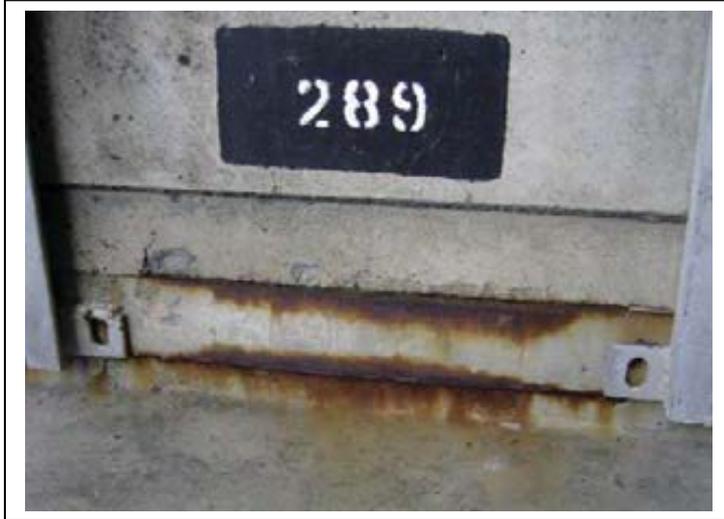
During the site visit inspection used to produce this case study, it was of concern that in certain areas “crevice corrosion” was evident. This situation is illustrated in the following photograph.

In other areas where the handrails have been cast into concrete, evidence of differential corrosion, so called necking corrosion, was observed.

**Cast in bottom rail showing
the effects of crevice
corrosion**
