Hot Dip Galvanized Case Study No. 20 Stratford's Guest House and Conference Centre

Hot Dip Galvanized Case Study No. 20 Strsrfords Guest House and Conference Centre

Findings

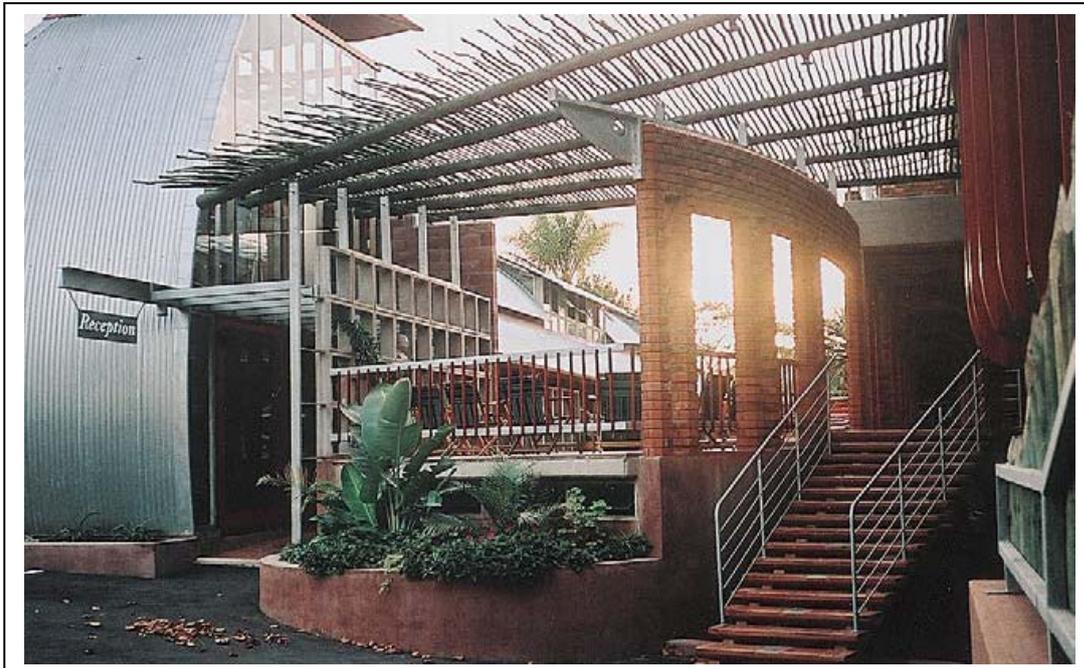
**North and south wing run parallel to each other enclosing a cloistered garden terminating in a covered patio centre
The main dining room is on the right with reception offices on the left, with timber banisters used to connect hot dip galvanized steel hand rails (*photo 2001*).**

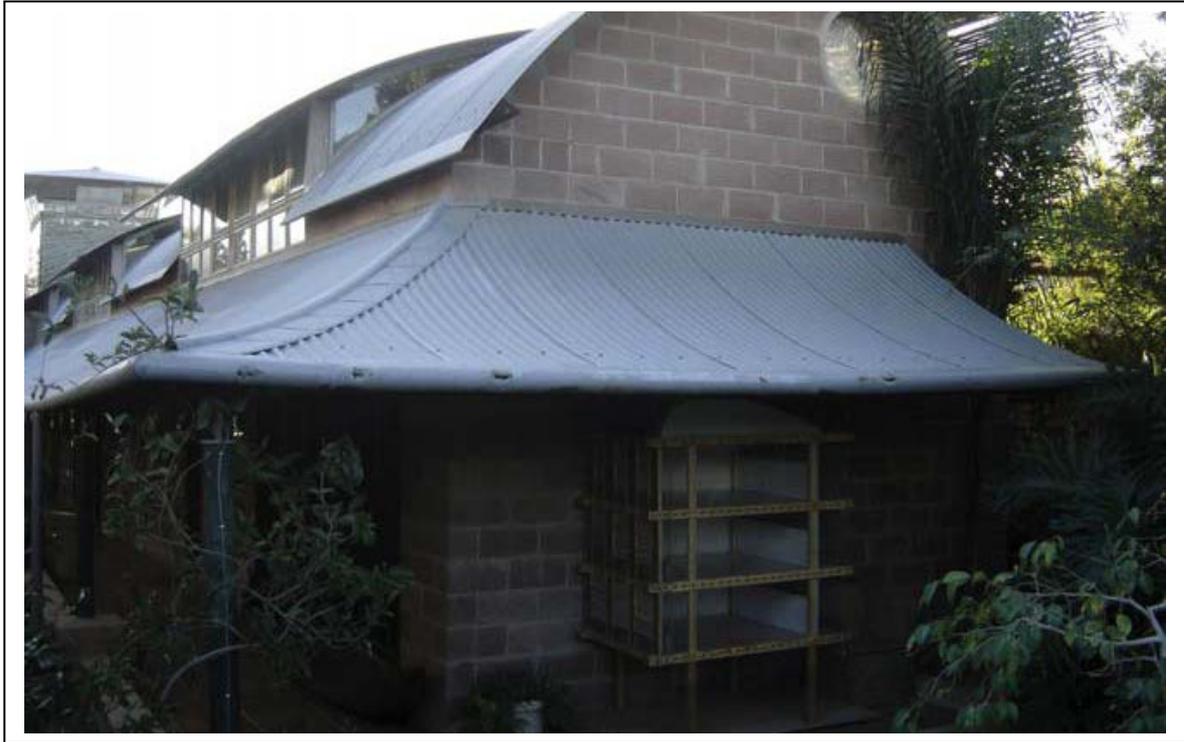
This lip together with dust, debris and leaf deposits from the closest tree together with the normal rainfall, created the conditions for under deposit corrosion and the gutter over these 10 years corroded through in a few areas

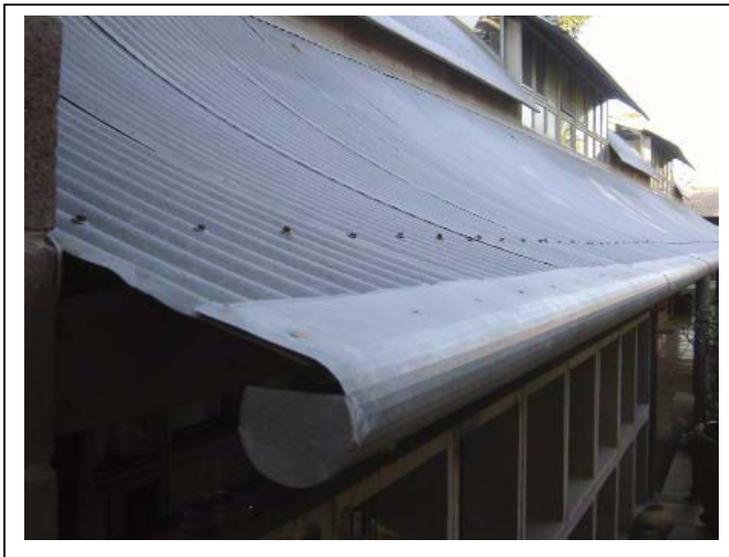
This novel shaped gutter also played the role of a fascia and to added strength a 180° return lip was added on the inside

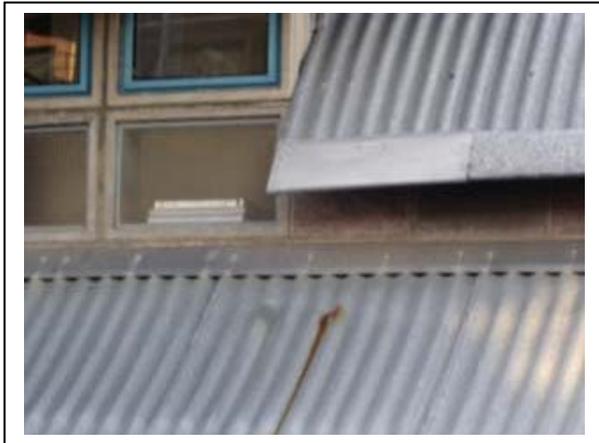
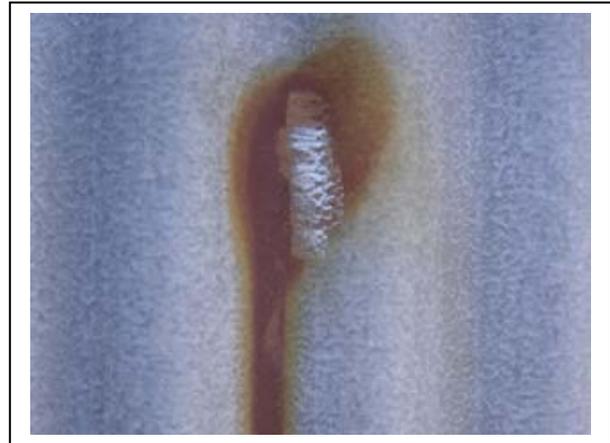
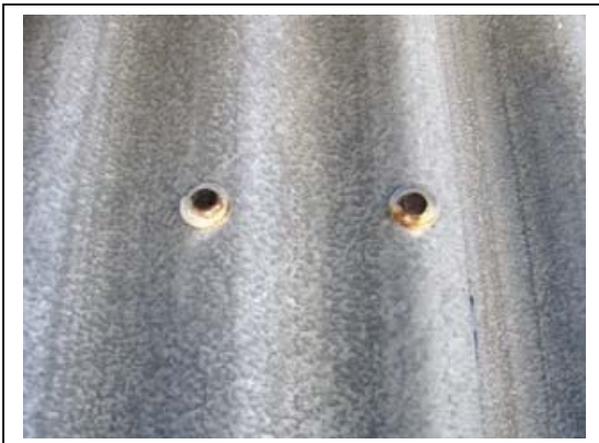
One particular spot on the roof sheet on the North Wing of the building was concerning, however, we found that the discolouration on the roof sheet was as a result of an inappropriately coated fastener, which had corroded to a point that the corrosion products now dripped onto the roof sheeting and caused staining. The coating at the discoloured area, however, proved to be intact and measured more than 30µm.

A number of the original fasteners, which were unfortunately zinc electroplated, were showing signs of discolouration and rust

- Hot dip galvanized roofing steelwork and handrails.
- Hot dip galvanized entrance signage.
- Hot dip galvanized visitor's signage – the electroplated shackles were showing signs of rusting.

When using a zinc coating system, it is a fundamental that service life is proportional to its thickness. "The thicker the coating the longer the service life". It follows that the thinner zinc electroplated coatings on the various screws highlighted, should be suitably cleaned and touched up with an appropriate paint, to ensure a longer durable life span.

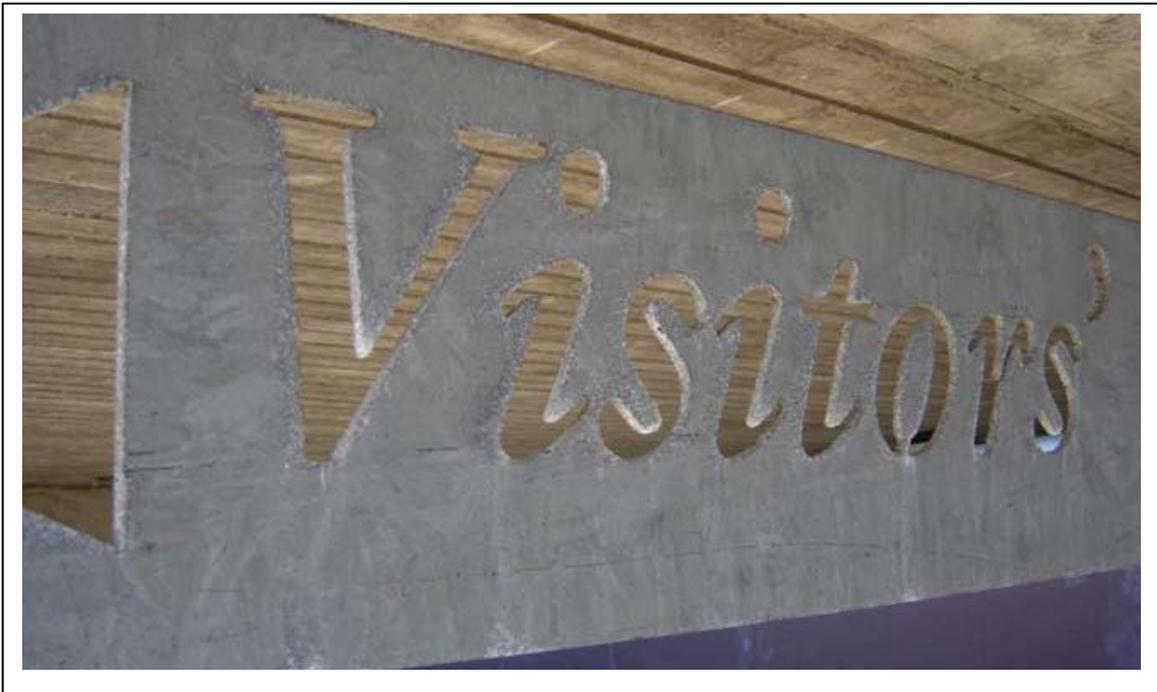
The visitor's sign was also hot dip galvanized as this was the central theme of the establishment
