## **Hot Dip Galvanized Case Study No. 26 Cape Peninsula – Corrosion rates**

This case study examines the environments across the Cape Peninsula and the application of hot dip galvanizing and duplex systems to provide a predictable maintenance free service life.

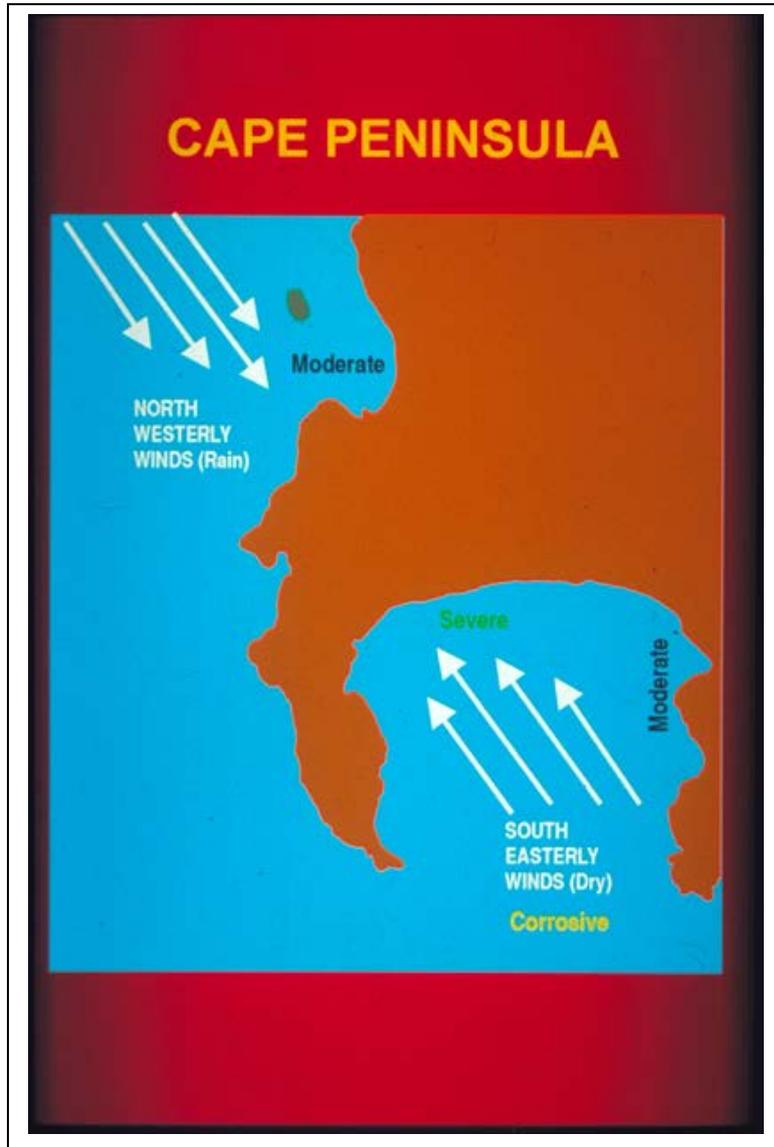
Sketch map of the Cape Peninsula showing the prevailing winds during the course of the year

The South Easterly winds (no rain) carry moist salts from over False Bay and deposit these onto steel structures along the Muizenberg coast line and are extremely corrosive. Gordons Bay is somewhat protected due to the high topographical features behind the town area.

The North Westerly and Westerly winds (rain) carry salts from the Atlantic, deposit these onto steel structures, but also has the washing effects from the rain. It is also significant that the topographical features (Table Mountain) also provide protection from the South Easterly winds.

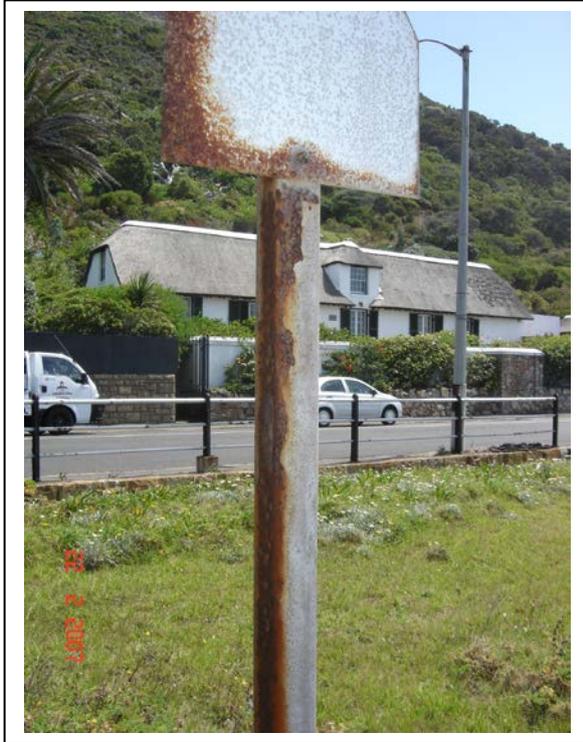
**A railway sign post photograph taken in 2007**

**Corrosive attack on the area face on to the South Easterly is extremely severe**

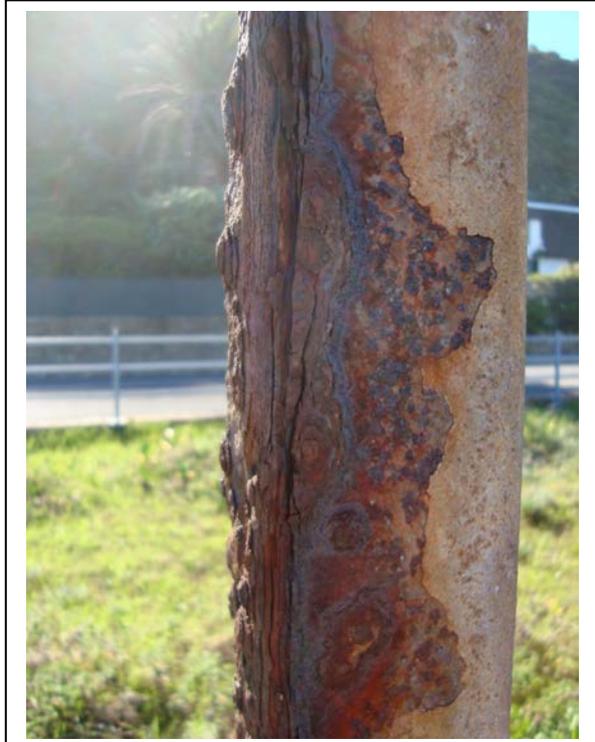
**A 2015 close up photograph of the same post showing the advanced state of corrosion to the point where the steel has been perforated**

It is of interest that the sides of the sign post and particularly the one on the lee side remains effective and provides corrosion control against the general atmospheric conditions. The area face on to the South Easterly is severely corroded due to moist salts (chlorides) that are retained within the shaded area away from the drying effects of the sun.
