GALVANIZING

HOT DIP GALVANIZERS ASSOCIATION Southern Africa

The world of hot dip galvanizing around us
Duplex coatings, coating report and galvanizing failures
Snap shot of the 2007 Eskom Awards Evening and
'Call for Nominations' for the 2008 Awards event
2008 Galvanizing Conference

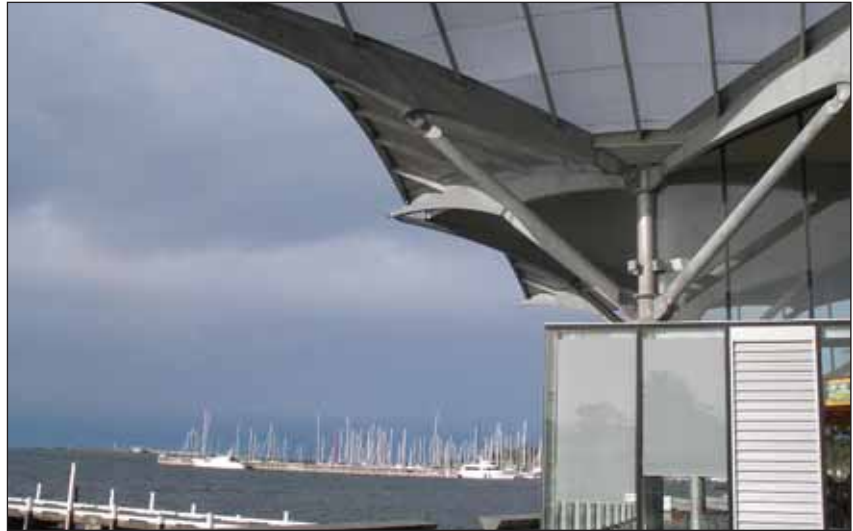
Geelong Carousel Pavilion looking out onto boat harbour.

The design and fabrication of the structure paid due consideration to corrosion through the use of bolting to

eliminate welding where possible, the minimization of "corrosion hotspots" due to proper detailing and the expanded metal roofing that reduced the wind loading and allowed the washing effects of rain on external steelwork.

It has been open for 6 years and has required no maintenance in that time. This is important since it means that the Carousel does not need to be shut down for any period of time. The steelwork is in excellent condition and all the galvanized coating thicknesses taken proved to be 2 to 3 times in excess of the coating thickness required by AS/NZS 4680.

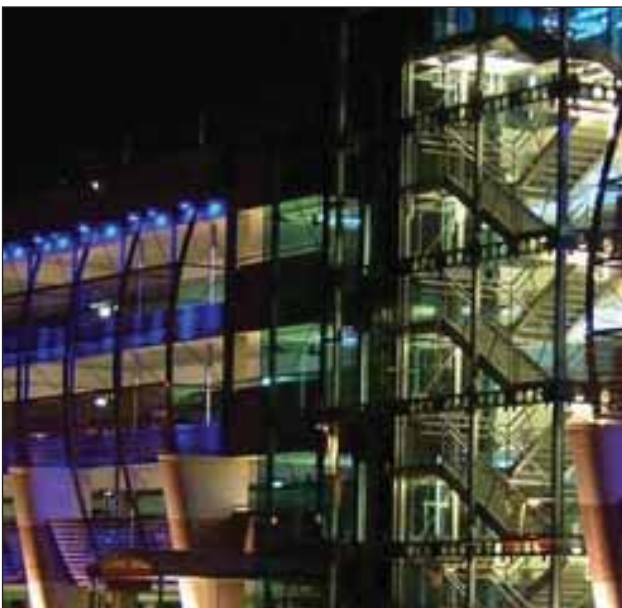
Charlotte Douglas International Airport, Parking Garage.

In order to accomplish this design, the architect and engineer decided to attach stainless steel cladding to a galvanized structural steel frame. Three hundred tons of hot dip galvanized steel was used in the project including: bow-string trusses, embed plates and anchors, stair towers, stairways, hand rails, and castellated beams.

Galvanized steel was specified for its exceptional maintenance-free service life, overall aesthetic appearance, and compatibility with stainless steel. When

used together, galvanized and stainless steel provide a uniform appearance and an economical alternative to specifying stainless steel for the entire structure.

By specifying a hot dip galvanized coating instead of a paint system, the garage will not require costly maintenance due to the constant vehicle and pedestrian traffic it will accommodate. Furthermore, the galvanized coating will allow the structure to remain a corrosion-free, attractive piece of the airport landscape well into the future.

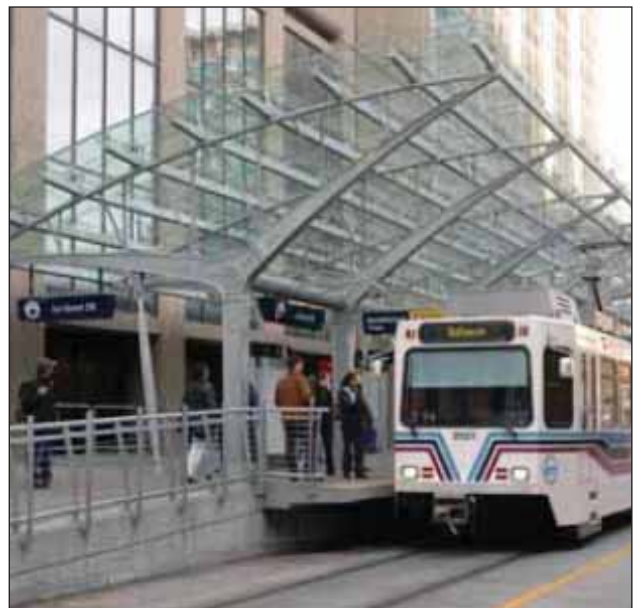
7th Avenue Light Rail Transit refurbishment.

The City of Calgary, Alberta is a leader in the use of hot dip galvanizing and duplex systems for infrastructure. Over the past decade, duplex systems have been used extensively on major overpass guardrails and pedestrian rails. Recently, the city specified hot dip galvanized reinforcing steel in all bridges. So when the city was ready to refurbish the 7th Avenue Light Rail Transit (LRT) System, hot dip galvanizing was the logical choice.

Because many commuters rely on the rail system, turnaround time was of the essence. The system had to be de-energised, erected, and re-energised in a 72-hour timeframe to minimise the impact on commuters.

To create a uniform appearance, all hardware, hollow structural steel cords, tension members, columns, upper and lower arms, ornamental light posts, handrails, benches, and trash bins were hot dip galvanized. The durable coating will be able to withstand the extreme winter climate and constant foot and rail traffic, while remaining aesthetically appealing. Following the success of this project, there are plans for up to 14 more similar station refurbishments in the near future.

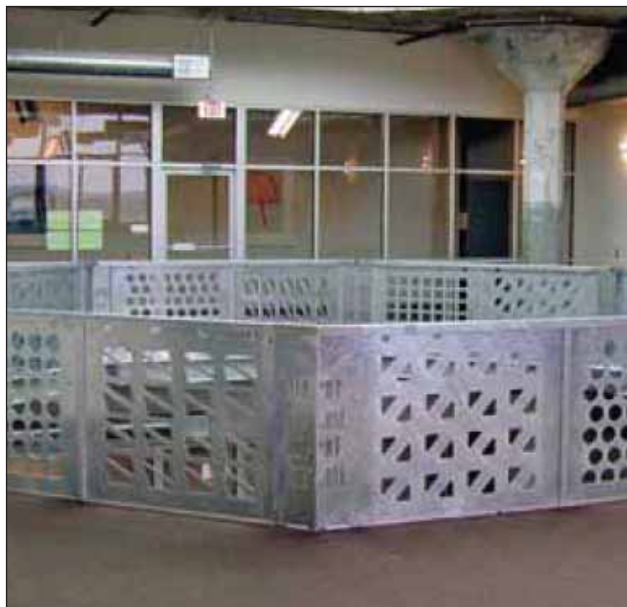
The hot dip galvanized laser skeletons provide a low maintenance but stylish stairwell balustrade in the Tip Top building .

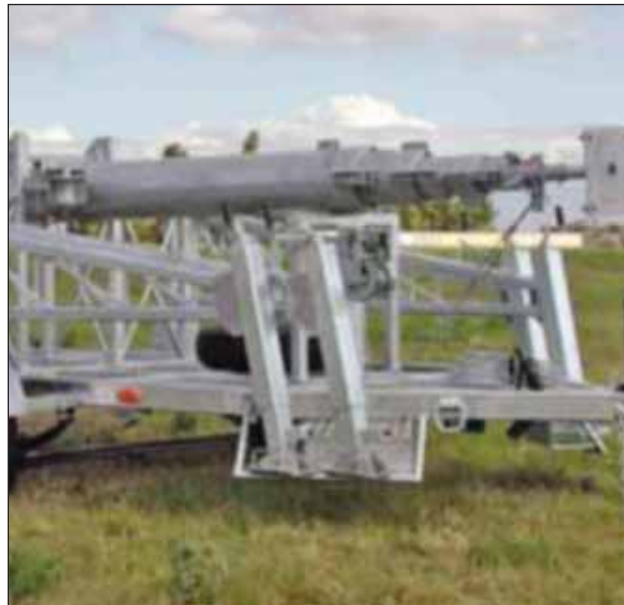
The trailer, fender, outrigger, and tower components were all galvanized for corrosion protection. The durable galvanized coating can withstand the rigors of international transport and handling of the systems, as well as the intense environment where they are installed.

Rapid Aerostat Initial Deployment System.

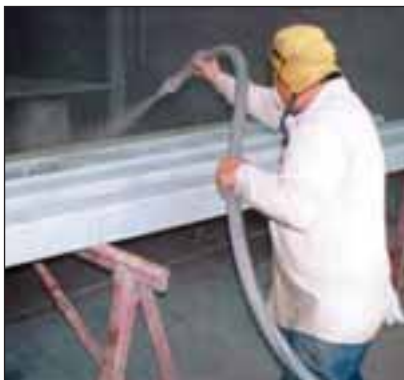
Sweep blasting at a blast pressure of less than 200kpa and correct angle removes the zinc corrosion products and roughens the surface to make a good profile for paint adhesion.

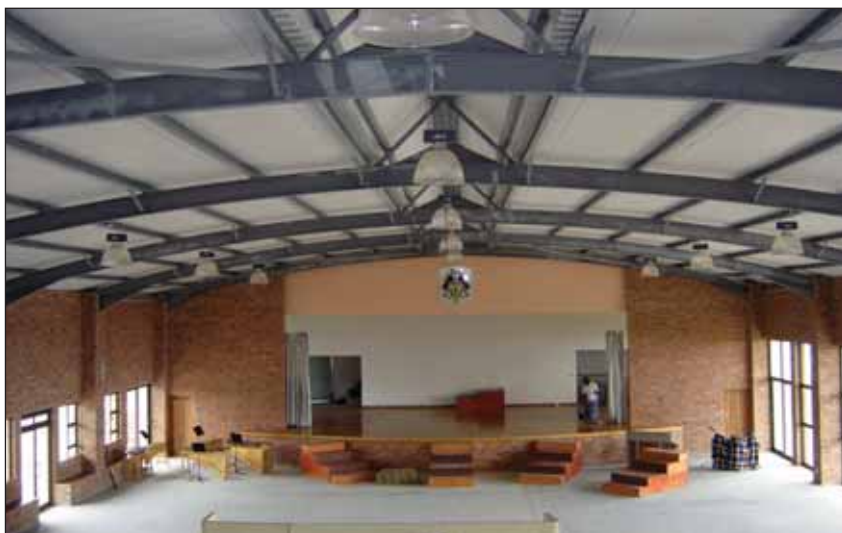
Hot dip galvanizing was used to protect the structural steel supporting the roof cladding.

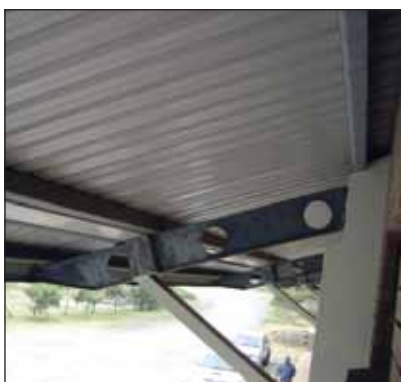
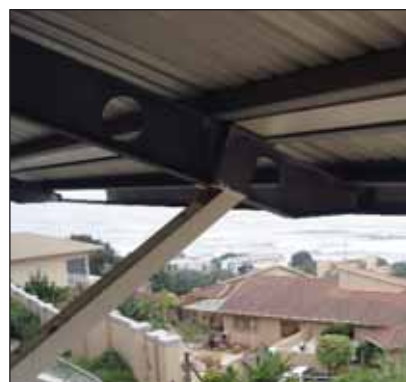
Photo left, showing the eaves from upstairs on the landward side and photo right, the eaves on the seaward side, indicating the different micro-climatical conditions that the hot dip galvanized coating is subjected to.

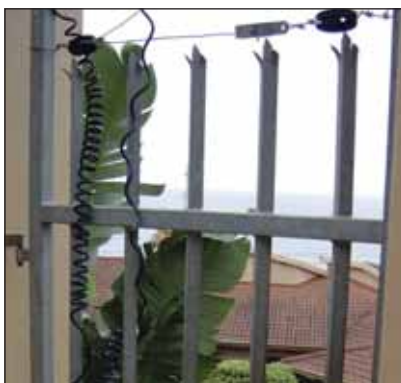
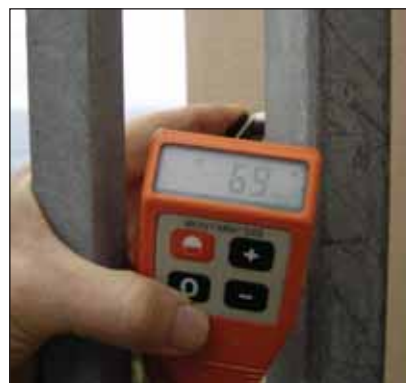
The pedestrian gate was installed in 2004 (left) and from coating thickness readings (right) the coating was hardly affected and in good condition. There were no signs of surface zinc chloride on the coating.

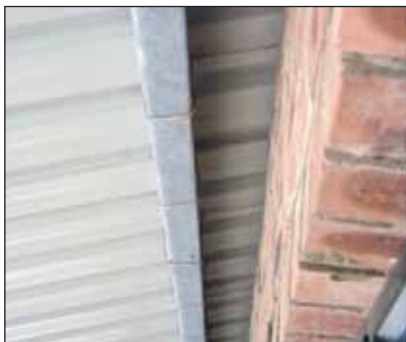
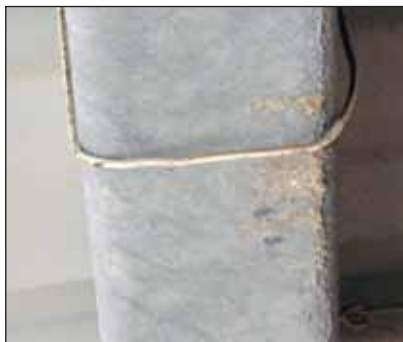
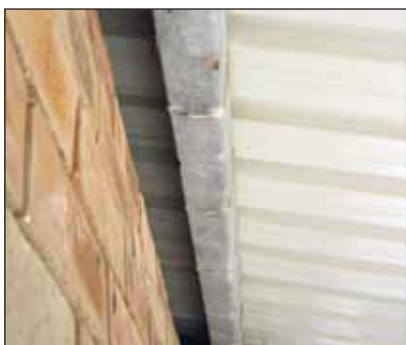
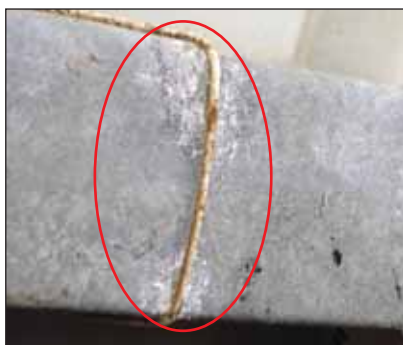
Top left, eaves purlin on the landward side and right, close up of the insulated wire, used to support the internal roof insulation. Note there is very little or no reaction between the insulated wire and the hot dip galvanized purlin, whereas, on the seaward the same cannot be said. Bottom left shows a general view of the eaves purlin on the seaward side with a close up, bottom right, showing the bulky zinc hydroxide product adjacent to the insulated wire.

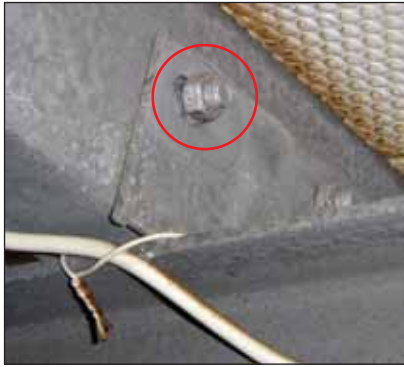
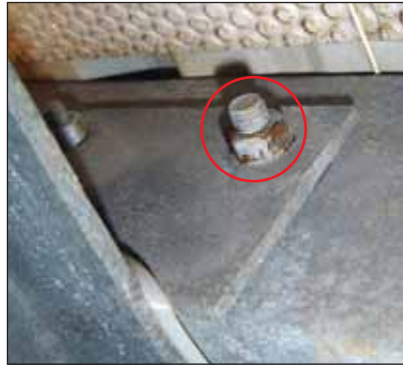
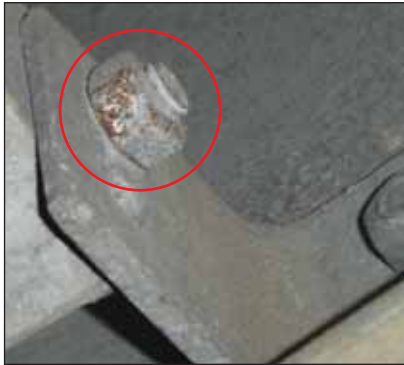
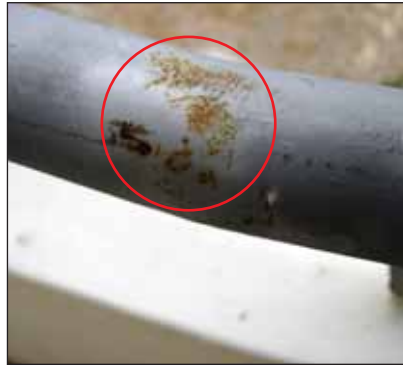
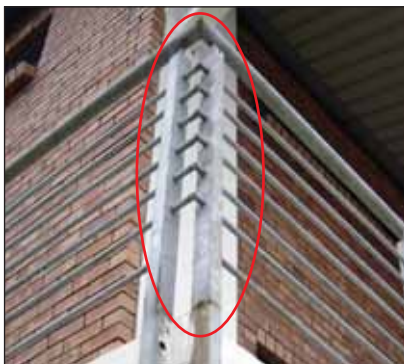
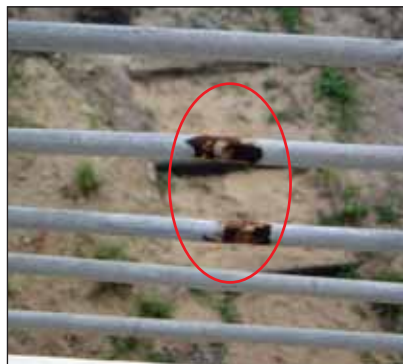
All fasteners were zinc electroplated providing less corrosion protection than an equivalent hot dip galvanized fastener. It was also noted that several hot dip galvanized components were subsequently welded and the coating insufficiently repaired, see photos. The areas of concern require attention using an appropriate coating repair material such as "Zincfix" or equal.

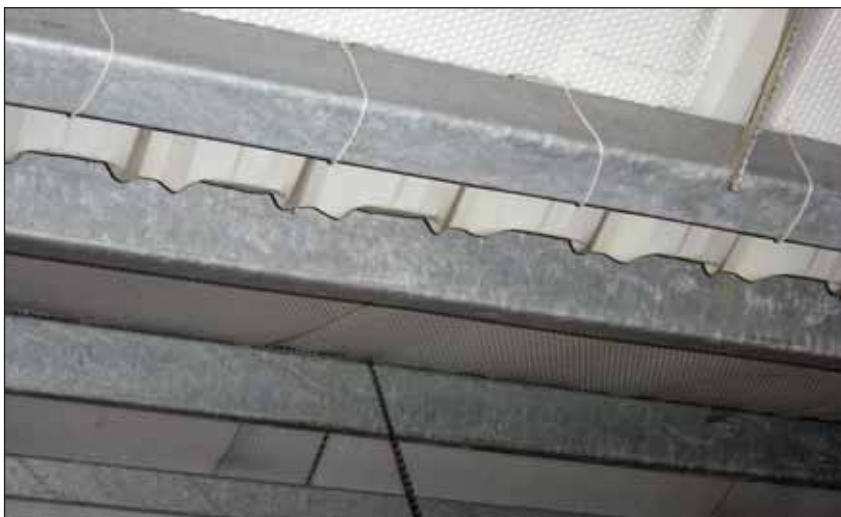
The insulating wires fixed to the hot dip galvanized purlins inside the building have no effect due to the mild interior conditions.

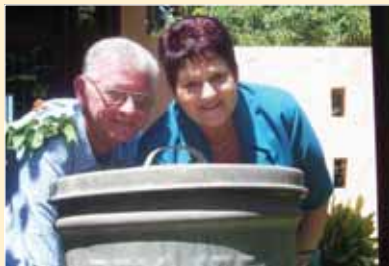
This remarkable piece of hardware has withstood the test of time. Recent coating thickness tests reveal that the hot dip galvanized coating is still in a remarkably good condition and the bin, unlike its pensioner owners, will not be going on retirement anytime soon. The trusty bin will be celebrating its 40th year of service a week before the Strydom couple’s ruby wedding anniversary in June 2008. Our warmest congratulations to all concerned!

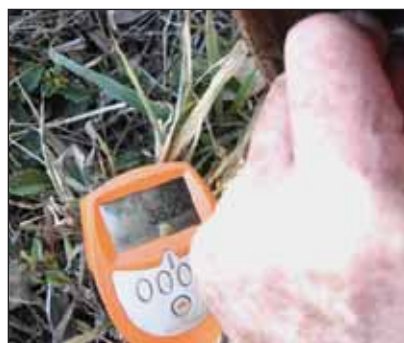
Coating thickness reading taken on the cleaned internal surface of figure 2 measured 38.2µm.

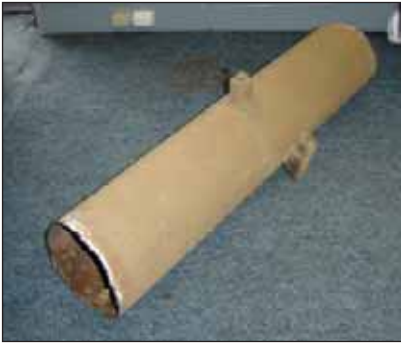
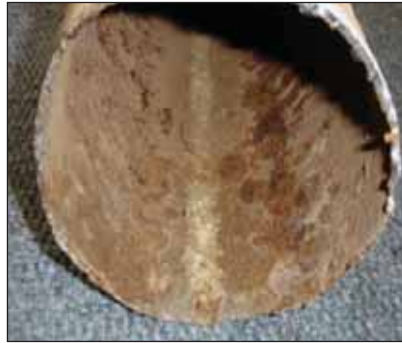
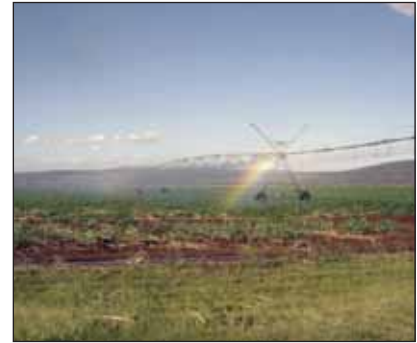
Sample pipe recovered from a 10-year-old centre pivot. Pipe was removed from service due to mechanical damage to the machine.

In addition to the water samples, a section of pipe was recovered from a centre pivot that had been mechanically damaged. The section of pipe was also reported to have been in service for approximately 10 years. This particular machine was on a farm located approximately 10kms from Malelane.

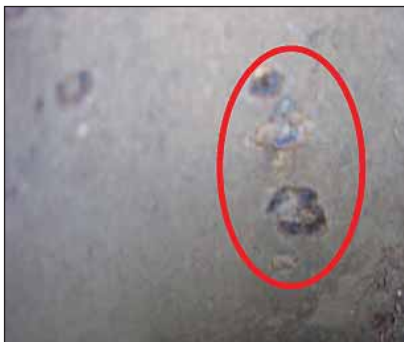
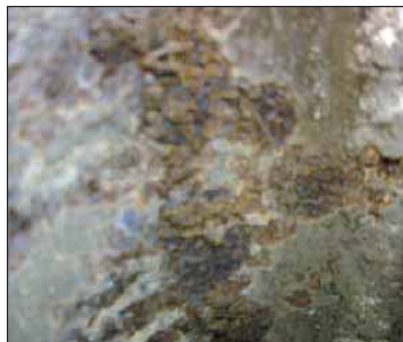
Zinc usually corrodes uniformly, but when localised or "pitting corrosion" is in evidence, it is found that one or other form of bacterial corrosion is the underlying cause. The two photographs shown above are taken from within the same pipe.

2. There is evidence of "pitting corrosion" typical of bacterial corrosion, such as sulphate reducing bacteria (SRB) or alternatively "iron oxidising bacteria" (IOB). It would appear that we can exclude SRB as a possible cause of corrosion, but the evidence is typical of bacterial attack, for which there are numerous types.
3. It is also possible that "iron products of corrosion" from upstream in the reticulation system, are washed down into the centre pivot, where it will cause the zinc to work "twice as hard" in protecting not only the pipe, but also the iron residues from elsewhere in the system. Such residues tend to settle within lower sections of pipe and tend to

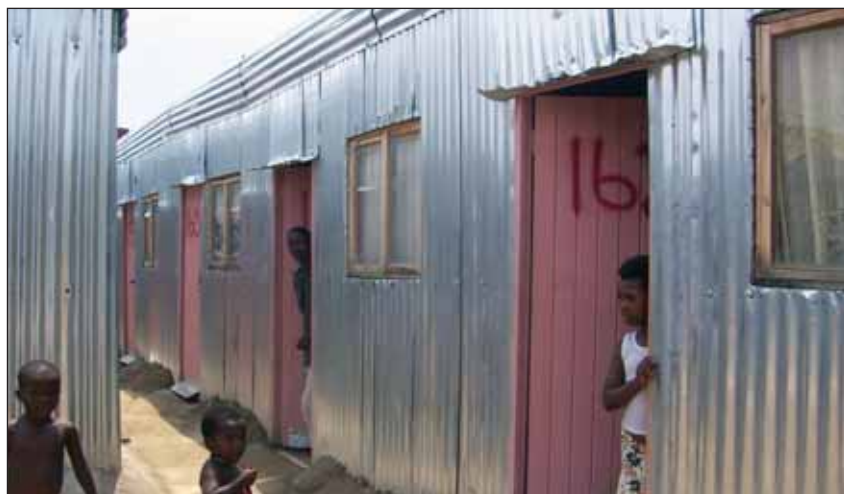
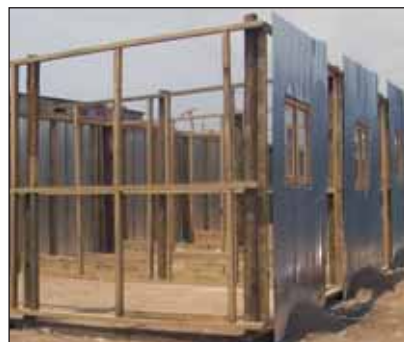
one squatter camp fire could potentially leave as many as 200 families homeless! Hot dip galvanized sheeting was the natural choice of material, due to its resistance to the corrosive Durban environment. The longevity of the hot dip galvanized coating is also an advantage as the units are re-used once families move on to their new homes. Dealing with the sweltering Durban heat has also been dealt with effectively as all the units are clad with masonite boards inside, which act as insulation. Converted containers are implemented as ablution facilities.

Editors comment: Although not 100% accurate for sheeting, the coating thickness readings taken by means of an electro magnetic coating thickness guage, indicates that the sheeting conforms to a Z200 class of coating. 🇿🇦
