## Hot Dip Galvanized Case Study No. 2 Storms river bridge

### Findings

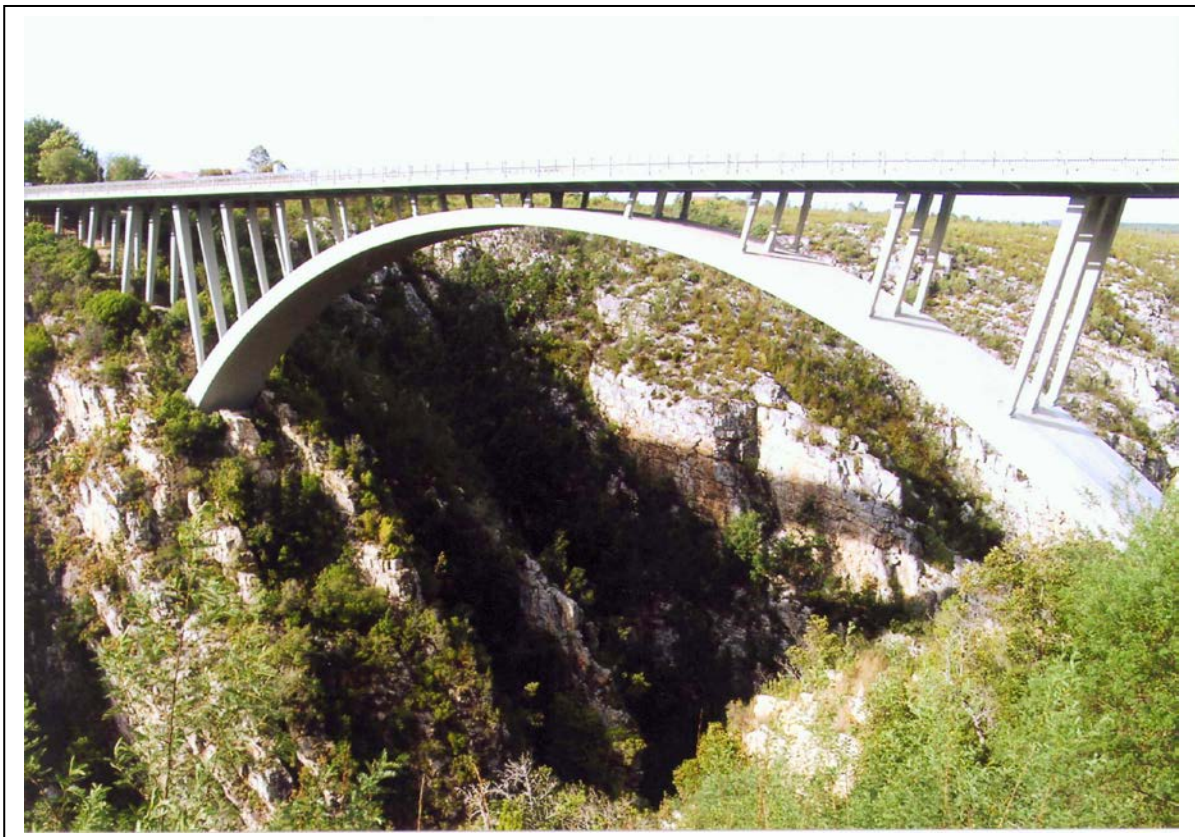
The Storms River Bridge is to many bridge designers and contractors alike,  
a symbol of bridge construction in South Africa

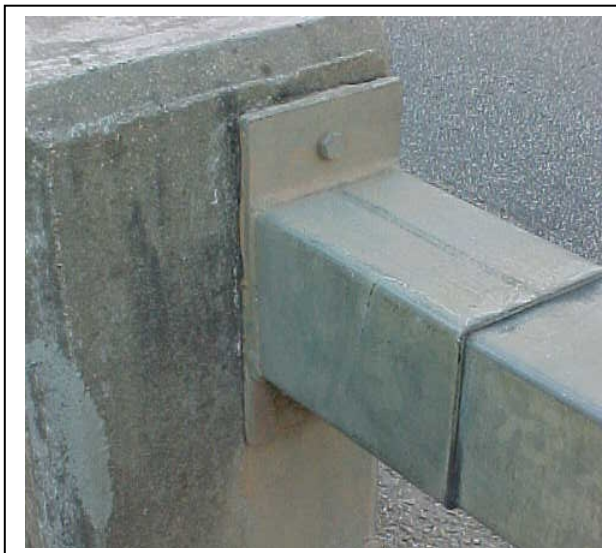
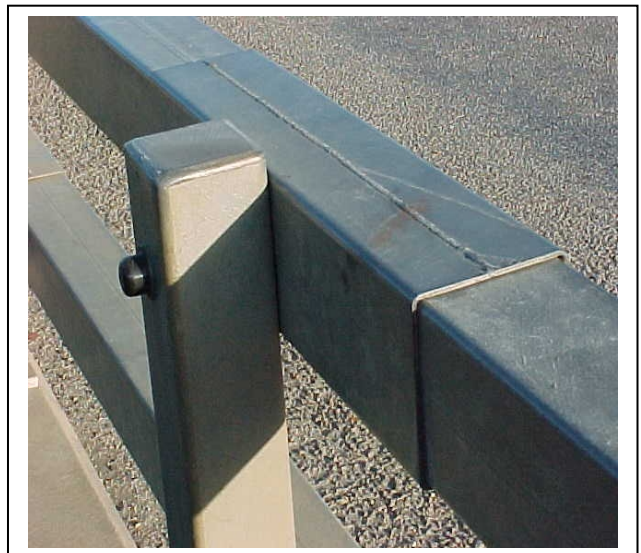
**Hot dip galvanized slip joint designs to eliminate a requirement for unnecessary site alterations, compromised service life and illumination of coating repairs**

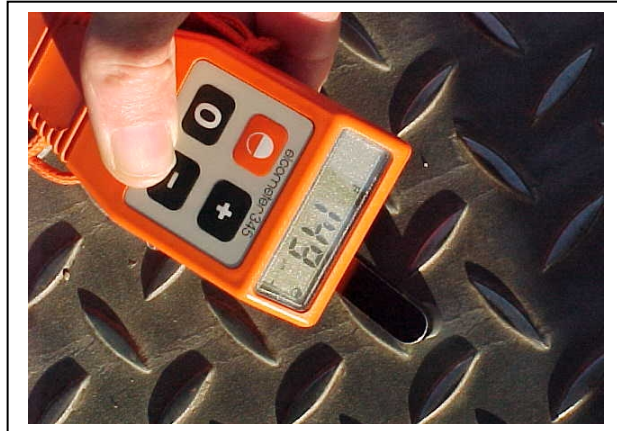
The hot dip galvanized coating is in excellent condition and coating thickness readings were all far in excess of the heavy duty coating (105µm) originally requested.

**General view of the “Vastrap Plate” walkway that shows coating thickness adjacent to the anti-skid ridges of 149µm**

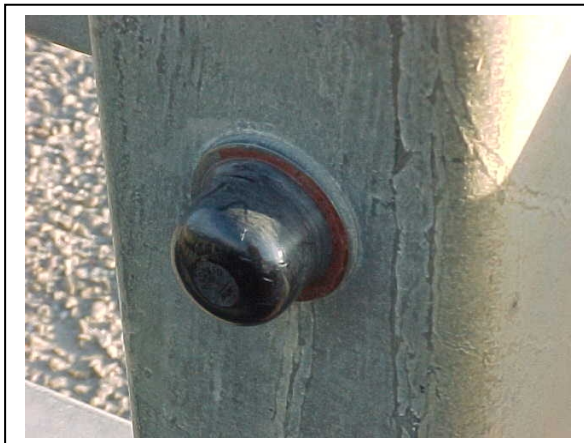
**Plastic covers filled with silicon were introduced to seal fasteners and to increase maintenance free service life**

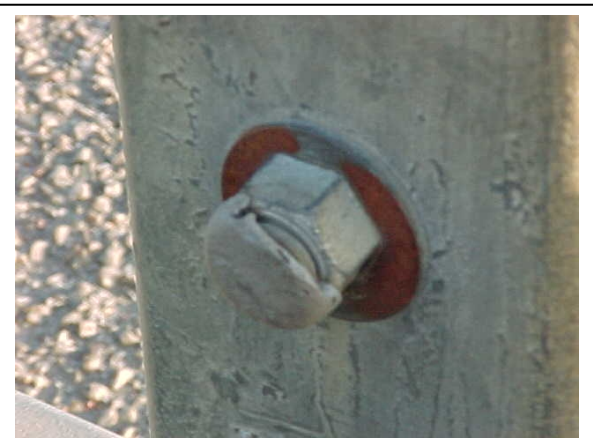
**Balanced design of structures is achieved by the use of hot dip galvanized fasteners throughout an installation**

**It would appear that the electro-plated wash is corroded due to an inadequate zinc coating thickness**

After approximately 18 years of service, the hot dip galvanized coating continues to provide a maintenance free life and to achieve design criteria. Some fasteners, which were originally inadequately coated (possibly zinc electro-plated), require coating repair. Adequate repairs to these specific areas, the bridge will continue to provide effective corrosion control and a maintenance free service life.

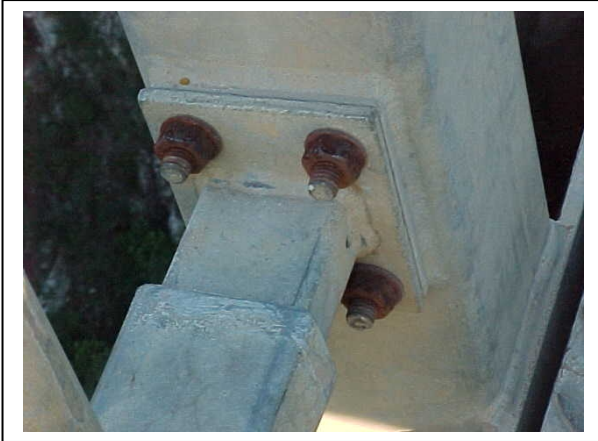
**Electro-plated fasteners that have corroded due to insufficient zinc coating thickness**

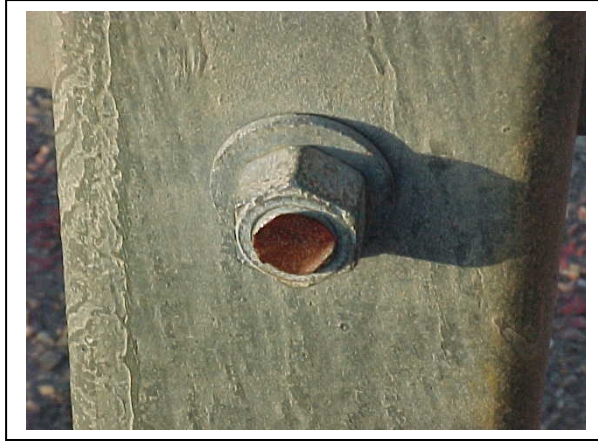
**Corroded bolt end cut off after installation; note the absence of under corrosion creep**

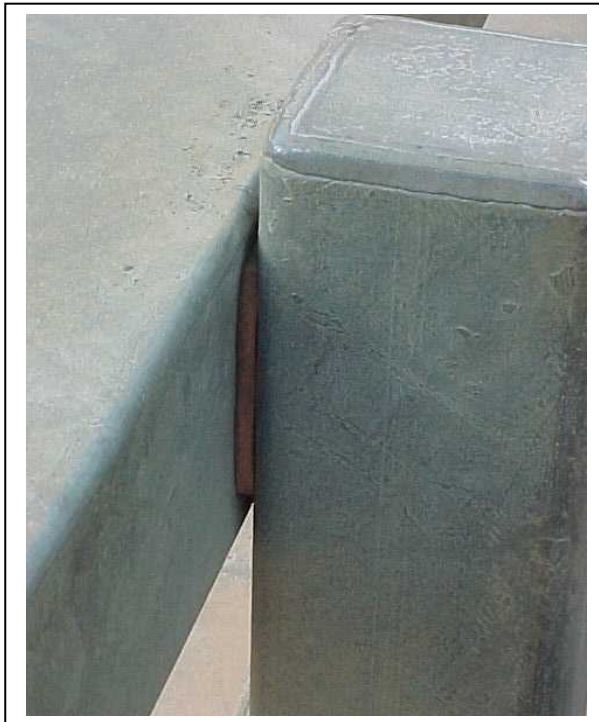
**Seal crevices at junctions to avoid the ingress of moisture and the potential crevice corrosion**

**The example illustrates the use of an insulating pad between the mating parts**
