Hot Dip Galvanized Case Study No. 12 Douglas Colliery Conveyors

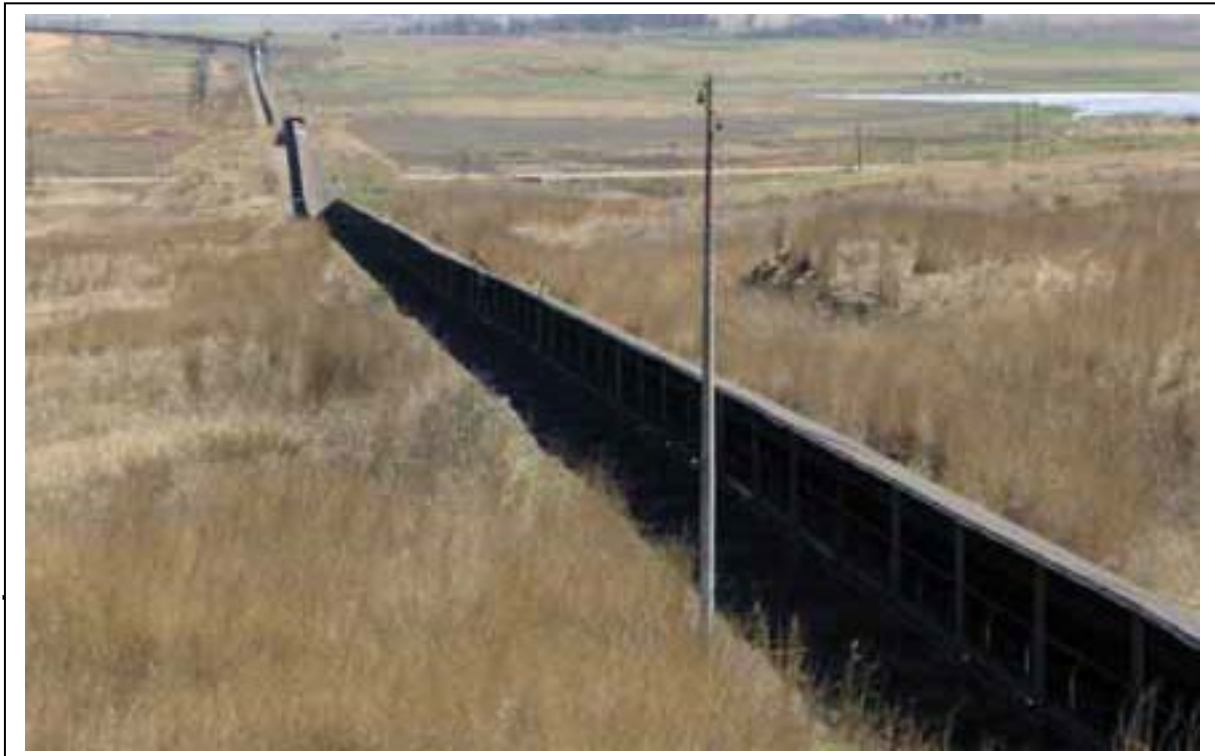
A photograph of the V3 overland conveyor that has been exposed to the atmospheric conditions for the past 20 years and is estimated to continue for a minimum of another 10 years

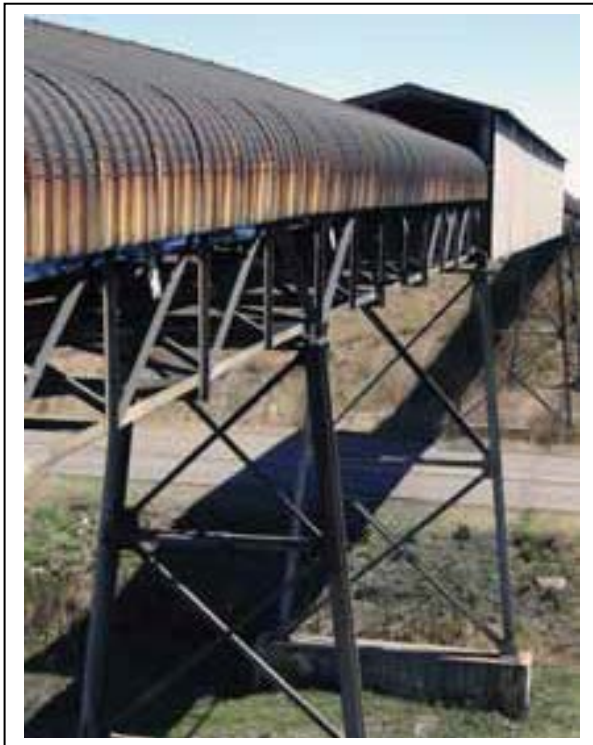
The hot dip galvanized structural steel supports at an access road, is in exceptional condition 20 years after installation, not so the sheeting that would in all probability have been a Z275 material with $\pm 20\mu\text{m}$ per side

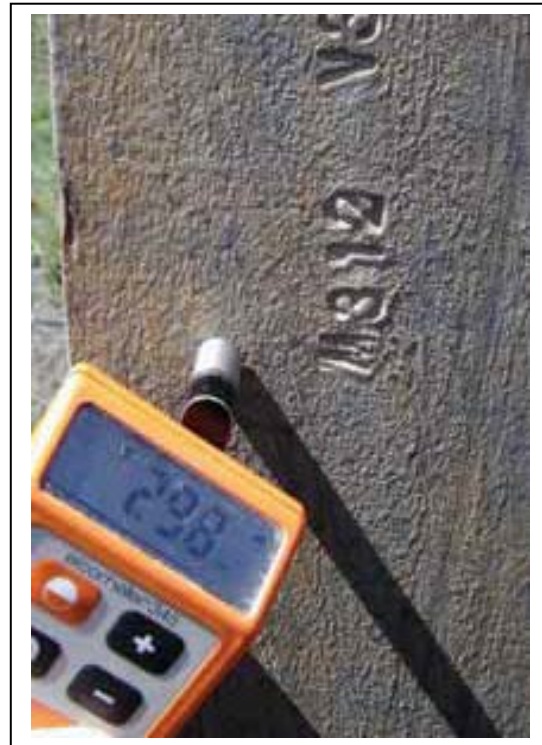
Coating thickness readings (298 μm) taken on the supporting structure that remains in excess of the specification requirement

Following several visits to sections of the V3, V4 and V5 conveyor it was established that the hot dip galvanized coating on the horizontal and vertical members were in excellent condition. Coating thickness measurements were in a range of 117 to 279 μm with a mean coating thickness of 140 μm . In total 108 coating thickness readings were taken on both the horizontal, vertical and angle support members. All measurements were well in excess of that required by the specification SANS 121 (ISO 1461:1999). In total 108 coating thickness readings were taken on both the horizontal, vertical and angle support members.

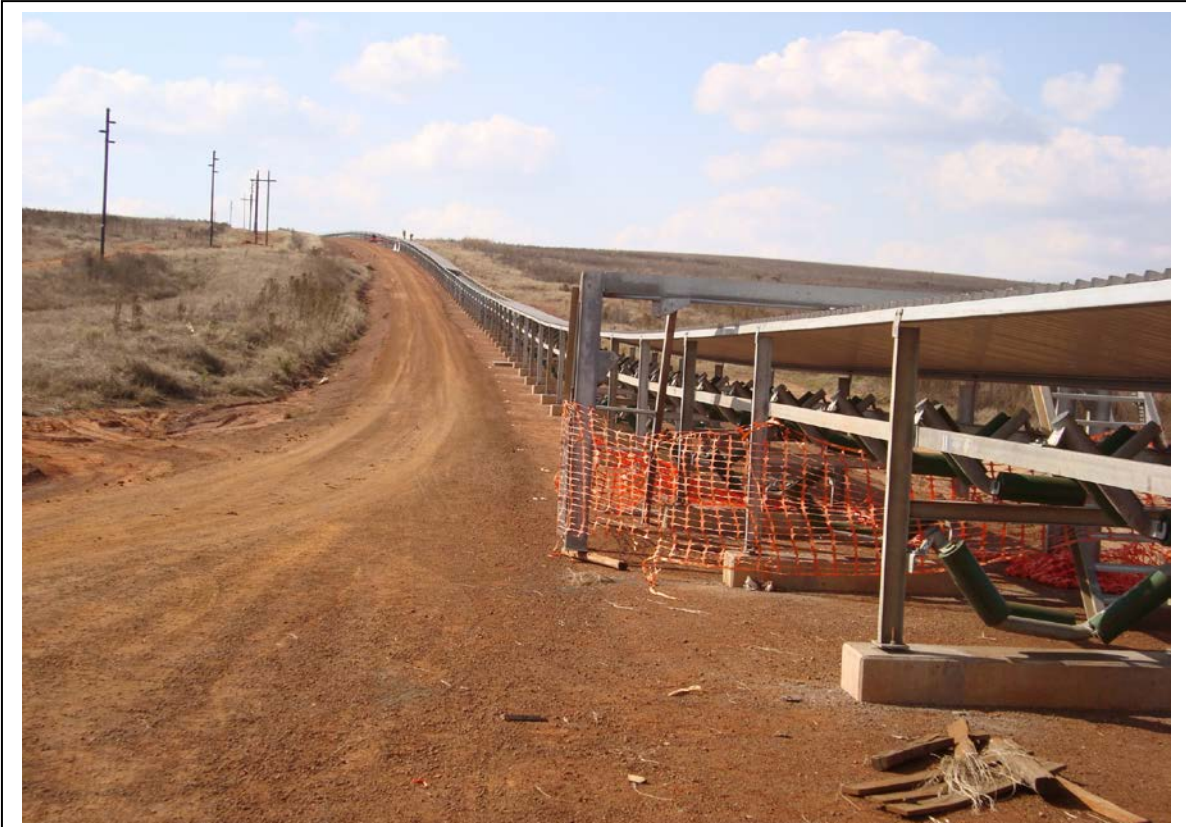
Installation of a new long haul overland conveyor system as part of coal mining in the Witbank area

All the structural support steel was hot dip galvanized for corrosion control and an extended service life
