Evaluation of the hot dip galvanized coating at Pentrich Sub-Station, Mkondeni, Pietermaritzburg

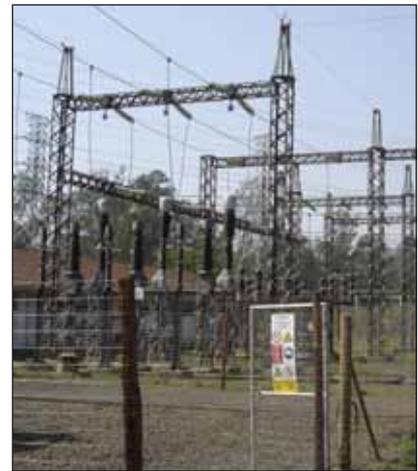
General photo of Pentrich Sub-Station.

In spite of the atmospheric conditions the hot dip galvanized coating has corroded very little in the 40 years of exposure.

The residual hot dip galvanized coating on the structural steel after 40 years of exposure to the atmosphere of Mkhondeni, Pietermaritzburg, is in a sound condition and will not require any refurbishment for another 40 years.
