# The performance of Pandrol rail fasteners in a marine environment on the Natal South Coast

Two sites were selected on the Natal South Coast for this study, viz, Park Rynie some 65kms south of Durban and Port Shepstone, 115kms south of Durban. Both areas were selected on the basis of their proximity to the sea being within 100 to 200 metres of the high water tide level. Surrounding corrosive conditions were observed by the review of other steel components in the area.

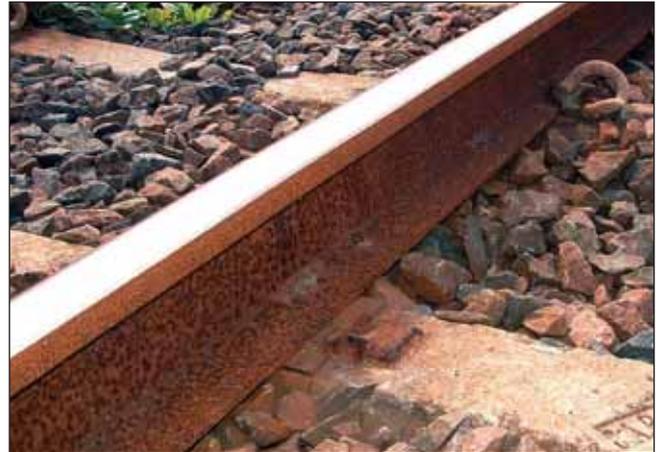
Figure 7.

- The sea is approximately 200 metres to the left of the Port Shepstone site and the town some 6kms further south (*figure 5*). Zinc coating thicknesses measured as follows: 136 $\mu$ m minimum, 154 $\mu$ m mean and 197 $\mu$ m maximum.
- The seaside (using an ungalvanized cast iron) shoulder had corroded away exposing the hot dip galvanized Pandrol (*figure 6*). The holding capacity of this particular fastener has become totally ineffective. Note the condition of the "land (lee) side" of the rail, where the system is intact and operative.
- *Figure 7* shows an example of a missing fastener, where the "ungalvanized" cast-iron shoulder is presumed to have

corroded away, allowing release and removal of the hot dip galvanized Pandrol fastener. No trace of the Pandrol rail fastener was found.
