## **Hot Dip Galvanized Case Study No. 15 Pentrich Sub-station, Mkondeni, Pietermaritzburg**

**Pentrich Substation** lattice steel structures were examined in order to establish the condition of the hot dip galvanized coating after 40 years of service life.

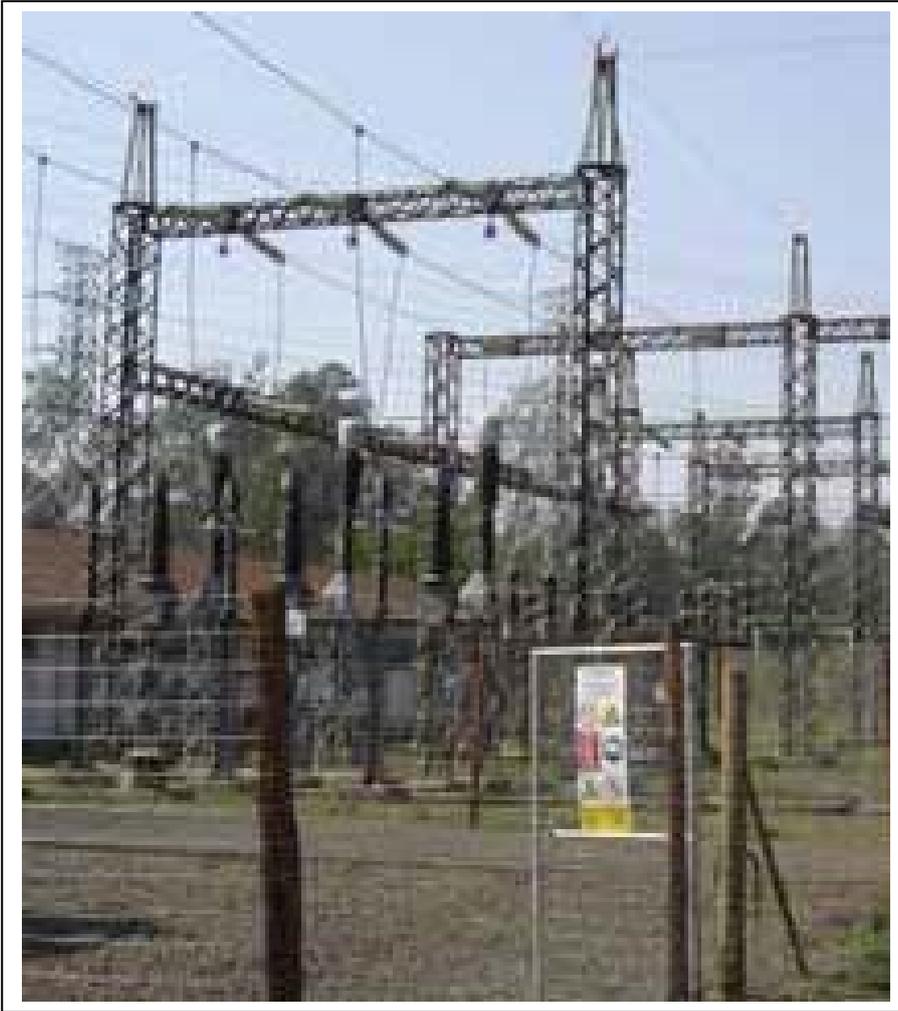
**General view of the  
Pentrich sub-station**

**Examination of the hot dip galvanized steel indicated that no maintenance would be required and the “rust staining” was found to be that of surface contamination**
