# **Mitchelsplein Train Station / Transport Interchange**

Case History No. 03/2005

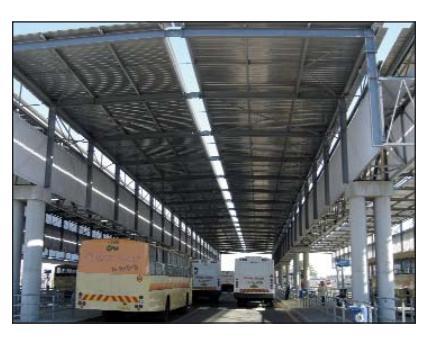
An end view of one of the bus shelters which forms part of the new Transport Interchange.

Due to the performance of the hot dip galvanized coating in this instance it was decided that the coating on its own be specified for the protection of all the steelwork in all the phases of the Transport Interchange currently being erected adjacent to this site. See a photo of a general view of the transport interchange below.

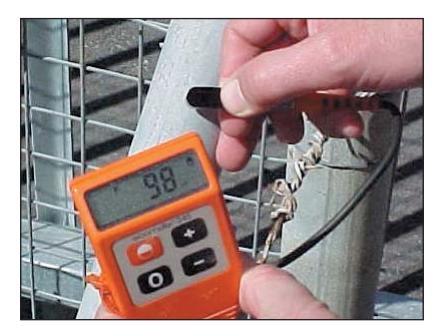
The residual coating thickness on the light pole  $(95\mu m)$  and on the diagonal fence support  $(98\mu m)$  is still in excess of the coating thickness required by the specification (SANS 121) after 26 years of exposure. The specification requires

General view of the hot dip galvanized fence support installed in 1979 (26 years old).
