Technical Paper

Duplex Coatings – An Overview

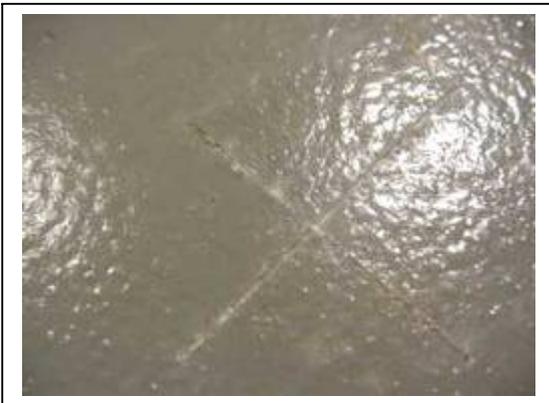
Photograph No. 1: Hot dip galvanized + epoxy primer + polyurethane acrylic enamel, after 4000 hours of salt spray.

After 4000 salt spray hours the barrier protection is fully intact. Where the coating has been cross scribed, the underlying hot dip galvanized coating is reacting through cathodic protection and thereby providing corrosion protection to the steel. No red rust is apparent on the damaged crosshatched surfaces. No corrosion creep has developed.

The comparative photographs 1 and 2 illustrate the benefit of a hot dip galvanized substrate under an organic coating system.

Both examples illustrated above are excellent corrosion protective coatings. Photograph 1 is a duplex system, while photograph 2 is a zinc rich primer with similar intermediate and top paint systems. The two photographs illustrate their relative performances and highlight the synergistic benefits of duplex coatings.

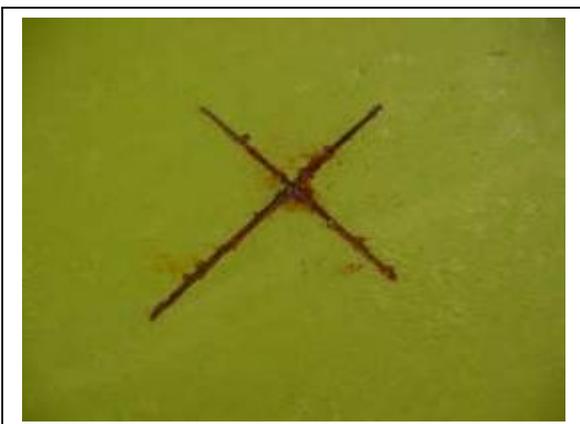
Photograph No. 2: Abrasive blast + inorganic zinc + epoxy primer + polyurethane

After 4000 salt spray hours the barrier protection provided by the 3 layers of paint is providing good corrosion protection to the steel, but is also exhibiting signs of “cracking” together with porosity. The inorganic zinc is providing no significant cathodic protection.

Red rust is apparent within the damaged crosshatched surfaces. Little or no apparent development of corrosion creep is in evidence.
