Hot Dip Galvanized Case Study No. 24 Richards Bay Pontoon

The Application

Berth 208, a new bulk liquid berth, in the Port of Richards Bay. This berth shares the border with the eChwebeni Natural Heritage site, which is of conservation significance, consisting of an ecologically sensitive mangrove area.

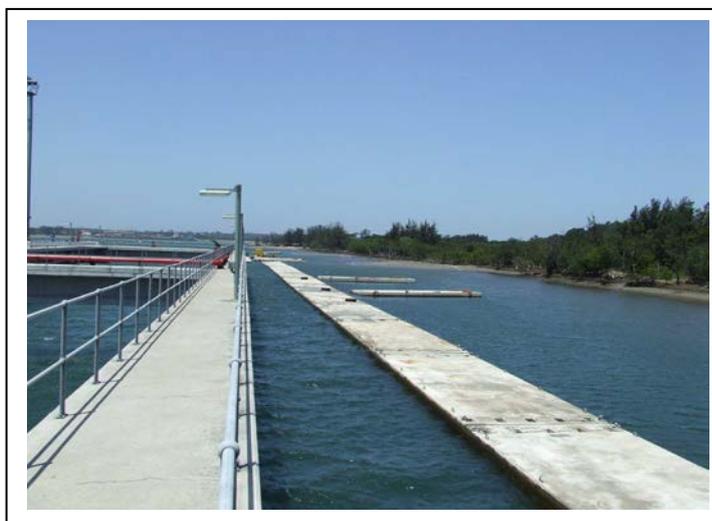
**Completed pontoons
in operation**

**Expected service life
well in excess of 35
years with hot dip
galvanized
reinforcement within
a severe marine
environment**

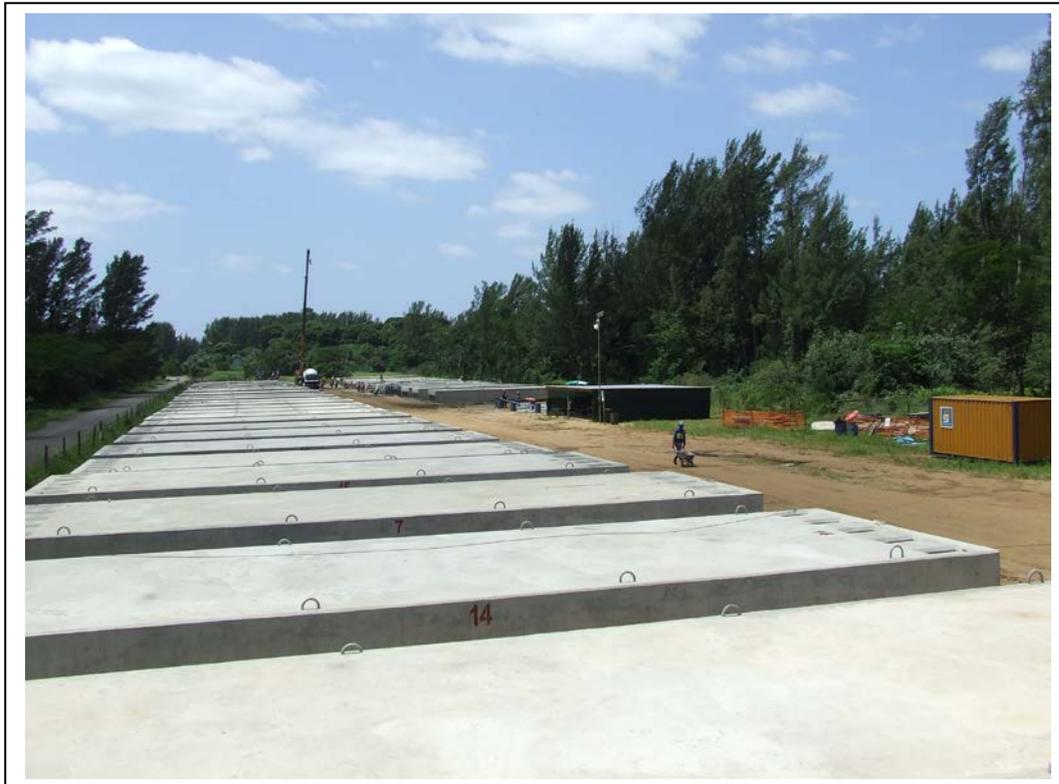
A total number of 44 concrete pontoons with galvanised reinforcing, each weighing approximately 63 tons and being 15m long x 5m wide and 1.5m deep were precast and lifted into the water and moored into position.

Completed Concrete pontoons waiting installation

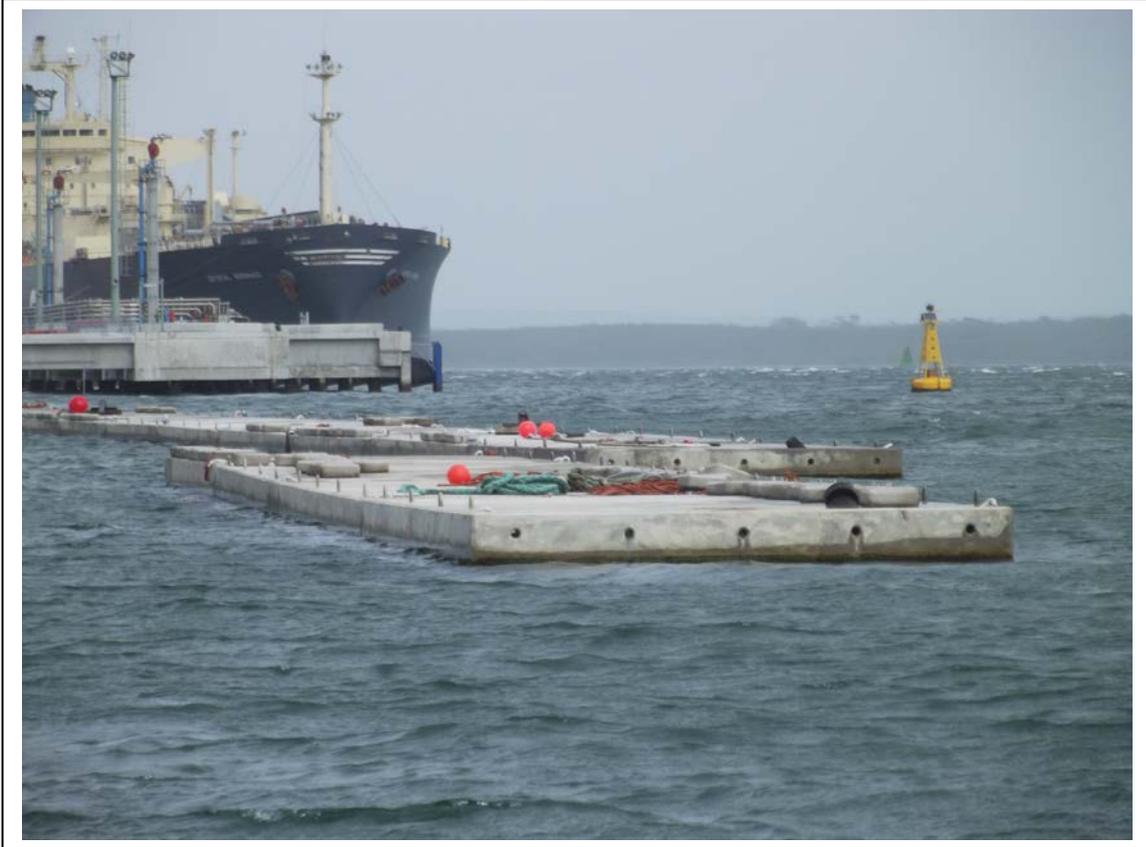
The pontoons are coupled together with specialised connectors and then moored to the seabed. The pontoons will extend over a distance of approximately 700m from the existing walkway of Berth 208 to Spinach point. They act as a floating wave attenuating structure to protect the environmentally sensitive mangrove area from further erosion and sand deposition blocking the drainage channel into the mangrove swamp area.

Hot dip galvanized reinforcement in cast concrete pontoons being floated out in preparation for positioning and anchoring to the sea bed
